REPORT OF INVESTIGATION

Facility  
(Dolomitic Lime)

Fatal Slip or Fall of Person Accident  
October 16, 2025

MLC-Bonne Terre  
MLC  
Bonne Terre, St. Francois County, Missouri  
ID No. 23-02371

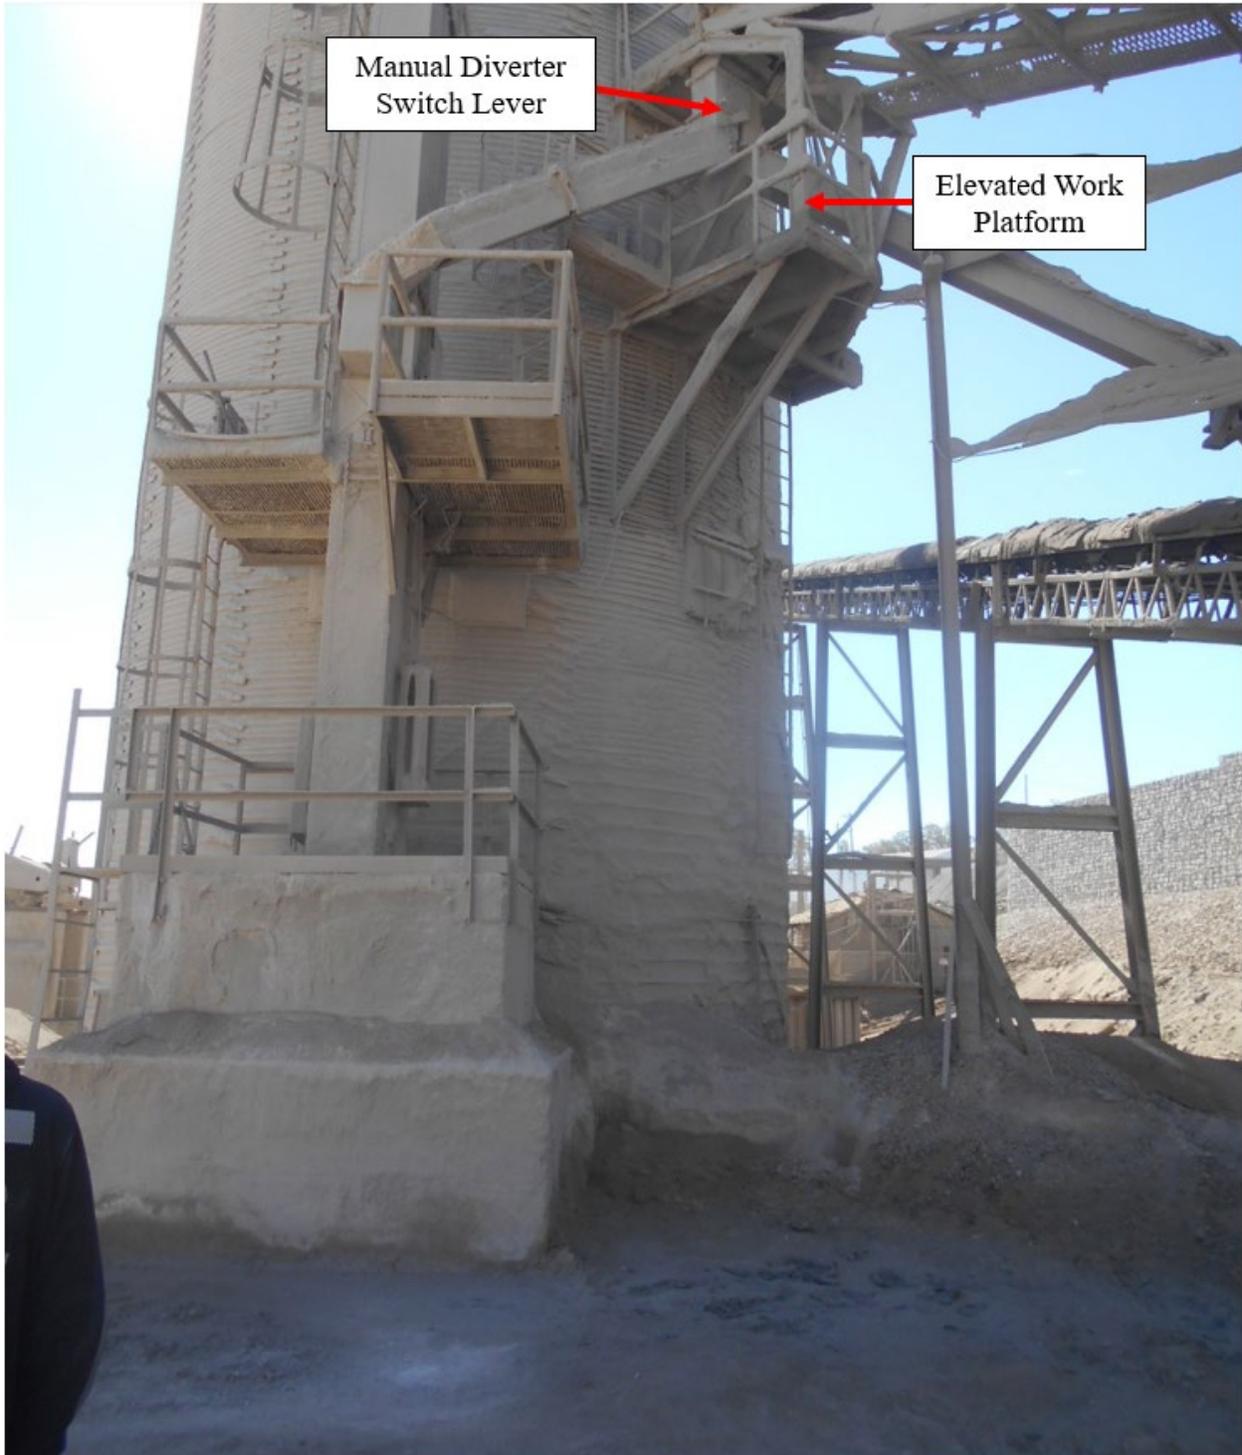
APPENDIX B – Elevated Work Platform at the No. 1 Silo

The accident occurred on an elevated work platform approximately 30 feet above the ground at the No. 1 Silo (see Appendix B). The bottom handrail was 23.25 inches from the platform floor, and the top handrail was 41 inches from the platform floor. Investigators determined that the handrails were adequate.

The mine operator did not design the chute installation to provide a safe location for miners manually actuating the lever, which contributed to the accident. When accessing the lever, miners had to crawl under chutes installed within the front and back walkway of the elevated platform. While miners were manually actuating the lever, the location of the chute-loading installation created a narrow and tight work location that did not allow free access to the lever.

Corrective Action: The mine operator removed the emergency material chute on the No. 1 Silo side of the elevated platform and relocated the lever to the No. 1 Silo side of the elevated platform.

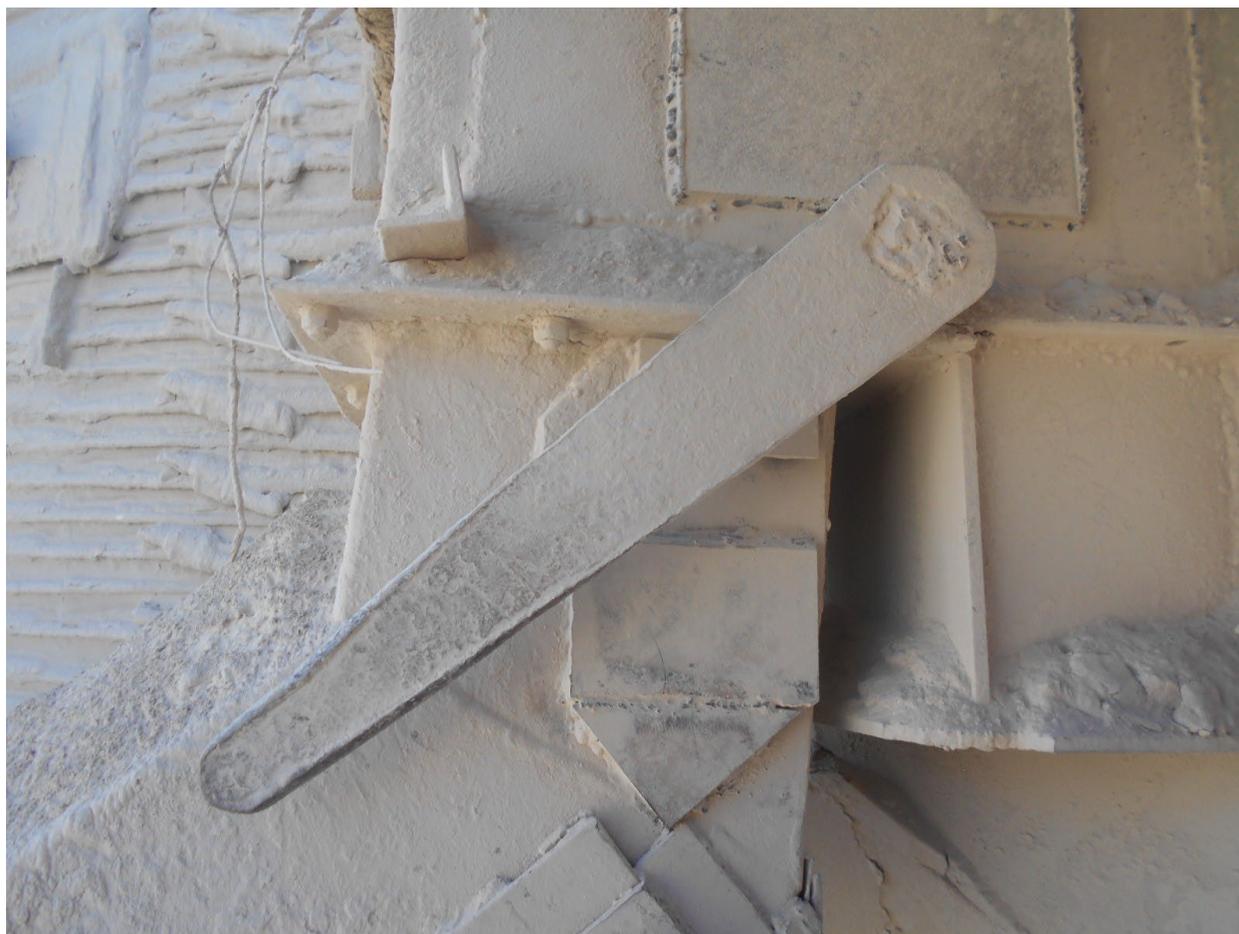
APPENDIX C – Manual Diverter Switch Lever

The equipment involved in the accident was the No. 12 Lime Belt Conveyor, EL-01 Lime Bucket Elevator, and a manual diverter switch lever used to pull the chute. At the time of the accident, Hayes was actuating the lever by pulling it (see Appendix C). This is a common practice, performed as needed, to move material from one silo to another when a silo was full or material was needed in another silo.

The mine operator did not correct defects with the lever that affected the safety of the miners, which contributed to the accident. The function of the lever was impaired and not in normal operating condition whenever material was built up in the chute. This caused the lever to be difficult to manually actuate and created a hazard for miners. The lever was very difficult to move as demonstrated by MLC when personnel attempted to actuate it for the MSHA investigators. According to interviews, actuating the lever required bracing against the bottom handrail and occasionally striking the lever with a hammer when it jammed. Investigators observed visible damage to the lever from hand tools previously striking it. Edward King, supervisor, stated that the lever would “clog up from time to time” due to built-up material that accumulated when the plant was down. To clear the built-up material, miners inserted a rod into the silo from a door on the upper level. If the plant was down for a day or more, miners also struck the side of the silo with a hammer.

Corrective Actions: The lever was relocated to the No. 1 Silo side, providing safe access and body position when manually actuating the lever.
