REPORT OF INVESTIGATION

Fatal Powered Haulage Accident
September 18, 2024

American Asphalt – Chase Quarry
American Asphalt Paving Company
Shavertown, Luzerne County, Pennsylvania
ID No. 36-00005

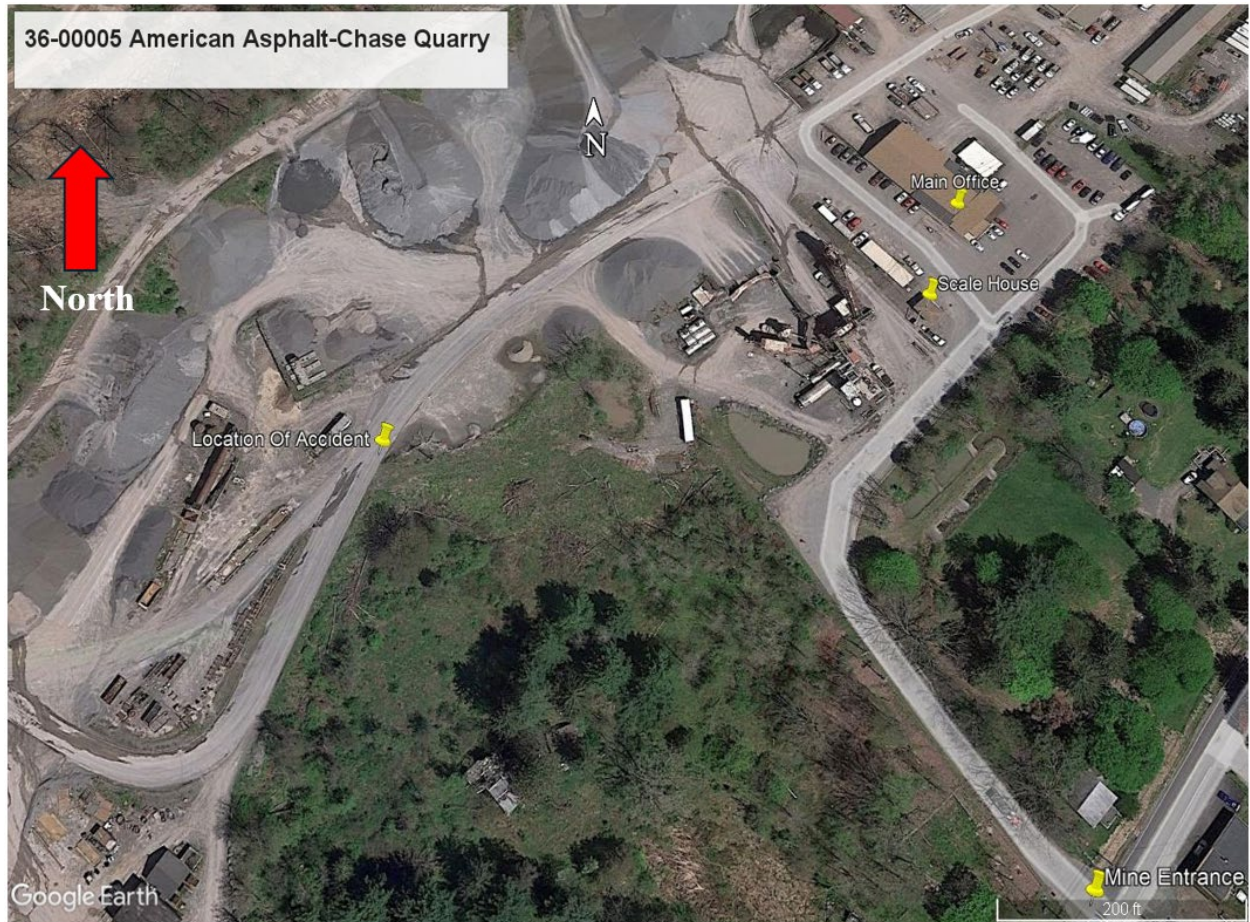
APPENDIX B – Aerial View

The accident occurred on the 40-foot-wide Main Haul Road (see Appendix B).

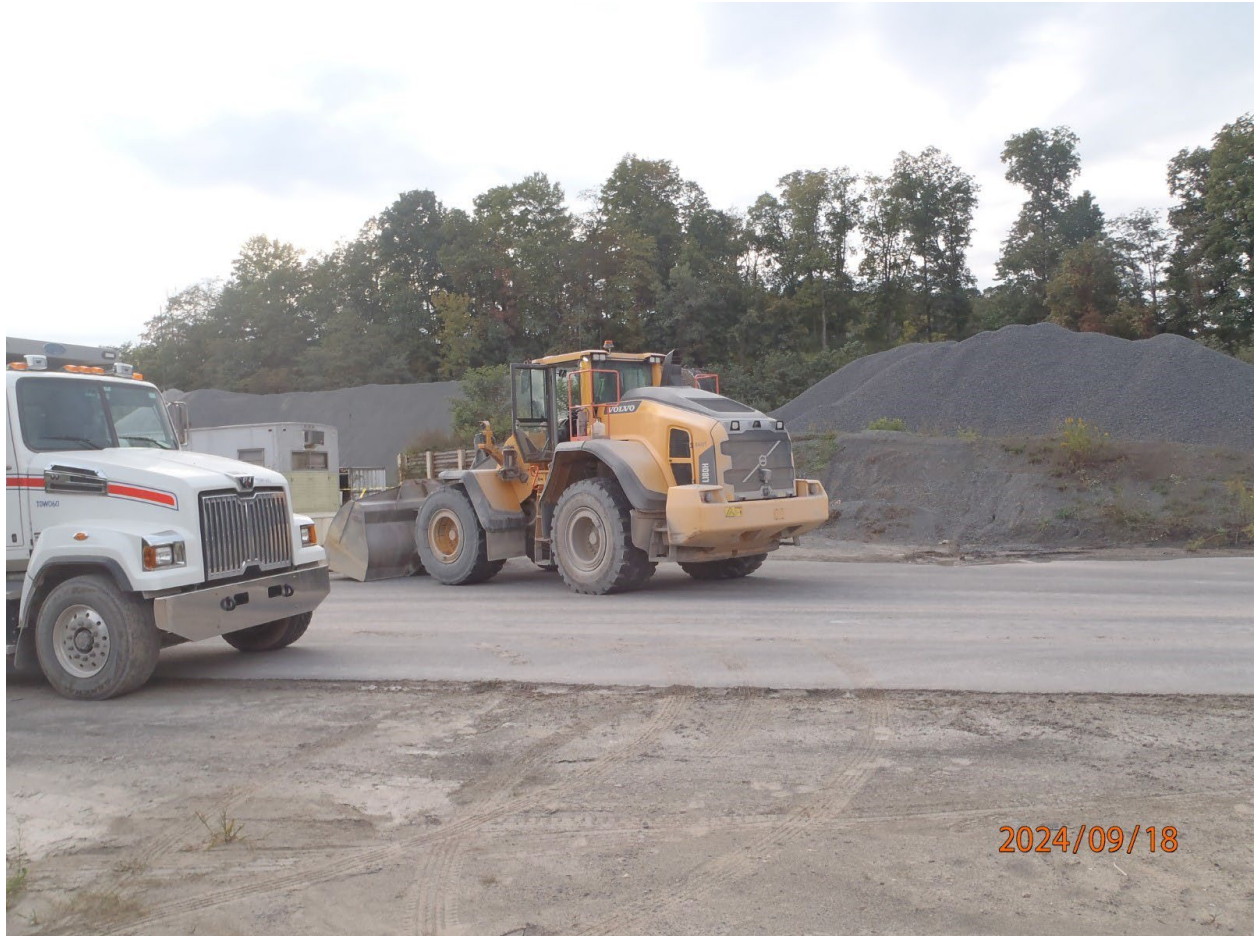
APPENDIX C – Photo of Front-End Loader

The equipment involved in the accident was a Volvo L180H front-end loader (see Appendix C). Investigators conducted an examination of the front-end loader and did not find any mechanical deficiencies or defects that contributed to the accident.

According to the manufacturer's manual, the bucket or other attachments should be raised to 12 to 16 inches off the ground when the front-end loader is traveling in the forward direction to provide operator visibility and machine stability. According to the video obtained from the dash camera on Brace's dump truck along with measurements taken by investigators at the accident site, investigators calculated the front-end loader was traveling 12 to 15 miles per hour with the bucket approximately four to five feet off the ground.

Investigators conducted a simulation to determine the areas of visibility for the front-end loader operator with the bucket raised. When the bucket was four feet off the ground, an investigator standing three feet in front of the bucket was not visible from the front-end loader operator's cab. The investigator walked away from the bucket and his head became visible to the front-end loader operator's cab when he was 27 feet from the bucket. When the bucket was five feet off the ground, an investigator standing three feet in front of the bucket was only visible from the knees down to the feet. The investigator walked away from the bucket and his head became visible to the front-end loader operator's cab when he was 57 feet from the bucket. The investigator's full body did not come into view until he was 131 feet away from the bucket.
