REPORT OF INVESTIGATION

Fatal Fall of Roof Accident
September 2, 2025

Torrance Mine (UG)
Heidelberg Materials Northeast LLC
Torrance, Westmoreland County, Pennsylvania
ID No. 36-08484

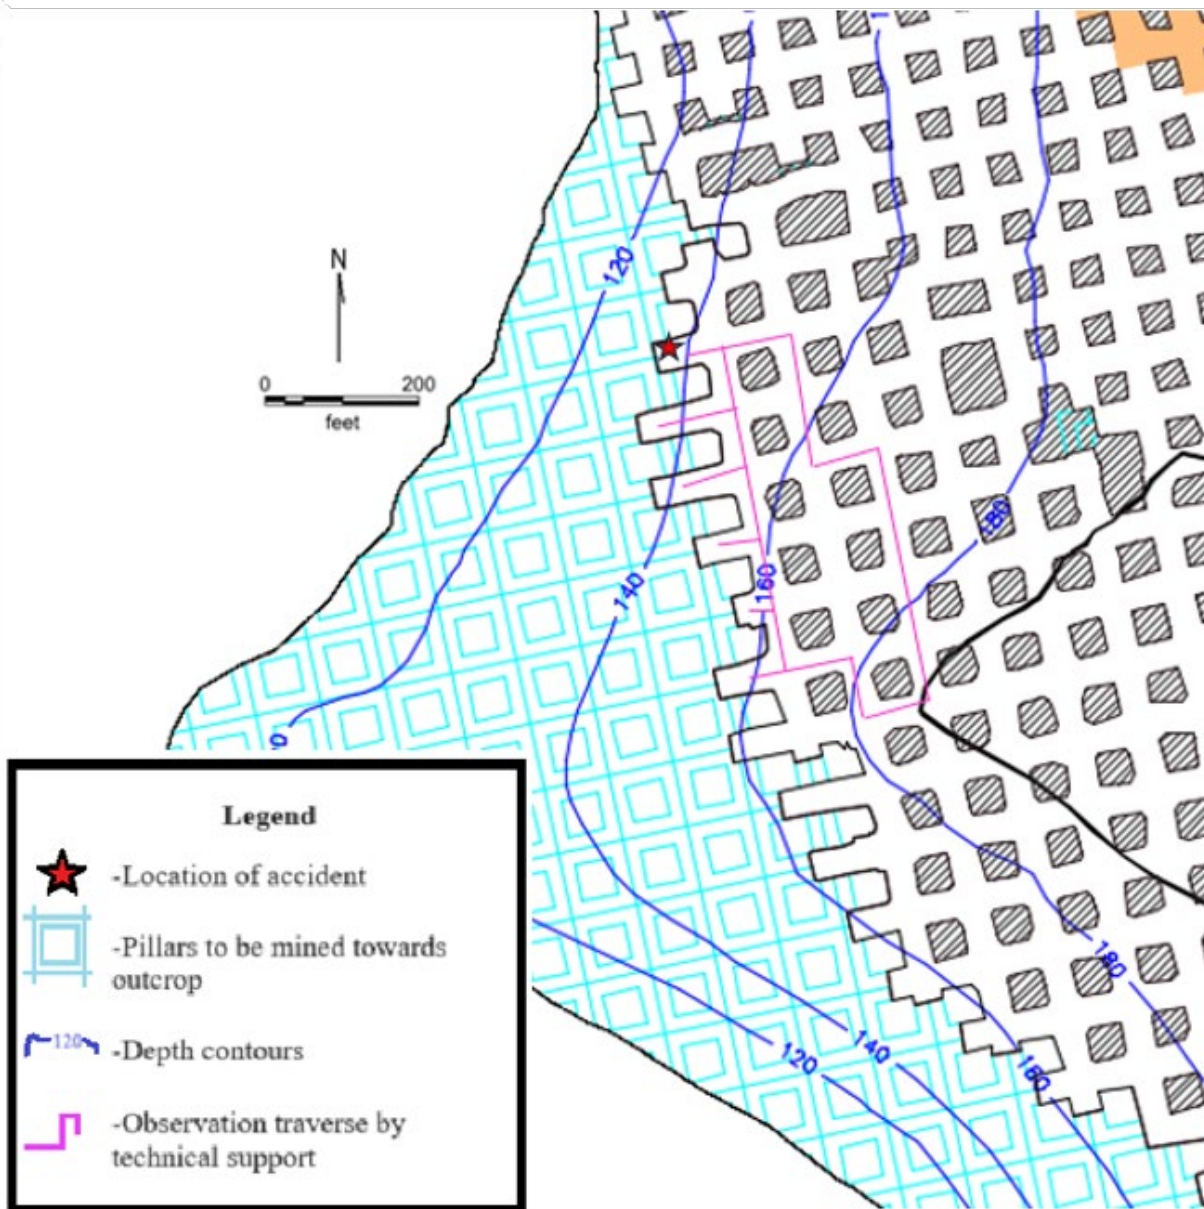
APPENDIX B – Map Showing Accident Location in M43-F heading with depth contour lines

The accident occurred in the advancing M43 main heading. This heading is being developed from 40 to 45 feet wide and 25 to 30 feet high. The rock fell 31 feet outby the M43 main heading face and against the right-hand rib line of the M43-F crosscut; this area was measured at 27 feet high. See Appendices B and C.

General map of showing observation traverse in magenta. Projected pillars are shown in cyan. Accident location represented by red star.

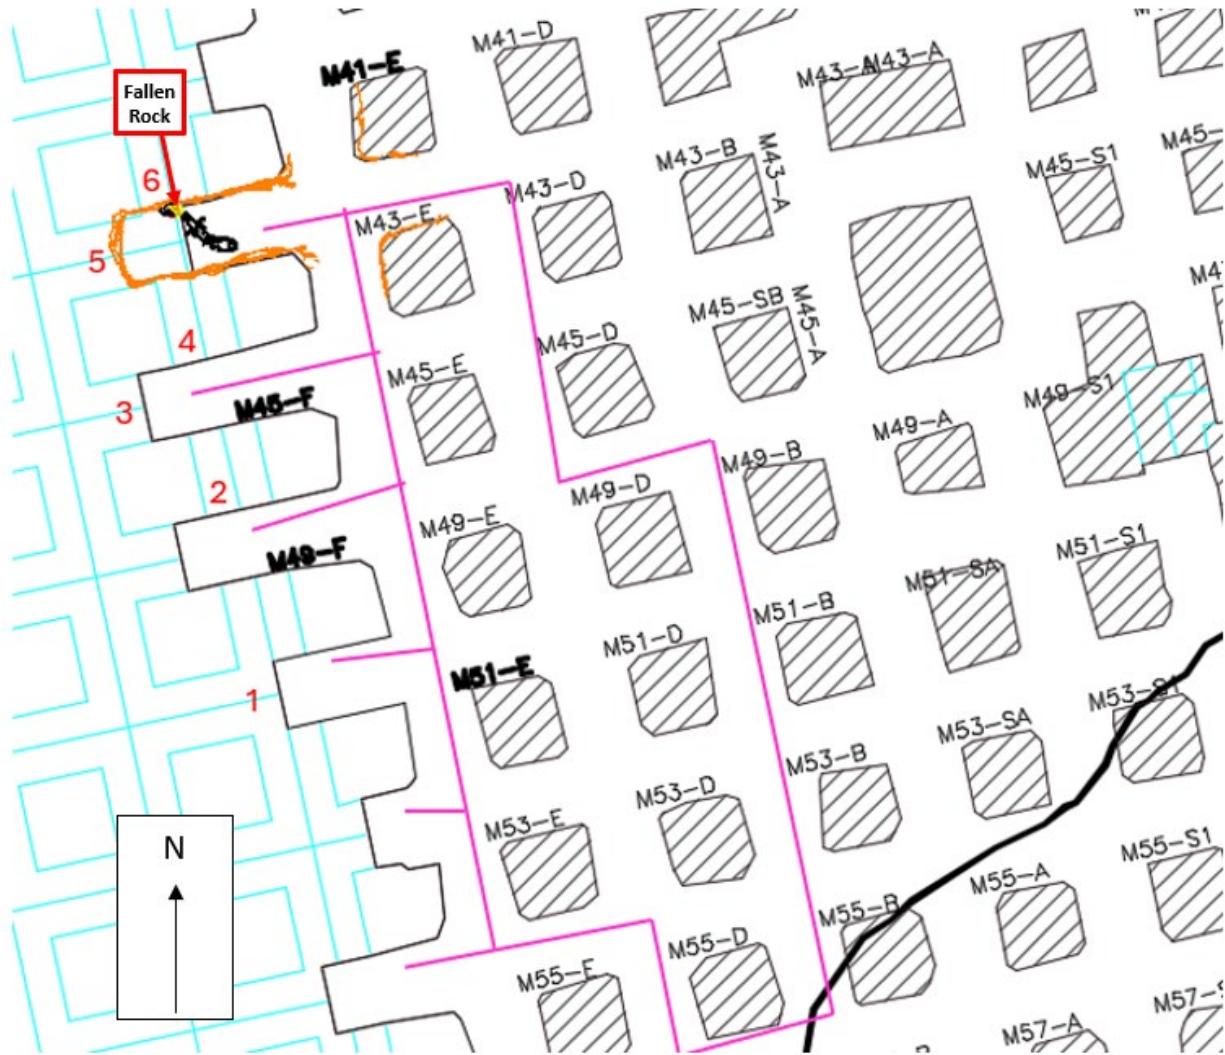
APPENDIX C – Mining Map

General map of showing observation traverse in magenta. Projected pillars are shown in cyan. Accident heading, as mined when the accident occurred, outlined in orange with the personnel lift shown in black and fallen material shown in yellow. The loaded faces are numbered in red.

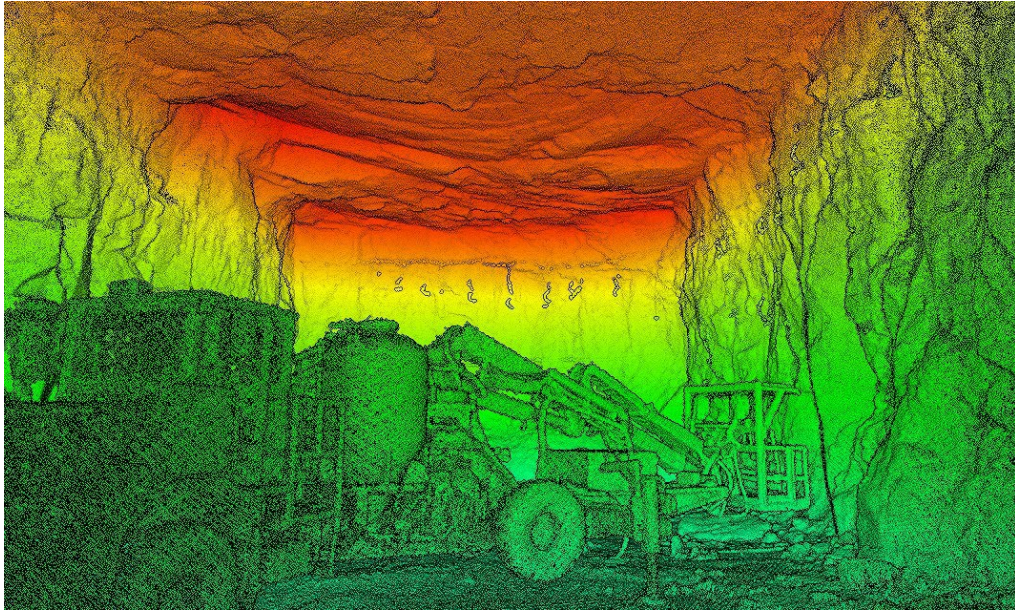
APPENDIX D – LiDAR Scans in M43 Heading

The cavity left by the fallen rock involved in the accident was bounded by joints on two sides, open at an exposed brow on the third side, and separated along a tensile crack at the rib line on the fourth side (Appendix D). The top of the piece of rock that eventually fell was represented by delamination from a bedding plane that hosted iron-stained limestone. The fallen rock separated from a layer of limestone that remained in the roof and was exposed at the brows. Most of the layer adhered to the roof, but the bounding joints allowed an individual block to separate and fall.

Point cloud generated from the LiDAR scan taken at the accident site. The fallen material and lowered personnel lift can be seen adjacent to the right rib.

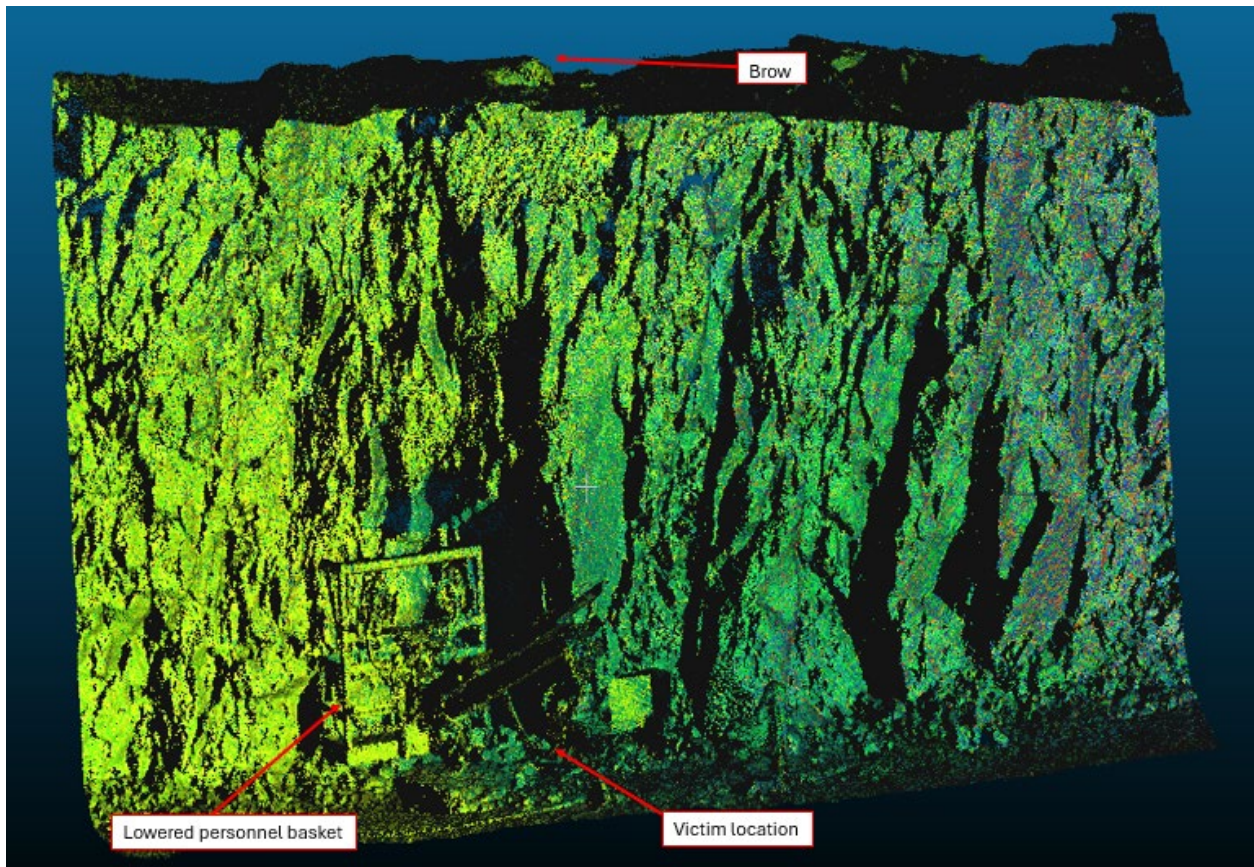
The M43 heading had been mined 26 to 29 feet high, depending on the presence of limestone beds in the roof that had either been removed by mining, scaling, or remained in place. The 3-foot difference in roof elevations is due to a series of brows that exposed individual bedding layers that were commonly highlighted by iron staining (Appendix C). Brows and bedding were not present in the roof two to three crosscuts east of the faces that included M43. The mining horizon had risen in the Loyalhanna Limestone while at the same time ground conditions became more degraded due to weathering. The upper portion of the Loyalhanna Limestone is composed of thin beds that are individually too thin and weak to span the width of the mine opening without the aid of roof bolts. In contrast, areas located three crosscuts to the east were in a lower level of strata characterized by a more massive texture without thin bedding planes, which was able to span the mining width without the aid of roof bolts. At the same time as the mining horizon rose into the weaker, bedded layers, iron-stained joints dissected the layers and made them even more susceptible to failure.

Point cloud generated from the LiDAR scan taken at the accident site showing the brows observed in the roof horizon, the location of the victim and the personnel basket.

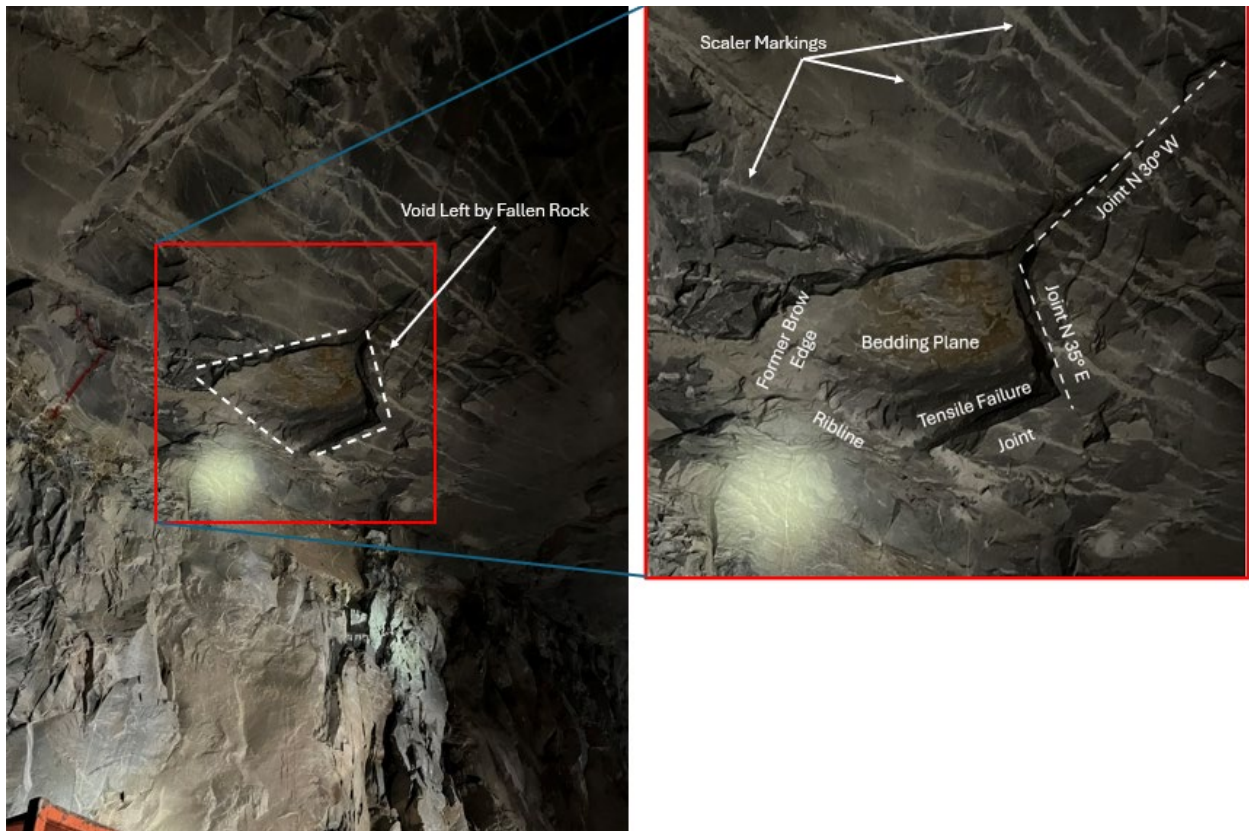
APPENDIX E – Photo of Rock Cavity at Accident Site

General conditions in the M43 heading and in the surrounding area were characterized by extensive jointing. Joints are naturally occurring fractures in the limestone that are planes of weakness and are typically seen in parallel sets with regular spacing. As observed in the accident location, multiple joint sets may be present at different orientations. Multiple joint sets may intersect to form blocks. In the M43 heading, joints were spaced 4 to 10 feet apart, defining a rock mass composed of multi-faceted blocks. The documented orientations placed joints parallel to headings and crosscuts, as well as diagonally through opposing corner pillars. Joints were generally iron-stained and often contained deeply weathered gouge, indicating that the rock mass was weak and weathered. The rock mass appeared much more degraded compared to conditions observed two to three crosscuts to the east, where joints were tight and generally lacked iron staining. It appears that the geological conditions had become more adverse as the mining front

Photo of cavity that hosted fallen rock with bounding planes highlighted, with annotations.

Corrective Action: The mine operator developed a written policy and procedure. On the same day a blast will be conducted, a miner who is experienced in examining and testing for loose ground will test and conduct a visual examination of the roof, ribs, face, and geological conditions. An experienced scaler will then perform hand-scaling of the roof, ribs, and face before blasters go in to load holes, and will perform mechanical scaling as required. The mine operator will install roof support for certain mining and geological conditions, and for loose ground conditions, where it cannot be scaled down. The mine operator trained all miners on the policy and procedure.
