REPORT OF INVESTIGATION

Fatal Powered Haulage Accident  
September 8, 2025

IDS Highway Safety, Inc. (A0491)  
Cumberland, Rhode Island

Lynch Corp  
Lynch Corp.  
Cumberland, Providence County, Rhode Island  
ID No. 37-00070

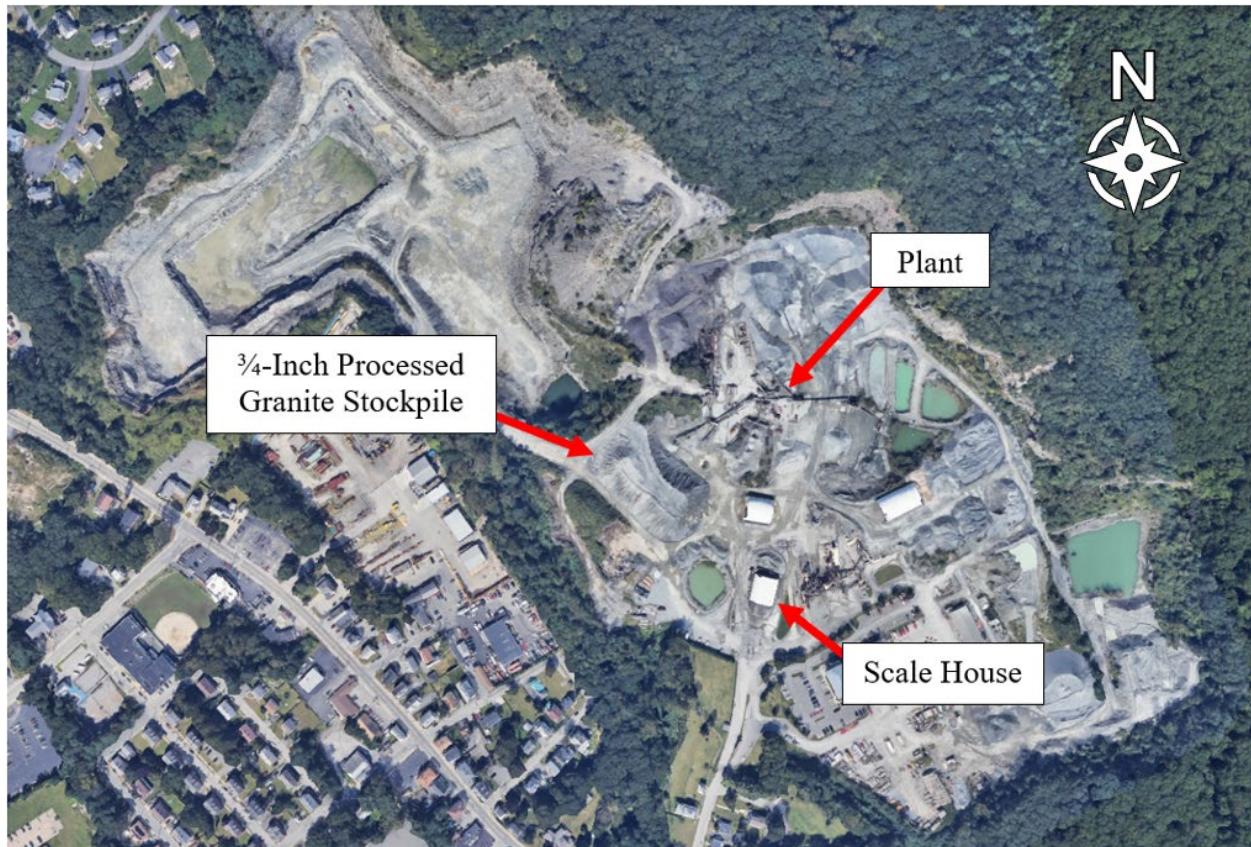
## APPENDIX B – Aerial View of Mine

The accident occurred at the  $\frac{3}{4}$ -inch processed granite stockpile located adjacent to the primary crushing plant (see Appendix B). The stockpile measured 42.5 feet high at the location of the accident. At the base of the stockpile, a front-end loader loaded material into customer trucks.

Note: The 3/4 -inch processed granite stockpile was smaller on the day of the accident than shown in this satellite photo.

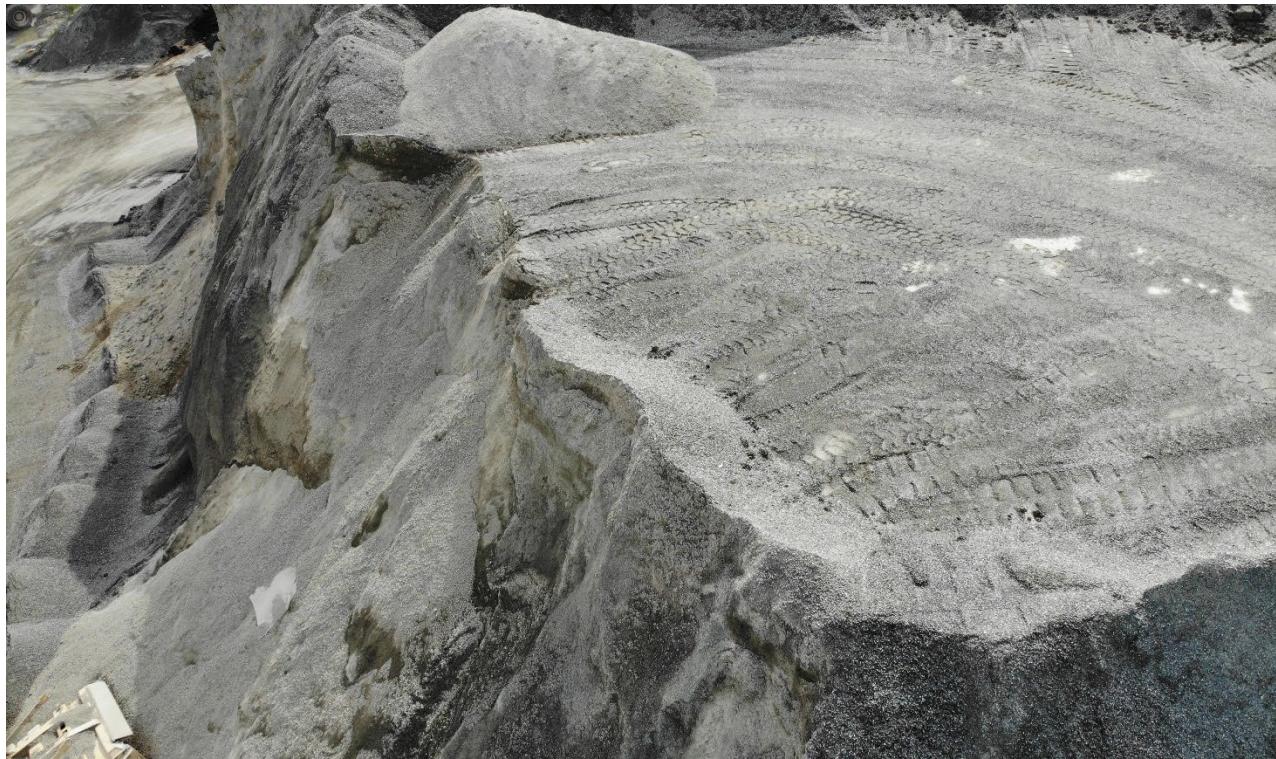
APPENDIX C – Dump Edge of ¾-inch Processed Stockpile where the Ground Collapsed

On September 4, 2025, and September 5, 2025, the mine operator undermined the stockpile when its front-end loader repeatedly dug material out from the toe of the stockpile where haul trucks dumped above. This was common practice at the mine, which caused the side and top of the stockpile to slough away and created instability in the stockpile's bank and slope. Investigators were informed that when the stockpile became undermined in the past, the haul truck drivers were directed to dump material short of the edge of the stockpile so that a front-end loader or bulldozer could push the material over the edge. Workplace examinations and

investigators' observations show that the face was vertical at the top of the stockpile where both trucks were dumping (see Appendix C). The investigator determined that the mine operator did not trim the stockpile face to prevent hazards, which contributed to the accident.

Corrective Action: The mine operator trimmed the  $\frac{3}{4}$ -inch processed granite stockpile, returning the stockpile face to a natural angle of repose and preventing hazards to miners. Also, the mine operator developed and implemented a new written procedure requiring the stockpile face to be corrected immediately when evidence indicates it is becoming unstable. The mine operator trained all miners in this procedure.

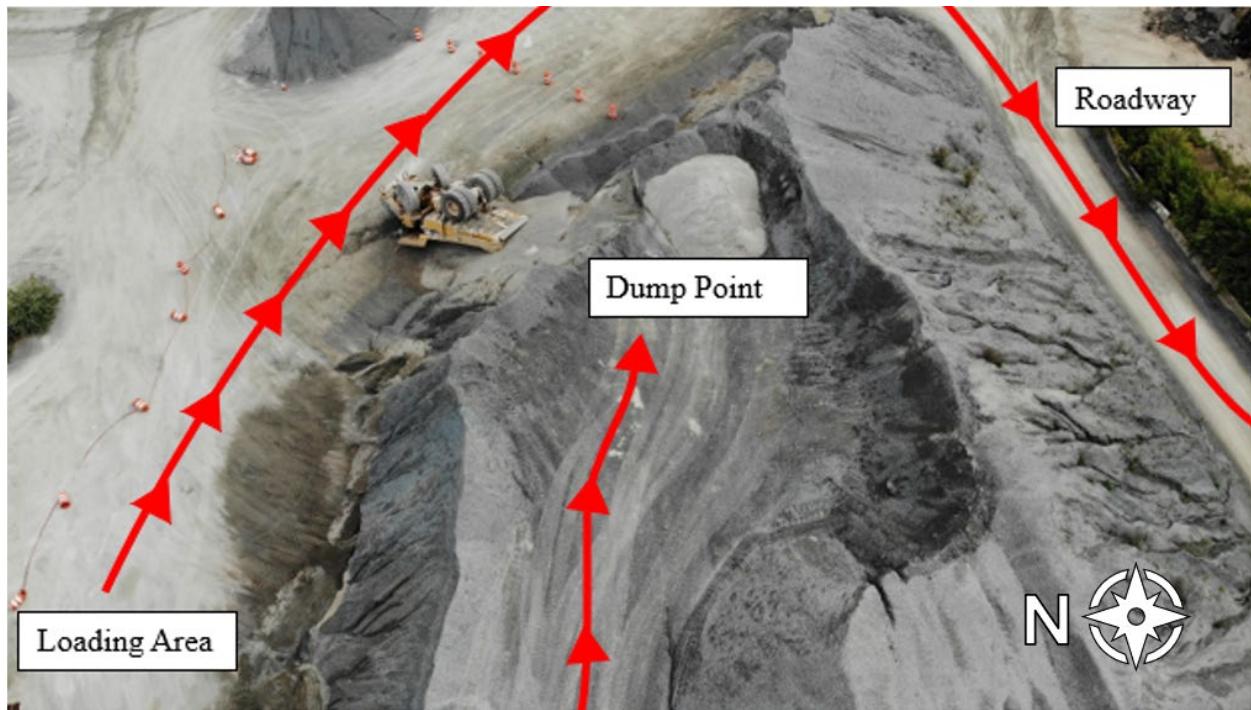
APPENDIX D – Aerial View of the Accident Scene

Refino traveled to the top of the stockpile and dumped the material at the east side of the stockpile face just short of the berm (see Appendix D). Sanantonio loaded DiTomasso's haul truck with material. Video evidence shows DiTomasso's haul truck backing straight toward the berm on the north side of the stockpile then turning toward the east side where Refino had dumped. The investigator determined that the mine operator did not ensure DiTomasso dumped a safe distance back from the edge of the unstable area of the stockpile, which contributed to the accident.

Note: Red arrows represent the truck's direction of travel, according to interviews and video evidence. The truck began at the loading area, continued driving around the roadway, and backed the haul truck up to the dump point.

Corrective Action: The mine operator developed and implemented a new written procedure requiring miners to dump a safe distance back from the edge of stockpiles and the material to

be pushed over the edge by a front-end loader, bulldozer, or excavator. The mine operator trained all miners in this procedure. Also, the mine operator will no longer use a contractor to operate their haul trucks. The mine operator hired two haul truck drivers from the local operating union to work at the mine and provided them with adequate task training for their assigned haul trucks.
