REPORT OF INVESTIGATION

Fall of Roof or Back Fatality Report  
April 2, 2026

Panther Eagle Mine  
Marfork Coal Company  
Whitesville, Raleigh County, West Virginia  
ID No. 46-09212

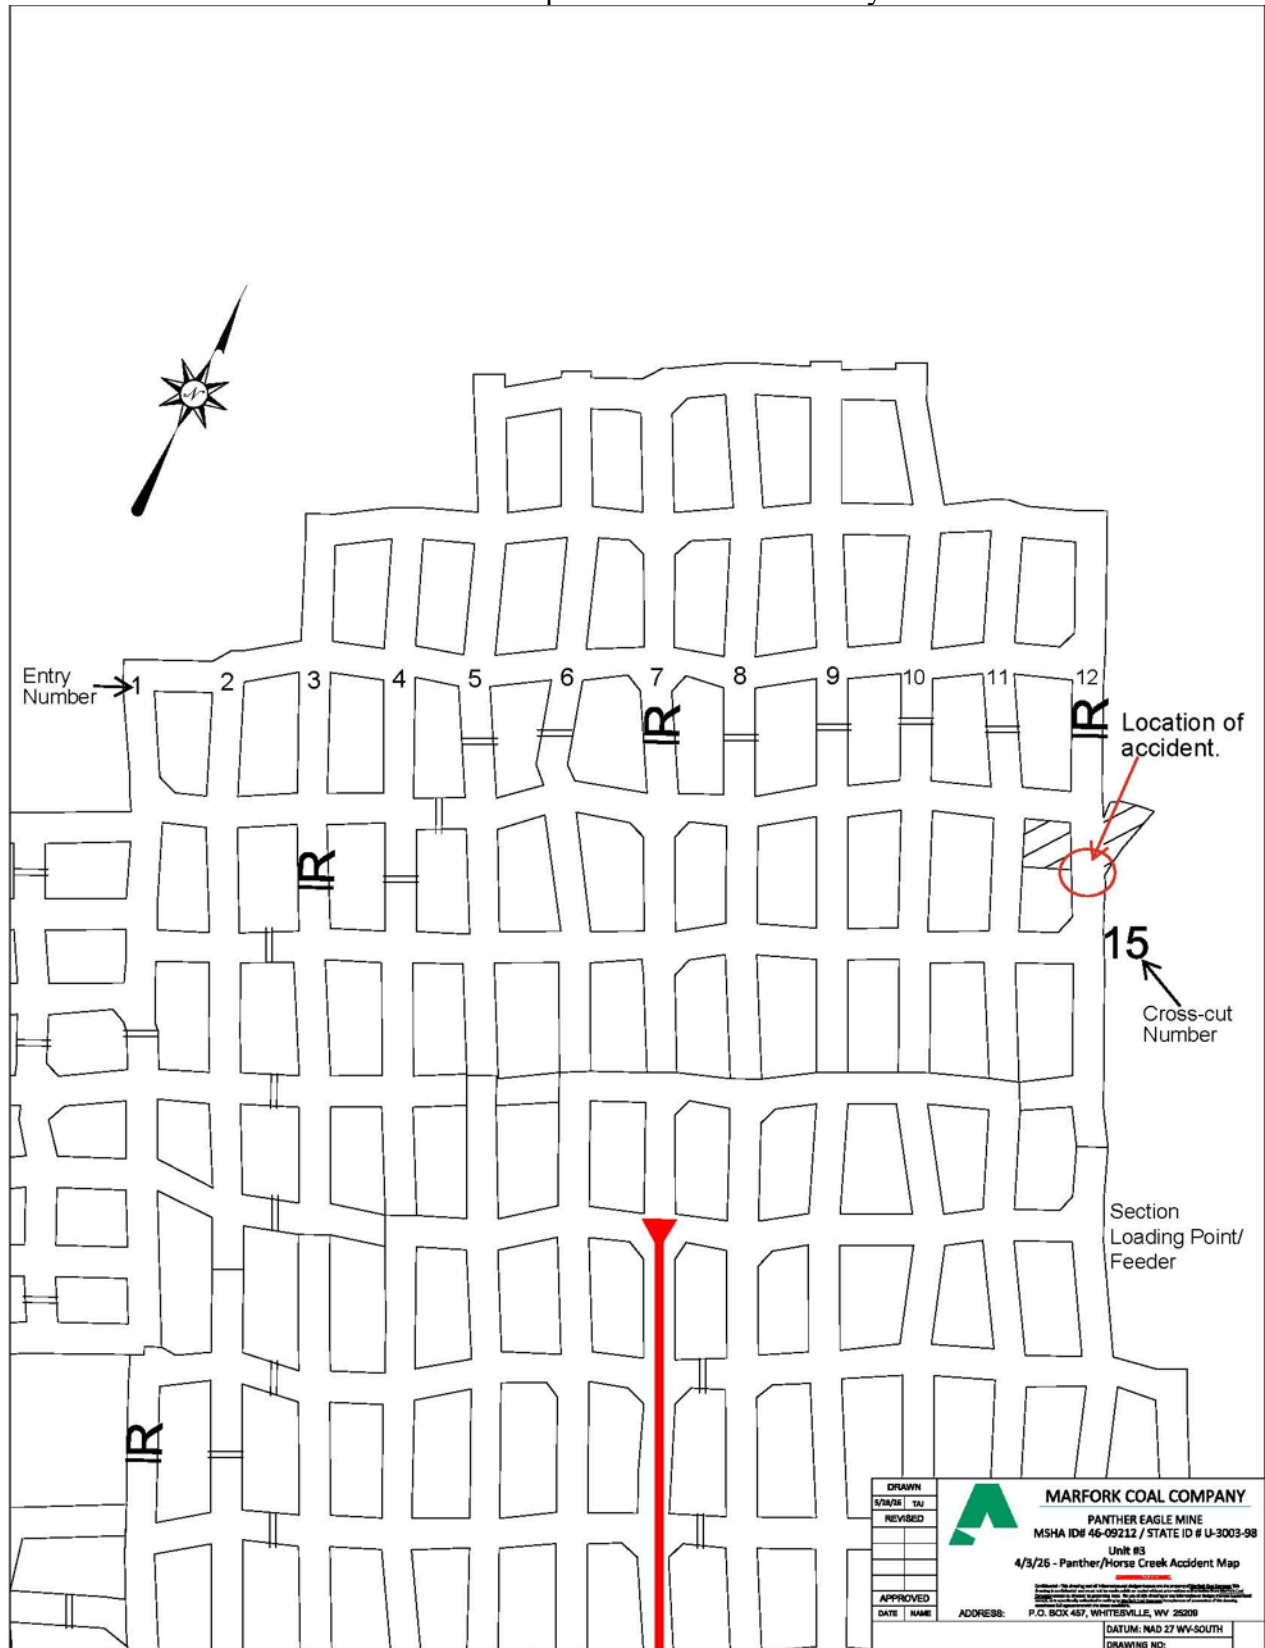
# APPENDIX A – Map of No. 3 Pillar Recovery Section

According to the mine's electronic tracking system, at 2:35 p.m., the crew traveled underground through the Horse Creek Portals to the No. 3 pillar recovery section (No. 3 section). The miners arrived at No. 3 section at approximately 3:20 p.m. The equipment operators conducted pre-operational examinations of their equipment and checked the roadways before beginning production. After completion of the pre-operational and dust parameter checks, Blevins operated the right CMM. He began mining the No. 2 barrier on the right side of the No. 12 entry between crosscuts 15 and 16 with Stables and Warrix operating shuttle cars (Appendix A).

The accident occurred on the No. 3 working section in the No. 12 entry between the No. 15 and No. 16 crosscuts (Appendix A).
