REPORT OF INVESTIGATION

Fall of Roof or Back Fatality Report  
April 2, 2026

Panther Eagle Mine  
Marfork Coal Company  
Whitesville, Raleigh County, West Virginia  
ID No. 46-09212

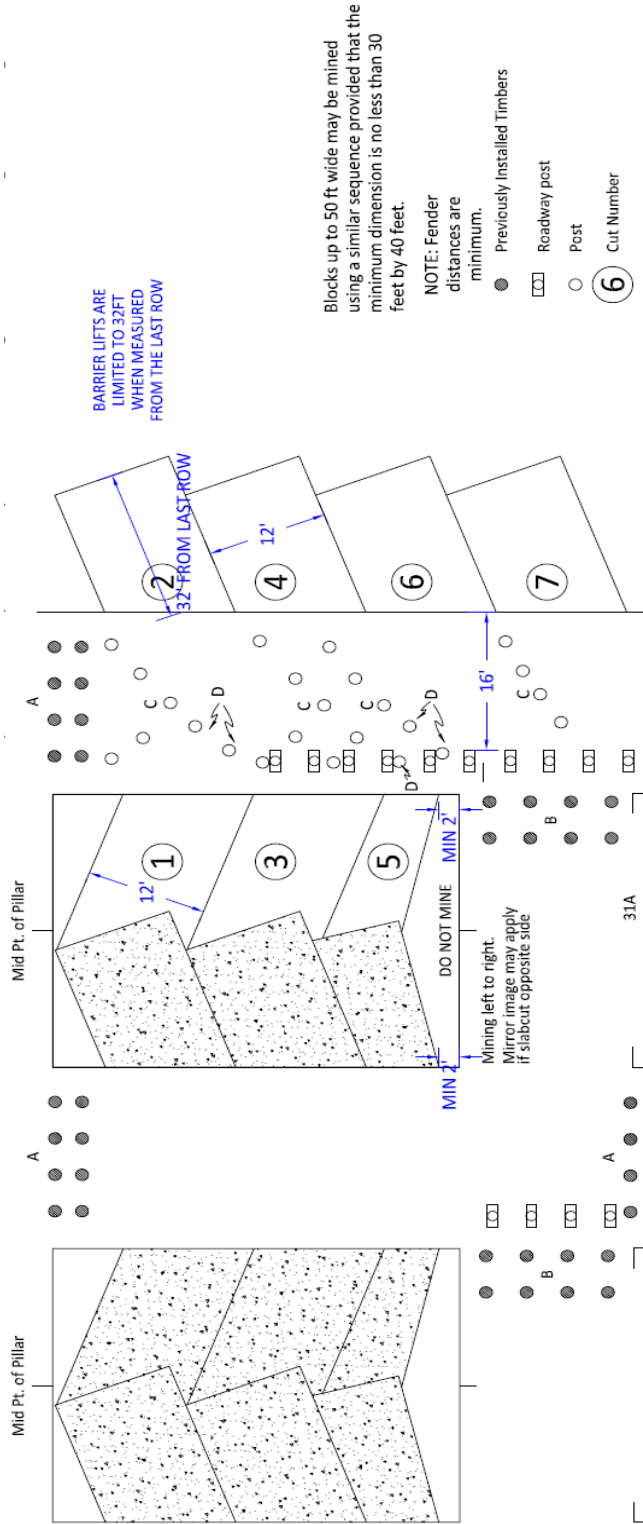
## APPENDIX C- Roof Control Plan (excerpt from page 31A)

According to the RCP sequence, Cody Catlett, day shift CMM operator, mined the No. 1 lift from the left of No. 12 entry during the previous shift. The No. 1 lift measured 30 feet in depth from the last complete row of roof support and was 29 feet in width. The depth of the No. 1 lift should not have exceeded half the 35-foot pillar block or 17.5 feet, and the width should not have exceeded 12 feet. The depth of the No. 1 lift was exceeded by 12.5 feet, and the width was exceeded by 17 feet (Appendix C).

As previously stated, during the evening shift Blevins mined the barrier No. 2 lift from the right side of No. 12 entry. The No. 2 lift measured 44 feet from the last row of roof supports and measured 36 feet across the width of the lift. The depth of the No. 2 lift should not have exceeded 32 feet, and the width should not have exceeded 12 feet. Investigators determined the No. 2 lift exceeded the RCP by a depth of 12 feet and width of 24 feet.

When a pillar block is mined by using twin lifts, the lift shall be 12 feet wide and the depth shall be limited to half of the pillar width, or 32 feet, measured from the last row, whichever is less.

(At the time of the accident, the pillar block measured 35 feet, wide making half the distance 17.5 feet deep for cut number 1).

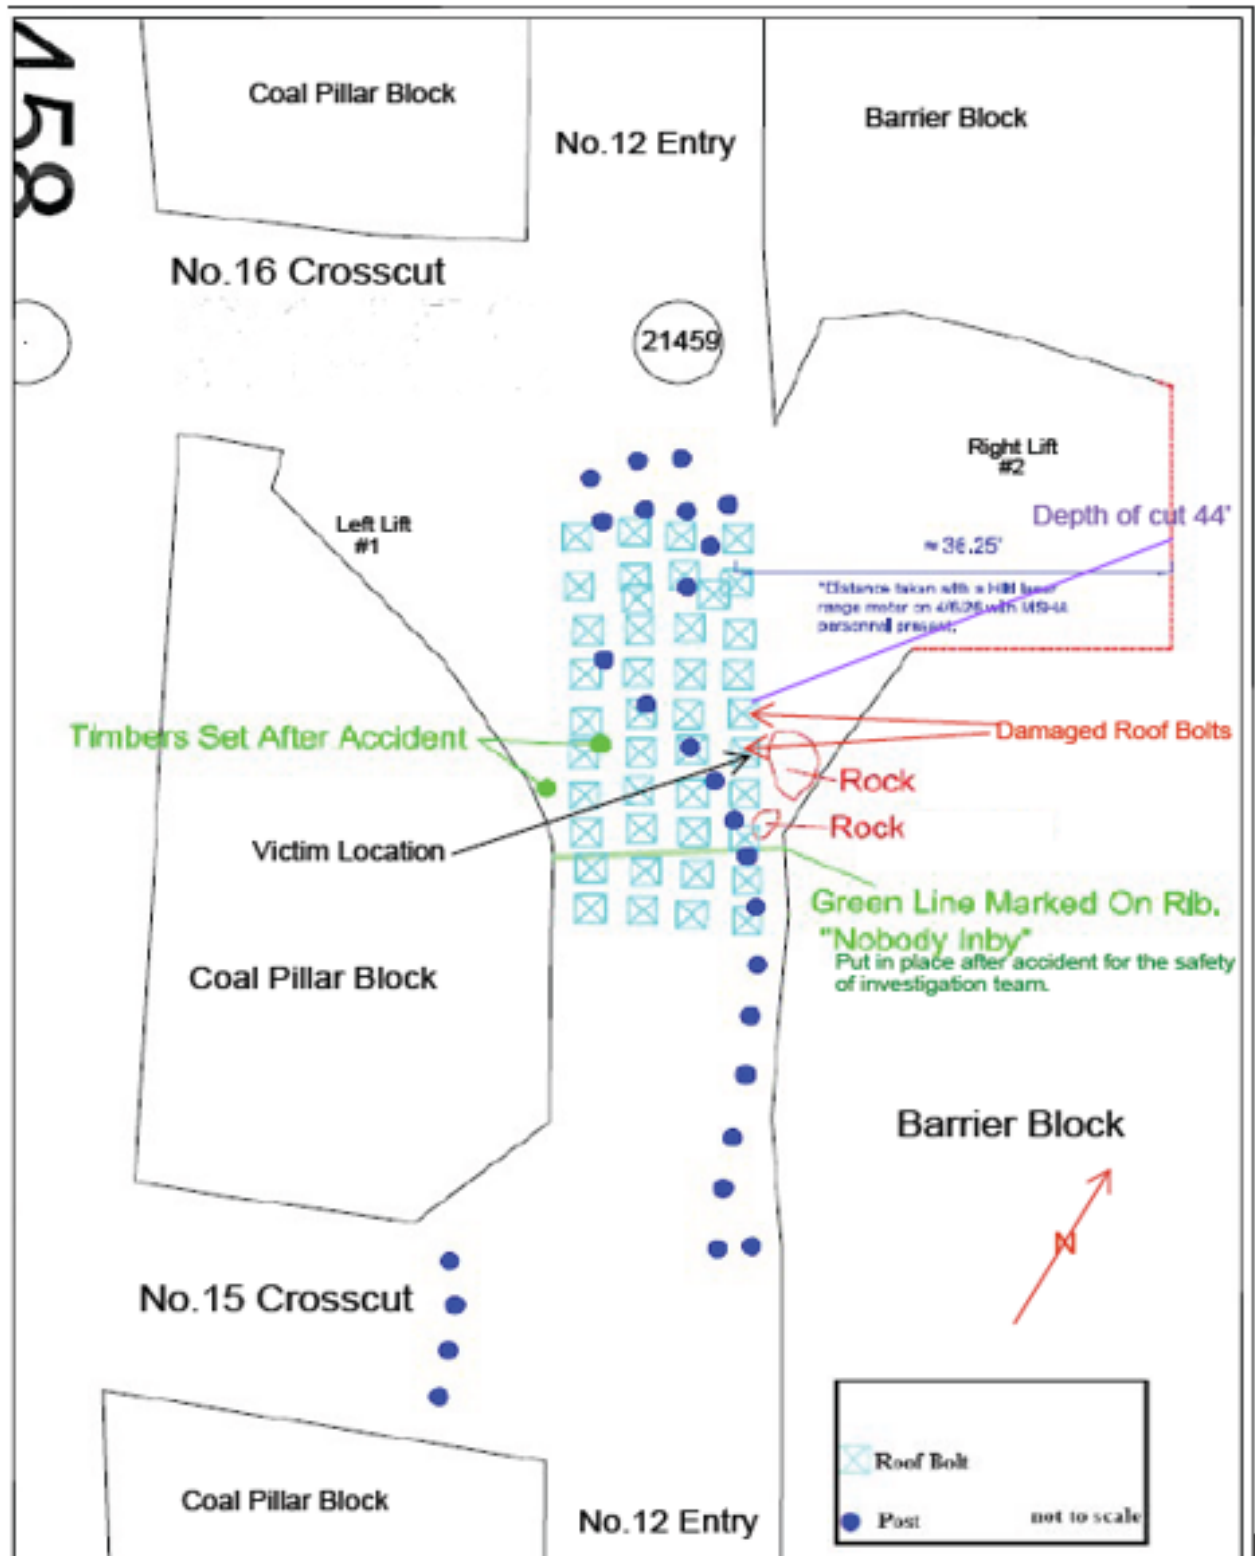
# APPENDIX D – Sketch of Accident Scene

During mining of the No. 2 lift, the CMM struck two roof bolts, removing the bearing plate completely from one and damaging the other. The dimensions of the lifts did not comply with the requirements in the RCP. During the day and evening shifts, the noncompliant sequence of mining prevented the proper installation of posts between lifts to supplement the roof support. Additionally, the damaged roof support and the absence of posts increased the span of unsupported roof. This allowed the roof strata to sag and become unstable. The compromised mine roof support exposed loose, unsupported draw rock.

While installing posts in preparation for the next lift, Warrix was positioned under unsupported roof, inby a turn post in violation of the RCP. Rock measuring approximately five feet long, three feet wide, three inches thick fell and struck Warrix. Investigators determined that not complying with the mining sequence of the RCP and improper post installation procedure contributed to the accident (Appendix D).

Corrective Action: The mine operator retrained all miners and supervisors on the requirement that no person work or travel under unsupported roof and implemented procedures to ensure supports are installed from supported areas. Additionally, the operator revised the RCP to include a different method for the installation of radius (turn) posts to minimize exposure.
