UNITED STATES
DEPARTMENT OF LABOR
MINE SAFETY AND HEALTH ADMINISTRATION

REPORT OF INVESTIGATION

Powered Haulage Accident Fatality Report
April 3, 2026

Ohio County Mine
Ohio County Coal Resources, Inc.
Dallas, Marshall County, West Virginia
ID No. 46-01436

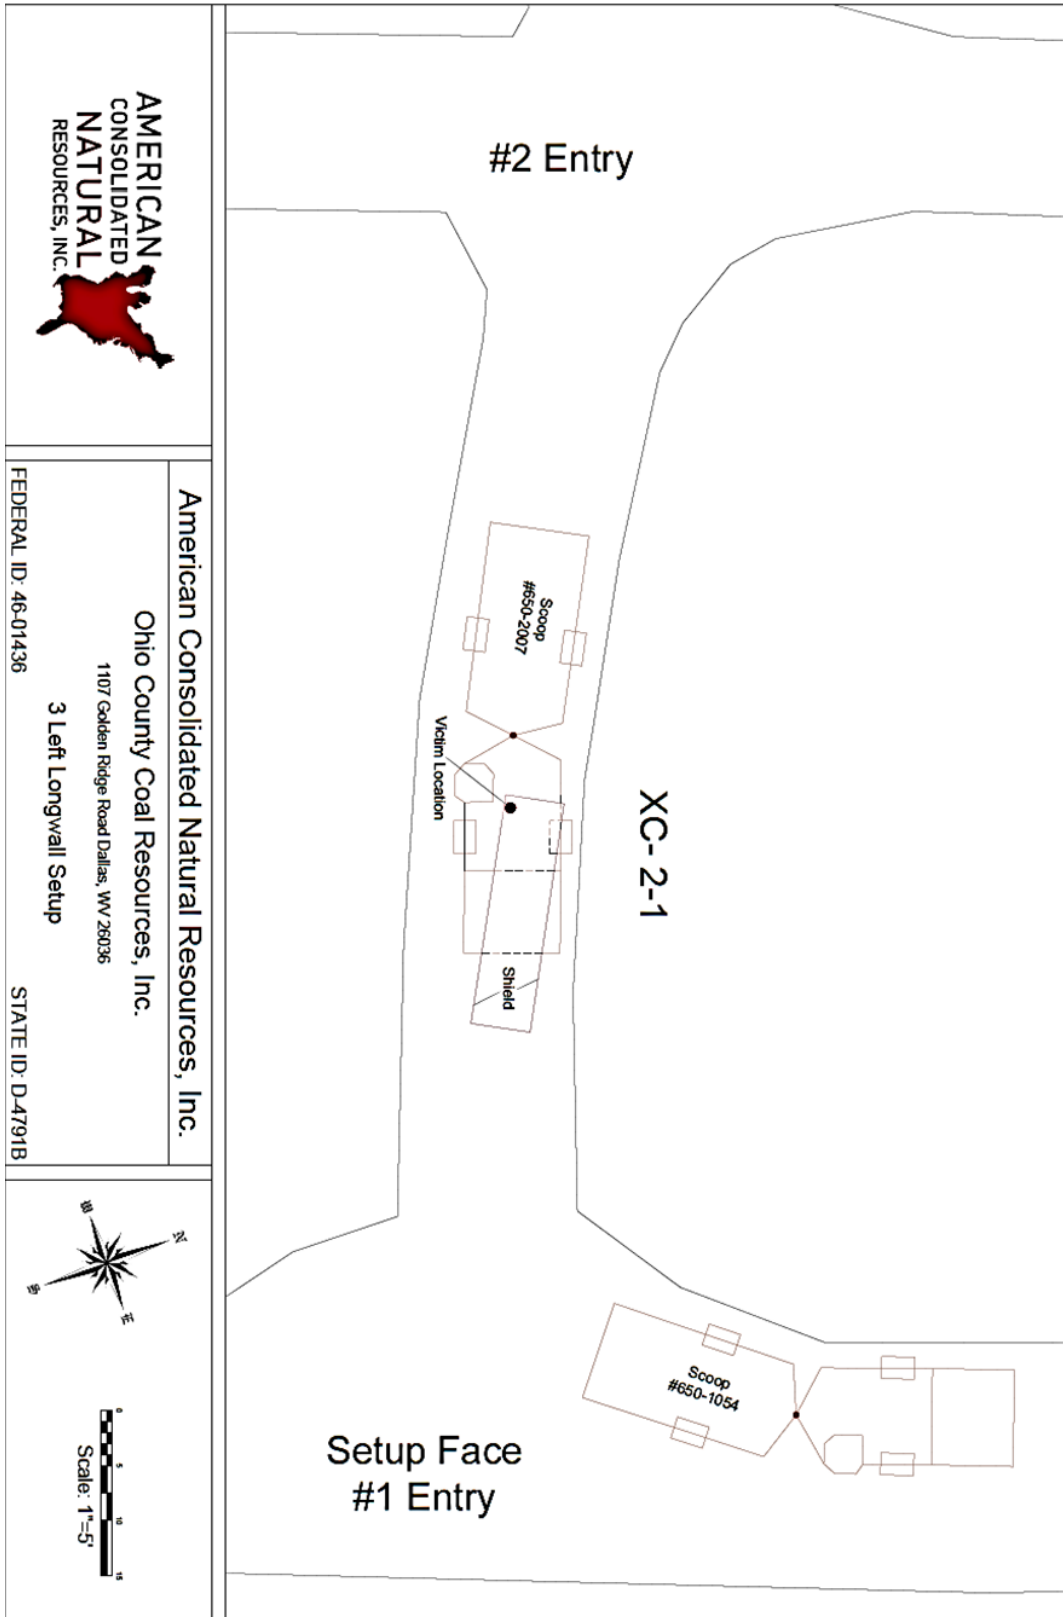
APPENDIX A – Map of the Accident Location

Bonamo conducted a preoperational check on the No. 2007 scoop and determined the winch rope needed to be repaired. Reece repaired the No. 2007 scoop's winch rope by cutting out a bad section of rope and reweaving the end through the winch rope hook. Bonamo trammed to the shield that was left by Wade in the No. 2-1 crosscut. Reece walked into the No. 2-1 crosscut to assist with loading the shield. While attempting to load the shield onto the front of the scoop, the restraining bolt on the winch reel broke. Reece positioned himself on the scoop to begin making repairs on the winch (Appendix A).

Tingley completed setting the shield on the setup face and trammed in reverse, back towards the No. 2-1 crosscut, to load another shield. As he rounded the corner from the setup face into the No. 2-1 crosscut, the No. 1054 scoop struck the shield partially loaded on Bonamo's No. 2007

scoop. The impact shoved the shield further onto the front of the No. 2007 scoop, striking Reece and pinning him between the underside of the shield canopy and the scoop's glancer bars.

The accident occurred on the 3 Left longwall setup in the No. 2-1 crosscut. The No. 2-1 crosscut was the only accessible roadway to the setup face because the shields were already set from the headgate to the 8th shield and from the tailgate to the 52nd shield. Investigators believe the turn from the setup face prevented a clear line of sight from the No. 1054 scoop operator's compartment to identify the No. 2007 scoop and shield sitting in the No. 2-1 crosscut.
