REPORT OF INVESTIGATION

Non-Powered Haulage Accident Fatality Report  
April 30, 2026

Portable Crusher #1  
Seubert Excavators Inc  
Weiser, Washington County, Idaho  
ID No. 35-03255

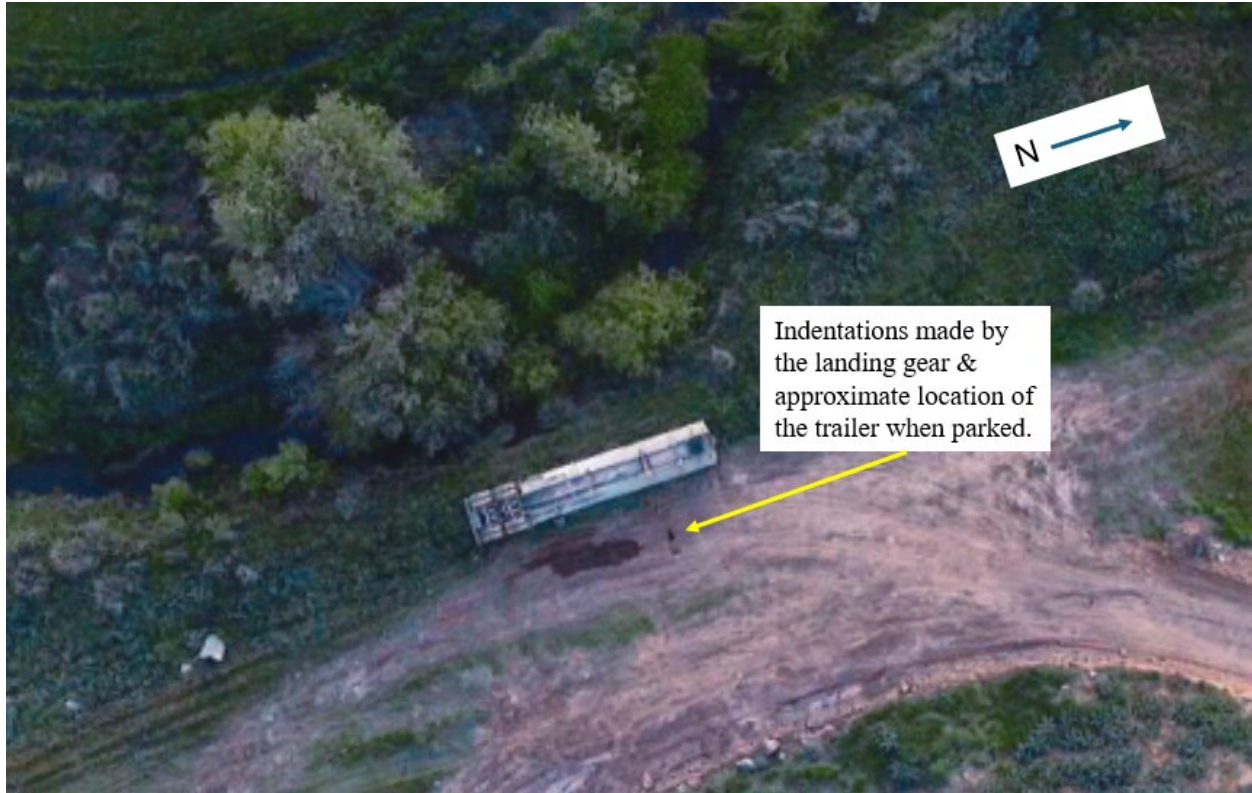
## APPENDIX C – Aerial View of the Water Tanker Trailer

The accident occurred on the lower road of the mine property, approximately 290 feet from the location where the other miners were dismantling and staging plant equipment. The lower road where the trailer was positioned was approximately 60 feet wide, dry, and primarily consisted of dirt and grass. Investigators observed that the road surface was uneven and contained ruts created

by equipment traveling to the loading area. For reference, an aerial view of the accident location can be seen in Appendix C.

Miners used a 7-inch-tall wooden block as cribbing beneath the driver-side landing gear and a 2-inch or 3-inch-tall wooden block beneath the passenger-side landing gear in an attempt to level the trailer. During the interview, D. Coleman stated that when the trailer was parked at its location on the evening of April 28, 2026, that he noticed the passenger side of the trailer was higher than the driver side.

Investigators measured an elevation difference of approximately 9 inches between the left and right trailer tires. Investigators also determined that the U-bolts for the rear leaf spring suspension could travel 4 inches upwards before the axle contacted the trailer frame, reducing the trailer's stability on the uneven ground. Investigators also measured an elevation difference of approximately 2 inches between the driver-side and passenger-side landing gear legs when a 2-inch-tall wooden block was placed beneath the passenger-side landing gear, and 2¾ inches when a 3-inch-tall wooden block was used. In both cases, the driver side of the trailer was lower than the passenger side at both the rear wheels and the landing gear. These conditions further reduced the stability of the trailer while it was disconnected from the semi-truck. As the trailer filled with water, the additional weight, combined with uneven ground, caused it to lean and shift toward the driver side. The landing gear slipped off the wooden block and the trailer rolled onto the driver side, crushing Knight.

Corrective Action: The mine operator provided an adequate supply of blocking and cribbing materials and established procedures requiring miners to properly block and crib the trailer to prevent lateral movement whenever it is parked with the landing gear supporting the trailer.

Corrective Action: The mine operator developed and implemented a written policy that establishes procedures for parking, blocking, and cribbing the water tanker trailer when it is disconnected from the semi-truck. The mine operator trained all miners on the new policy.

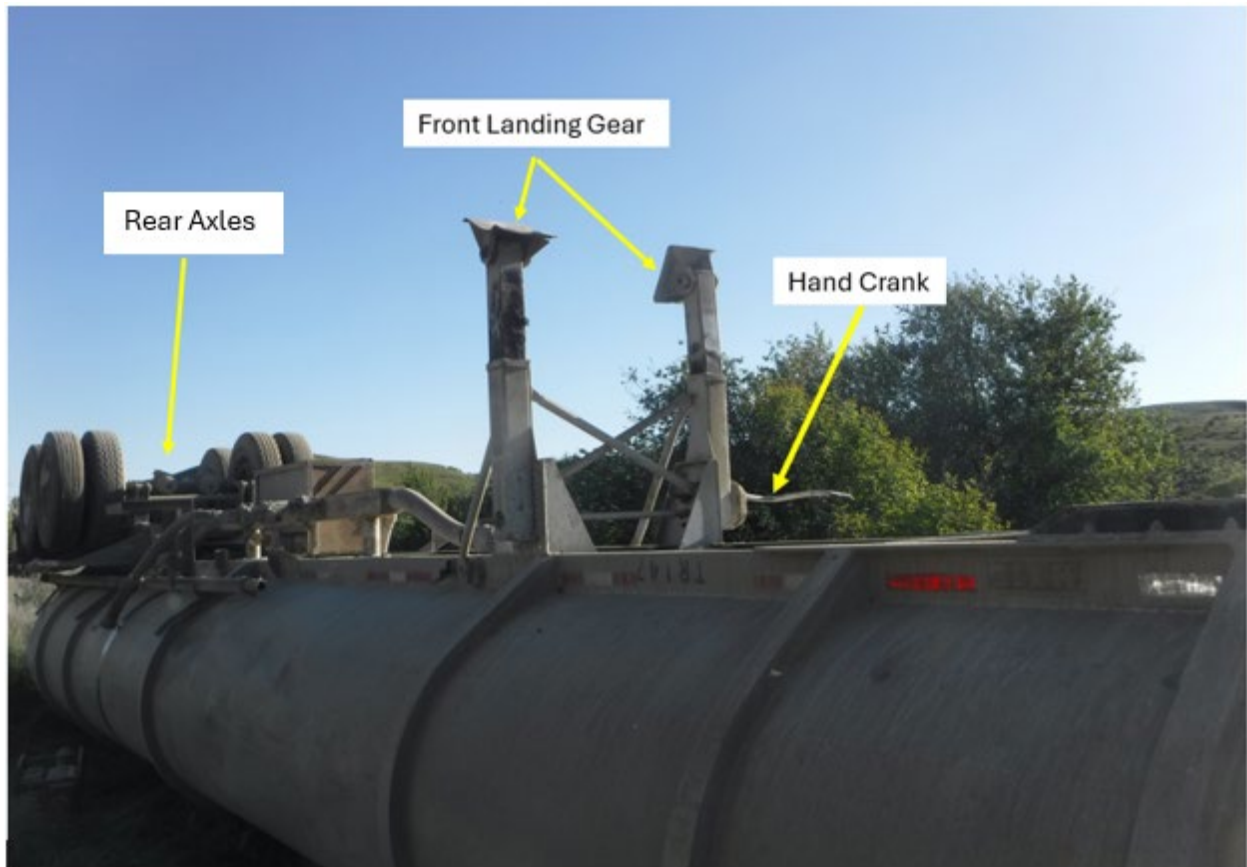
APPENDIX D – Photo of the Water Tanker Trailer

The trailer involved in the accident was a Heil Trailer model S-76 water tanker trailer manufactured in 1976. The tank measured 40 feet in length, 76 inches in diameter, and had a capacity of approximately 8,400 gallons. The trailer was equipped with tandem rear axles and dual front landing gear. The front landing gear supported and stabilized the front end of the water tanker trailer when it was not connected to a semi-truck. A single hand crank raised and lowered both landing gear legs simultaneously. At the time of the accident, the landing gear was fully extended. For reference, a photo of the trailer can be found in Appendix D.

Investigators inspected the trailer and identified damage consistent with the accident. The mine operator had not reported any defects or mechanical problems with the trailer before the accident. Investigators determined that the trailer did not have any defects that would have contributed to the accident.
