REPORT OF INVESTIGATION

Exploding Vessels Under Pressure Accident Fatality Report  
December 22, 2025

Rockydale-Flatrock Quarry

Mundy Stone Company  
Quicksburg, Shenandoah County, Virginia  
ID No. 44-00081

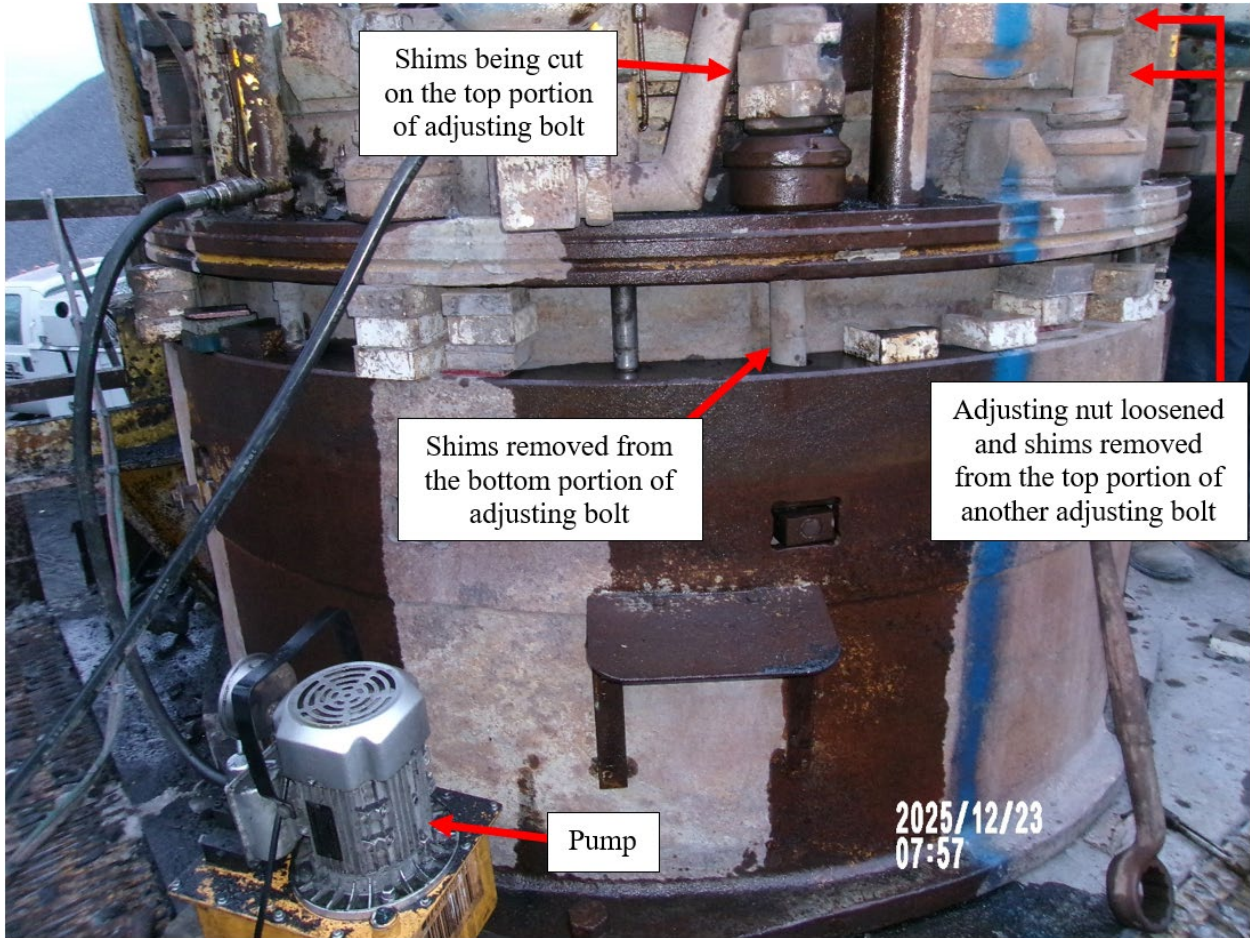
APPENDIX A – Cone Crusher

Loveday pressurized the hydraulic system, loosened all but one of the adjusting nuts, and removed the shims on the top and bottom portions of all but one of the adjusting bolts (Appendix A). Loveday could not loosen one of the adjusting nuts and used an oxygen and acetylene torch in an attempt to remove one of the shims from the top portion of the adjusting bolt. A hydraulic line was directly behind the shim that was being removed. At 4:16 p.m., heat from cutting the shim caused the hydraulic line to rupture, and the flames from the torch ignited the escaping hydraulic fluid. Loveday received burns from the resulting fire.

The cone crusher involved in the accident was an EL-Jay 54 Roller Cone Crusher. At the time of the accident, Loveday was disassembling the cone crusher to change the liner. According to the manufacturer's manual, the cone crusher is disassembled by connecting a pump to the hydraulic system. Pressure from the pump is applied to hydraulic jacks which raise the upper assembly. This allows shims on the bottom portion of the adjusting bolts to be removed by hand. The hydraulic system is depressurized, and the adjusting nuts are loosened if necessary. The shims on the top portion of the adjusting bolts are then removed by hand, without the use of a torch. The mine operator and contractor did not ensure that these procedures were followed, which contributed to the accident. Loveday used a torch to remove the shims on the top portion of the adjusting bolts. Prior to using the torch, the hydraulic line was required to be drained, ventilated,

and thoroughly cleaned of any residue; vented to prevent pressure during the application of heat; and filled with inert gas or water.

1. Root Cause: The mine operator and contractor did not ensure that the manufacturer's disassembly procedures were followed to relieve pressure from the upper assembly so the top shims could be removed by hand.

2. Root Cause: The mine operator and contractor did not ensure that the hydraulic line was drained, ventilated, thoroughly cleaned of any residue, and vented to prevent pressure during the application of heat; and filled with inert gas or water before using torches near a pressurized hydraulic line.

Corrective Action: The mine operator and the contractor each developed and implemented a written procedure, included in their respective training plans, that requires the equipment manufacturer's procedures to be followed when assembling and disassembling equipment.

Corrective Action: The mine operator and the contractor each developed and implemented a written procedure, included in their respective training plans, that requires: 1) all associated hydraulic systems to be fully depressurized and, where practical, vented to the atmosphere prior to performing cutting, welding, or other hot work activities in close proximity to any hydraulic system component; and 2) a heat shield to be positioned to protect the hydraulic system from excessive heat. The mine operator and contractor trained all miners in this procedure.

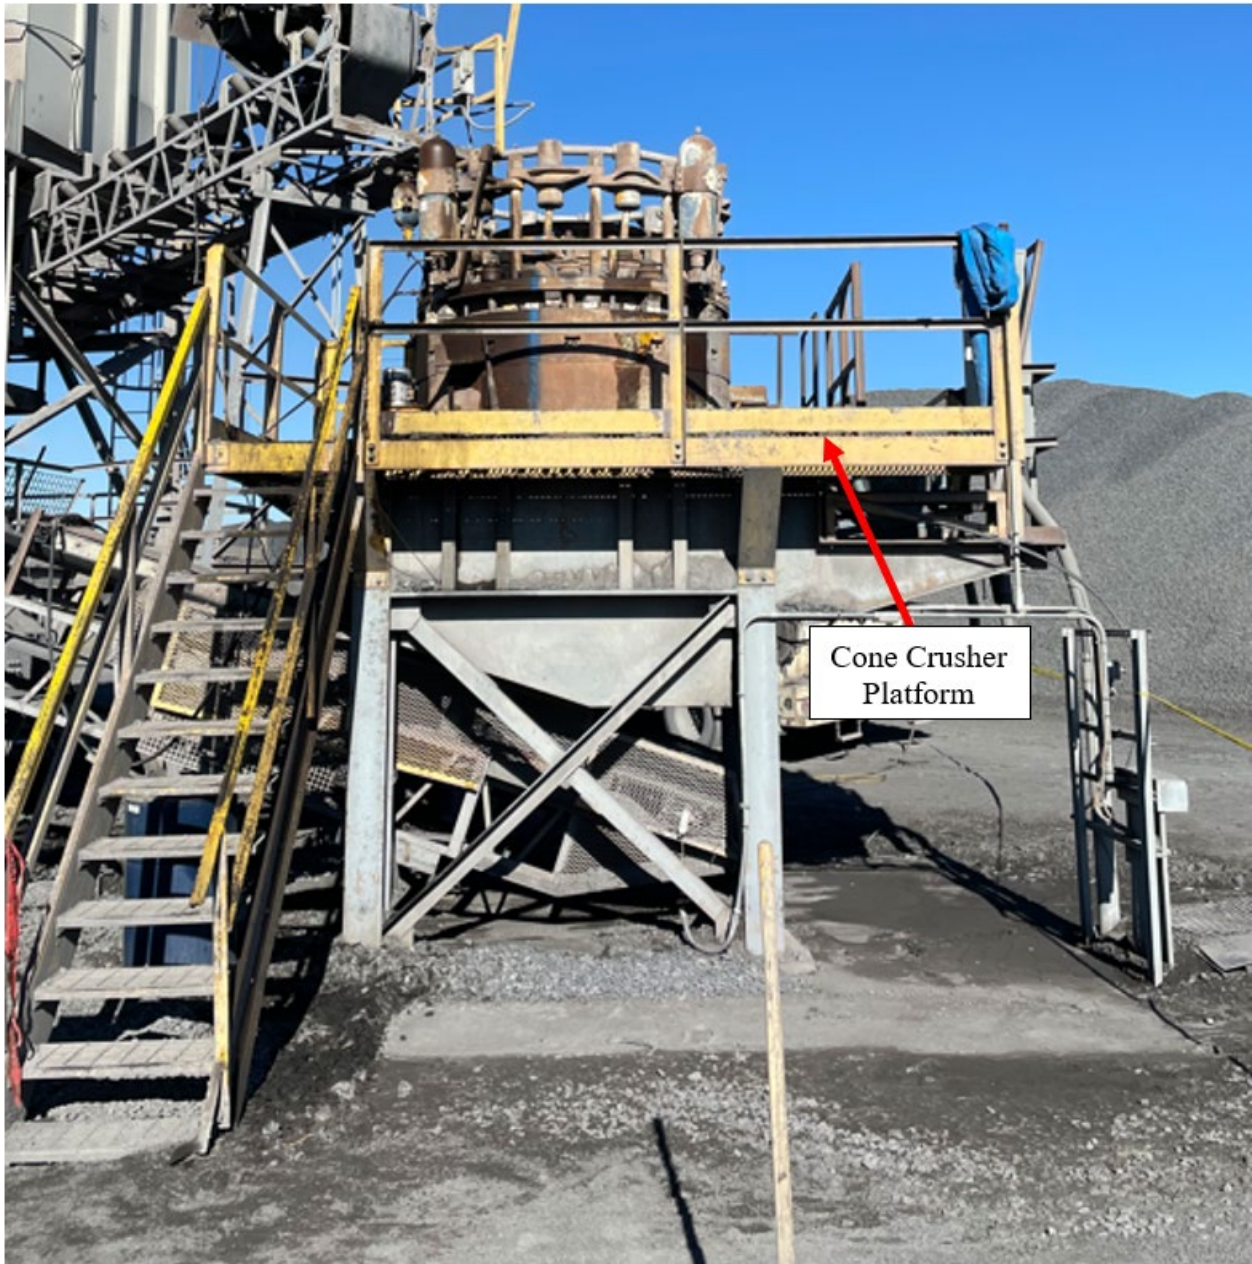
APPENDIX C – Location of the Accident

The accident occurred on the cone crusher platform (Appendix C).
