REPORT OF INVESTIGATION

Falling, Rolling, or Sliding Rock or Material of Any Kind Accident Fatality Report  
January 19, 2026

Vermont Quarries Corp.  
Danby Quarry  
Danby, Rutland County, Vermont  
ID No. 43-00042

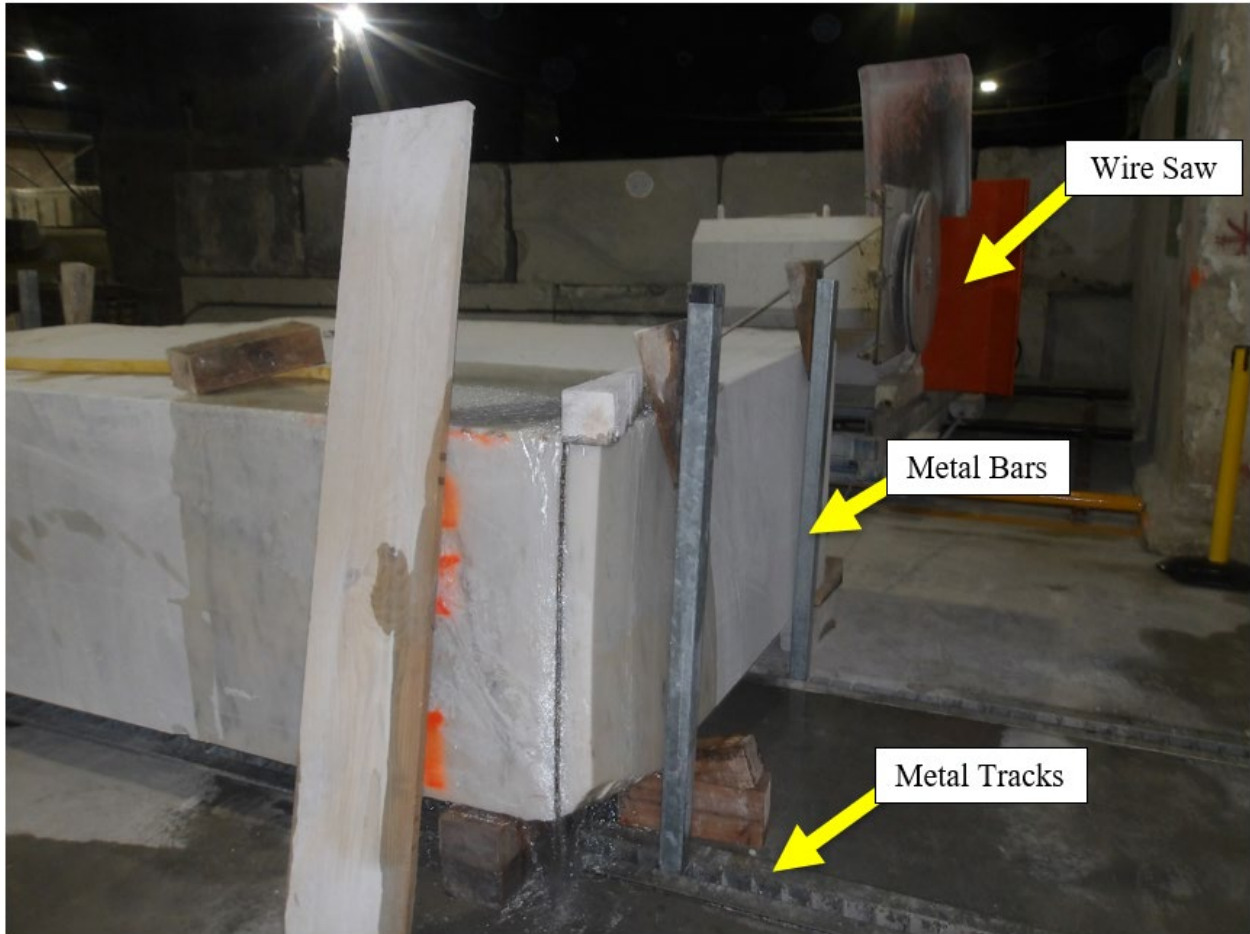
APPENDIX A – Wire Saw

This photograph shows the new concrete pad with metal tracks and bars installed as part of the corrective action to support cut marble slabs.

Corrective Action: The mine operator installed a new concrete pad with metal tracks and bars so that marble slabs can be properly stored and to prevent fall-of-material hazards to miners working in the area (Appendix A).

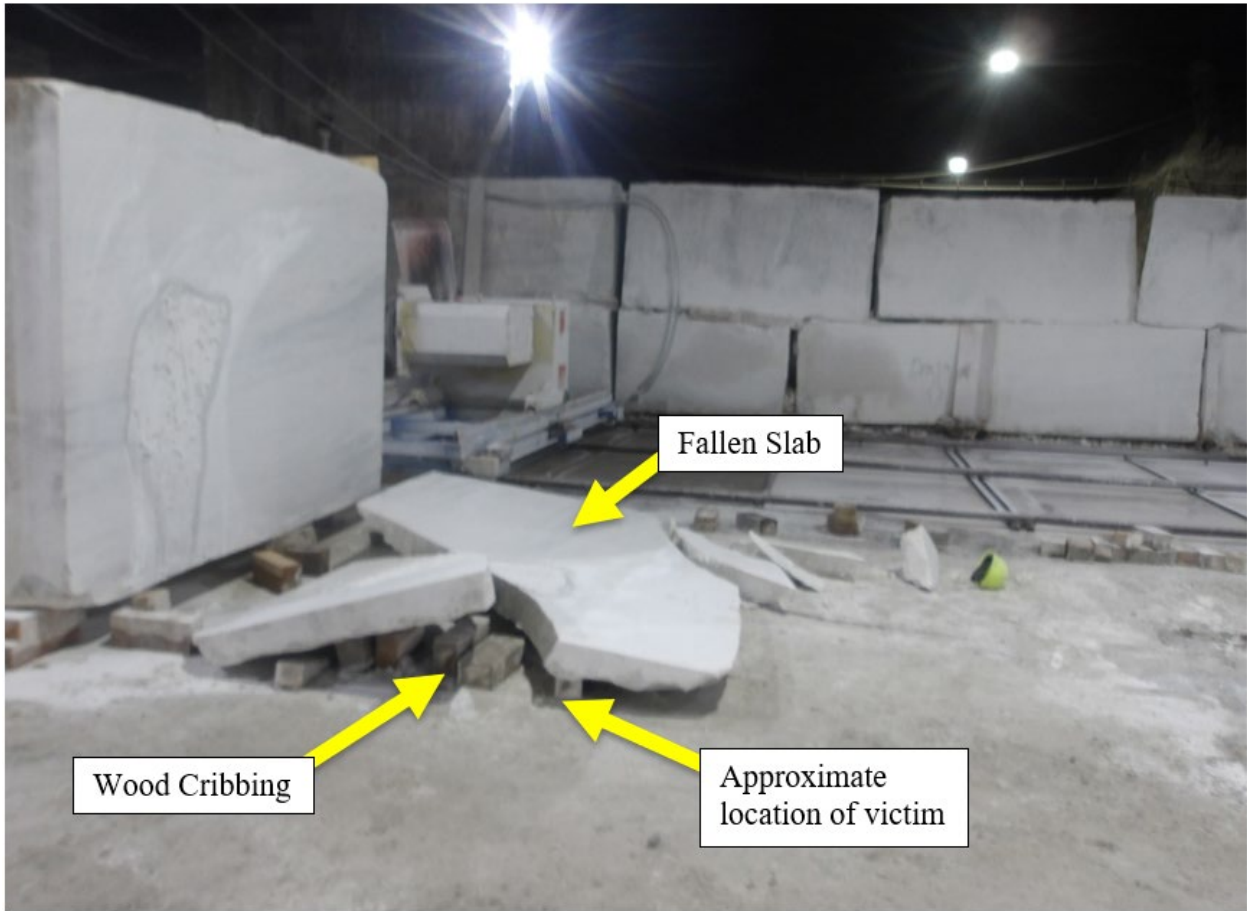
APPENDIX C – View of the Accident Scene

The accident occurred at the underground mill trim saw area (Appendix C).

entered the area immediately in front of the unsupported marble slab and was crushed when the slab fell forward. Investigators determined that the procedures for storing and supporting the cut marble slabs were not followed. Additionally, investigators determined that the procedures for supporting the cut marble slabs with the front-end loader were not adequate because the procedure did not prevent a fall-of-material hazard when the front-end loader was not in place, which contributed to the accident.

An accident occurred on January 19, 2026, at approximately 10:10 a.m., in the trim saw area. Slabs of marble, weighing approximately 4,500 pounds, were stacked and stored in a manner that created a fall-of-material hazard. The miner working in the area was struck by the falling slab of marble and received crushing injuries. The miner died on April 2, 2026, from complications related to his injuries.
