REPORT OF INVESTIGATION

Machinery Accident Fatality Report  
January 6, 2026

MZP Kiln Services, Inc. (B1636)  
Ambridge, Pennsylvania

Lebec Cement Plant  
National Cement Company of California Inc  
Lebec, Kern County, California  
ID No. 04-00213

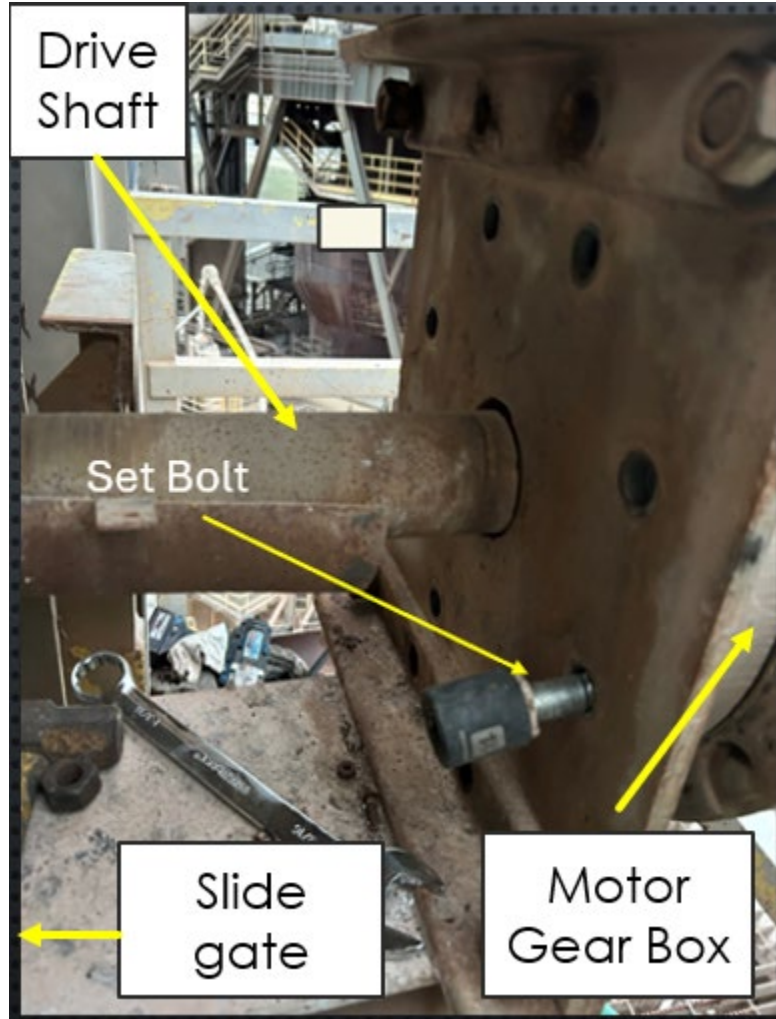
## APPENDIX A – Gearbox Mounting Plate

Hernandez began removing the bolts that held the gearbox mounting plate (Appendix A) to the slide gate shaft. As he loosened and removed the last bolt, the slide gate shaft and the assembly began to rotate rapidly, catching Hernandez's pants and harness leg strap, and entangling him as the assembly continued to rotate. Molina was on the platform and became injured after trying to stop the gearbox. Molina yelled for help. Other workers in the area heard Molina yelling and ran to the area to help. At 10:29 a.m., Scott Kuhn, control room operator, called for emergency services while Andrew Dixon, Sr., production shift supervisor, cut Hernandez's harness once

Investigators found that the slide gate was fully closed (at its highest elevation) when Molina, Amaya, and Hernandez began the process of removing the assembly. Hernandez removed the last set bolt, which released the weight of the slide gate. As the gate fell, the slide gate shaft spun

freely in a clockwise direction, causing the motor and gearbox to rotate on the shaft attached to the slide gate. Investigators tested the assembly and found no issues with the gate. Investigators determined that the assembly was not blocked against hazardous motion, which contributed to the accident.

Corrective Action: The mine operator and contractor each developed and implemented a written procedure for blocking moving machine parts against hazardous motion and trained their employees on the new procedure.

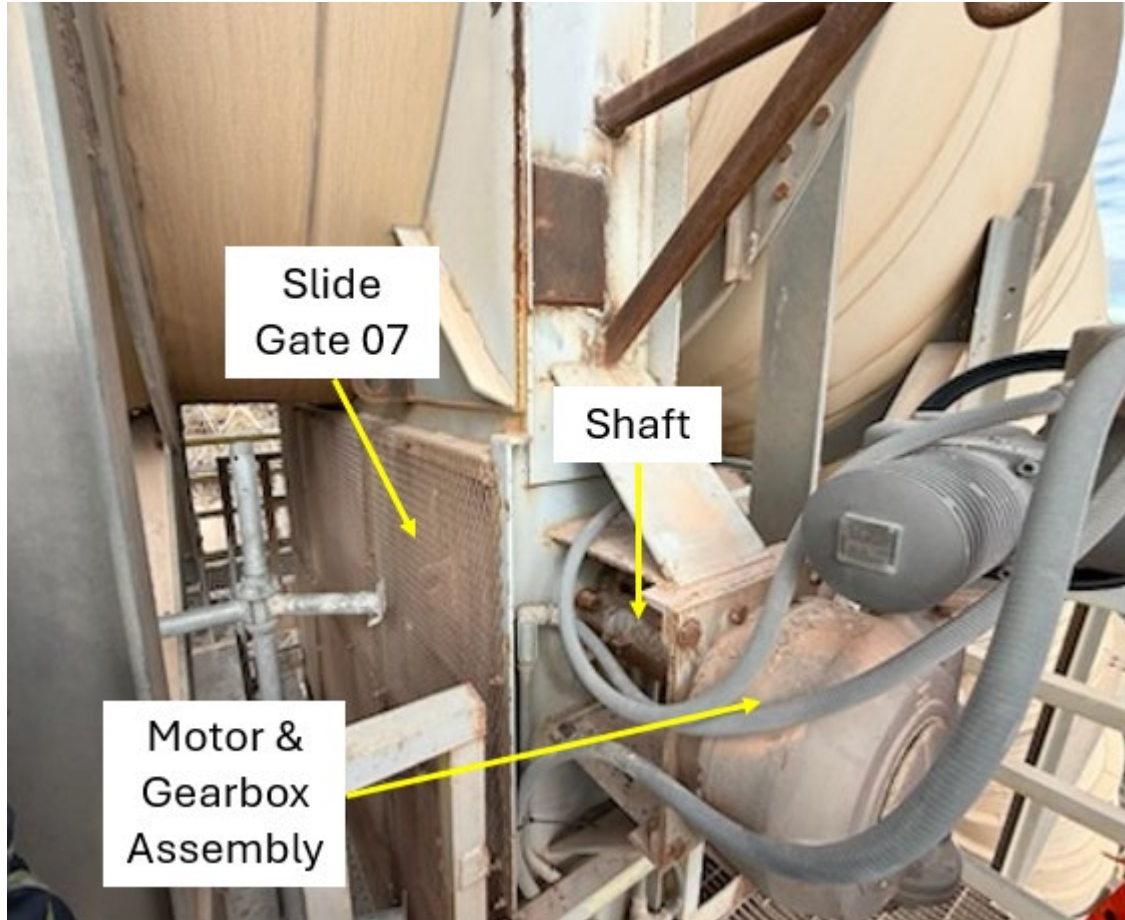
## APPENDIX C – Slide Gate 07

The accident occurred on the platform with slide gate 07's gearbox and motor assembly. For reference, a photo of the motor assembly can be found in Appendix C.

Slide gate 07 is installed in a gas/dust duct between the preheat tower and a baghouse. The duct is a large, enclosed metal passage that moves air from one place to another, helping bring in clean air or remove dusty air to keep the work area safe. Inside this duct is a slide gate, which acts like a heavy metal door that can open or close to control how much air or material passes through and can also shut off part of the system when maintenance is needed. The motor and gearbox are the components that move this gate. The motor provides power, and the gearbox slows its movement and adds enough torque for the 10,600-pound gate to open and close in a safe and controlled way. When the gate is up, the duct is closed off. The motor assembly must lift the gate to close it.

Neither the mine operator nor MZP conducted a workplace examination of the work area on the date of the accident. The investigator determined that a workplace examination should have identified the hazard created by stored energy of the slide gate in the closed position (meaning there was tension on the drive chain). Investigators determined that the lack of an examination contributed to the accident.
