REPORT OF INVESTIGATION

Fatal Machinery Accident
June 15, 2025

Coleman Quarry
P&K Stone LLC
Coleman, Atoka County, Oklahoma
ID No. 34-02246

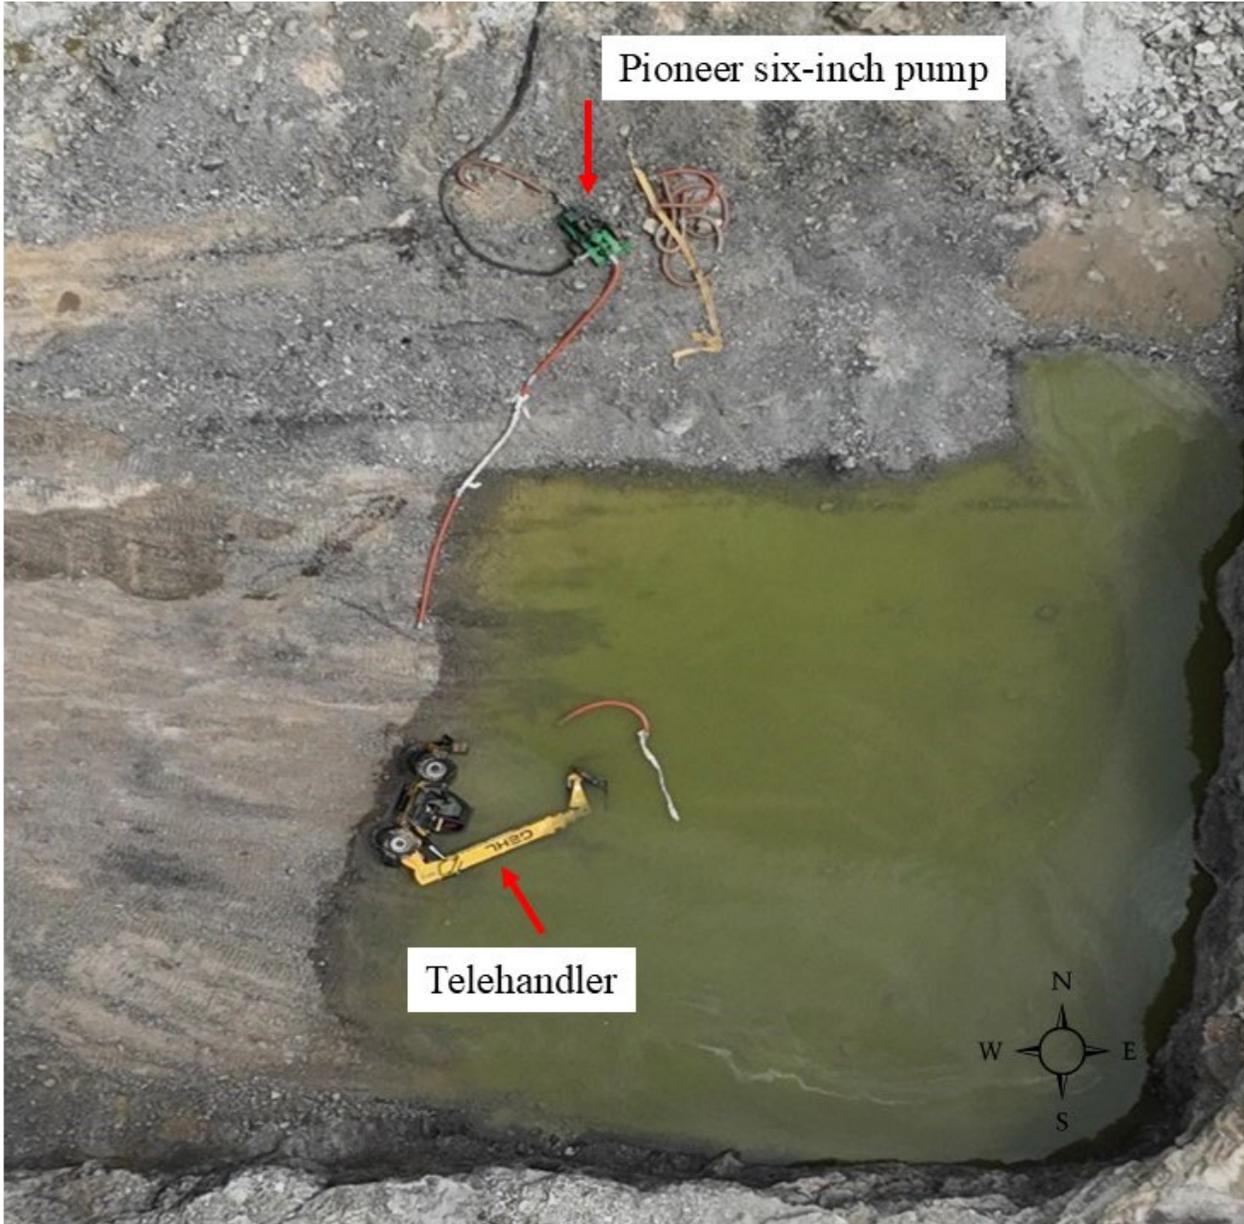
APPENDIX B – Pump and Telehandler in the Quarry Pit

The accident occurred in the quarry pit (see Appendix B). The mine operator allowed the miner to work alone while checking the pump in the quarry pit without any means of communication. Investigators determined that this contributed to the accident.

Investigators determined that the telehandler was located at the bottom of the ramp parked parallel to the water's edge, on a 15-degree slope. The investigators observed that the front two outriggers were in the up position. The boom was raised to a 45-degree angle, and all the boom sections were retracted. The right fork of the telehandler was inserted approximately 18 inches into a 20-foot section of six-inch plastic corrugated suction line. The mine operator should have known that Bird's assigned task would require the telehandler to be operated on the 15-degree slope. The mine operator used the telehandler beyond its designed capacity, which contributed to the accident.

Additionally, the telehandler's stabilizers and boom attachments were not lowered to the ground. The manual states, "Do not use outriggers on soft or uneven surfaces. Be sure the surface can support the machine and load." The mine operator did not ensure the boom and outriggers were positioned to prevent movement of the telehandler, which contributed to the accident.

On June 15, 2025, a maintenance person died when a GEHL TH10-55 telehandler overturned onto him while he was outside of the operator's cab. The mine operator did not ensure the boom and outriggers were positioned to prevent movement of the telehandler. The telehandler was left unattended and parked on a 15-degree ramp with the boom and outriggers in the raised position.

Corrective Action: The mine operator developed and implemented a procedure to ensure that no miners or contractors work alone. The mine operator has trained all miners on this procedure.

Corrective Action: The mine operator retrained all miners on the telehandler's safe operating procedures according to the operator's manual.

Corrective Action: The mine operator trained all miners on safe parking procedures.
