REPORT OF INVESTIGATION

Surface  
(Frac Sand Mine & Plant)

Slip or Fall of Person Accident Fatality Report  
March 28, 2026

Alpine Silica-San Antonio  
Alpine Silica, LLC  
San Antonio, Bexar County, Texas  
ID No. 41-05426

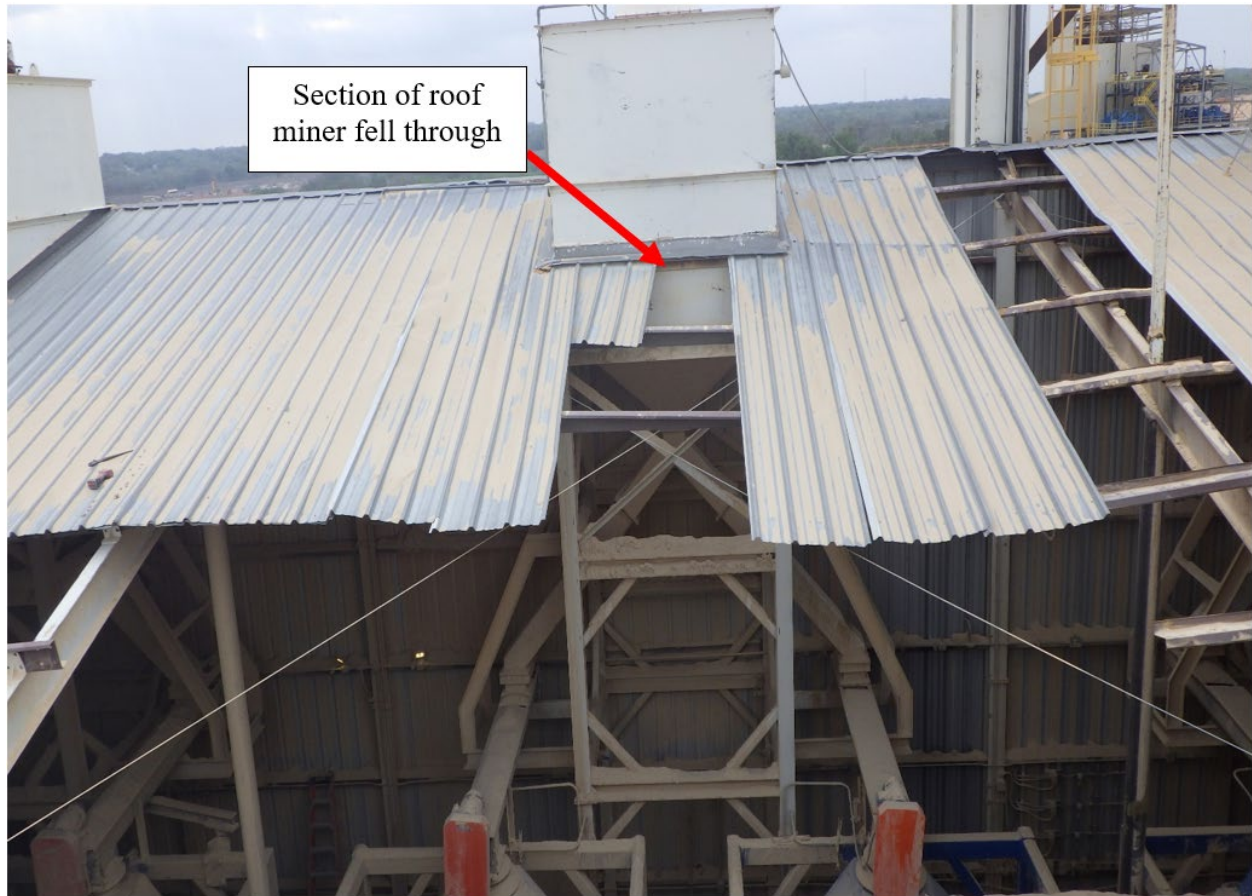
## APPENDIX B – Top View of Roof

At 9:00 a.m., Lopez stepped onto an unsecured section of roofing material near the surge bin and fell about 37 feet and 6 inches down to the Rotex screen building floor below. Nobles notified Sparks of the fall. Sparks immediately went to the Rotex floor and found Lopez unresponsive. Nobles, Rogers, and Sparks began administering cardiopulmonary resuscitation while also applying an automated external defibrillator (AED). The AED did not advise administering a shock. Sparks called 911 at 9:20 a.m.

roof to attach a replacement section of purlin died when a section of the roof tin collapsed, allowing him to fall to the floor below.
