REPORT OF INVESTIGATION

Surface  
(Industrial Sand)

Falling, Rolling, or Sliding Rock or Material of Any Kind Accident Fatality Report  
March 3, 2026

North American Silica Sand, LLC  
North American Silica Sand, LLC  
San Antonio, Bexar County, Texas  
ID No. 41-05470

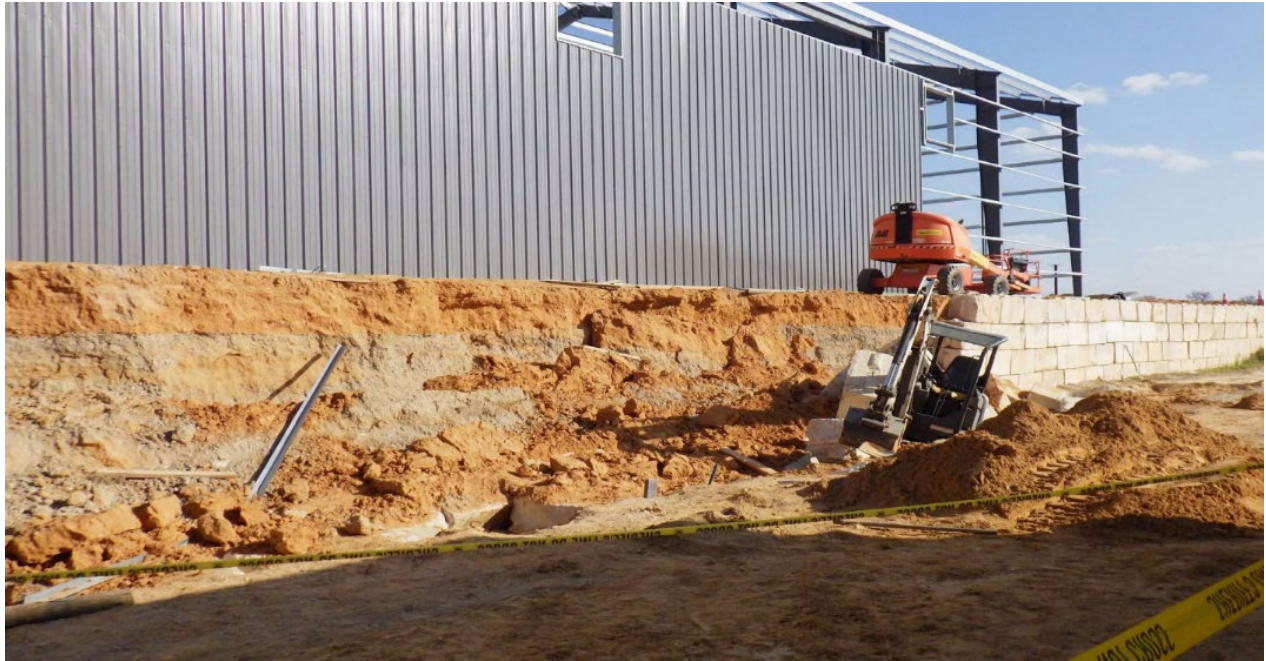
On March 3, 2026, at 1:08 p.m., Leandro Castro, a 63-year-old contract miner with about 16 days of mining experience, died after a concrete block retaining wall collapsed into the excavated footing below, crushing him.

The existing retaining wall was built using concrete blocks, each measuring 4 feet in length, 2 feet in width, and 2 feet in depth, and weighing about 800 pounds each. The blocks were stacked four blocks high, in total measuring nearly 285 feet in length, and 8 feet in height. The concrete blocks had not been secured in place. They were simply resting on top of one another. The area above the existing retaining wall was being used as an access point for the JLG 460 Man Lift to travel and continue working on the sand storage building while work was being performed on the retaining wall. The footing excavation for the new retaining wall that was being constructed in front of the existing retaining wall measured nearly 220 feet in length, 3 feet in depth, and 8 feet in width.

The mine operator observed that the existing retaining wall was not permanently fixed; was unstable; was leaning out, away from the building; and needed to be reinforced. The mine operator contacted Axis Engineering in November 2025 to evaluate the construction of a new building. Mine management, J-Co construction, and Axis Engineering met on February 9, 2026. Prior to this meeting, the existing retaining wall was two to three layers high. During this meeting, Axis Engineering noticed the existing retaining wall had grown to four layers high. The existing retaining wall was discussed, specifically the portion of the wall that showed signs of leaning. Axis recommended the top two layers of blocks be removed along the stacked block wall length.

On March 3, 2026, when Axis Engineering arrived on-site to assist with the footing elevation issue, they noticed that the top two layers of blocks had not been removed. Axis Engineering recommended that the layers be removed before work continued. Instead of correcting hazardous ground conditions or preventing contract miners from being exposed to the hazardous ground conditions, North American Silica Sand, LLC's managers Geoff Hicks and Sydney Hokamp, as well as Jason Miller of J-Co construction, allowed contract miners to continue to work in the area, knowing the retaining wall was unstable.

These factors created hazardous ground conditions. Investigators determined that the mine operator and J-Co Construction did not correct known hazardous ground conditions, which contributed to the accident.

Corrective Action: The ground condition was corrected by removing the stone block retaining wall and grading the slope to remove any other hazardous ground condition.

Corrective Action: The mine operator has added barricades to stop vehicular traffic near the side of the building above the sloped area.
