REPORT OF INVESTIGATION

Machinery Accident Fatality Report  
March 5, 2026

Deer Run Mine  
Patton Mining LLC  
Hillsboro, Montgomery County, Illinois  
ID No. 11-03182

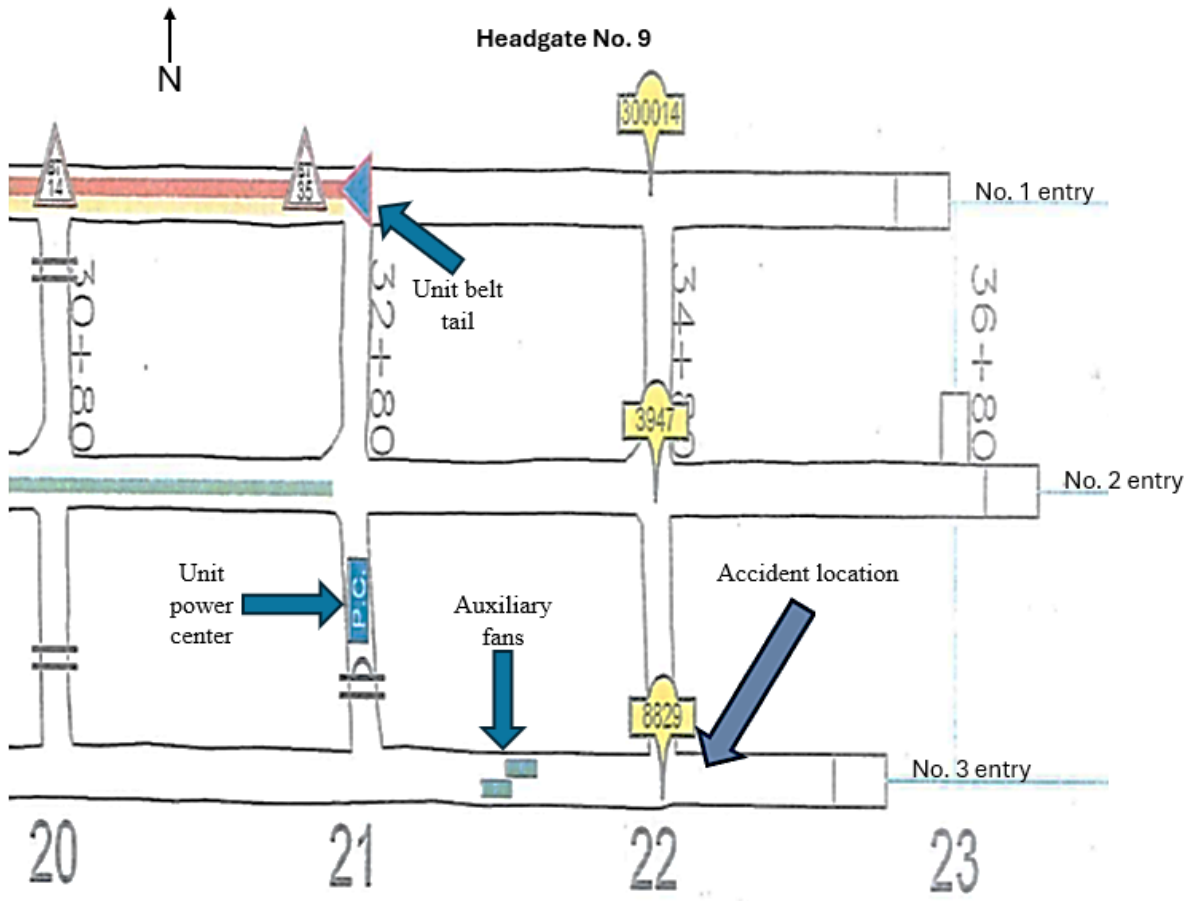
# APPENDIX A – Section Map

The accident occurred just inby the intersection of crosscut No. 22 in the No. 3 entry on Headgate No. 9 (Appendix A). The mine height in the entry where the accident occurred was 10 feet 3 inches. The mine floor was dry. The mine roof had metal screen wire installed and no support was installed in the coal ribs. Ventilation tubing was hung from the roof and extended from the No. 3 entry face to the auxiliary fan located in the return air course in the No. 3 entry.

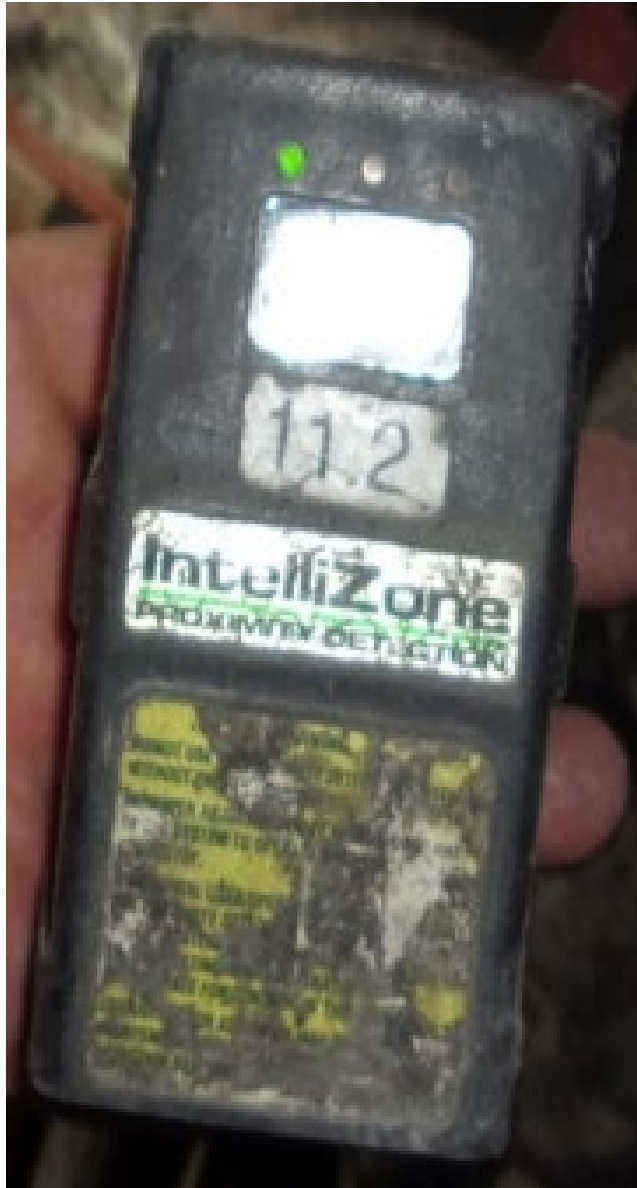
APPENDIX D – Photograph of Smith's Miner Wearable Component

The MMCs include four electromagnetic field generators (referred to as drivers) and one Machine Mounted Locator (MML). Two drivers are located near the front of the CMM, one on each side, and two drivers are located near the rear, one on each side. One MML was mounted on the right side of CMM No. 28. MMLs are designed to prevent tramping or swinging of the conveyor tail of a CMM if the electromagnetic signal from one of the drivers changes by a preset amount. The PDS uses the electromagnetic fields generated by the drivers and radio signals from the MWCs to determine the location of each MWC relative to the CMM. When an MWC enters the warning or shutdown zones in the electromagnetic field, the MMCs and MWC recognize the intrusion and relay the appropriate signal to the system. For further reference, a photograph of Smith's MWC is in Appendix D.

However, if the MWC is metallically shielded, the electromagnetic fields from the drivers are not accurately measured by the MWC, and the warning and shutdown zones do not work as intended. A warning from the Matrix user manual states: “Do not position the MWC on the

Investigators determined through interviews that Smith, along with other CMM operators, were defeating the PDS by placing the MWC in areas of the conveyor tail that surrounded the MWC with metal. This created an electromagnetic shield that caused the PDS to assign locations to the MWC outside the shutdown zone. When the MWC was shielded in this manner, it allowed the CMM operator to be anywhere around the CMM while performing any function of the machine including tramming and repositioning the tail.

Corrective Action: The mine operator developed and implemented procedures for PDS examinations and red zone safety and implemented them into the RCP. The procedures require a foreman to visually examine for proper placement of the MWC on each CMM operator at the beginning of the shift and a mid-shift visual exam is performed. The foreman is required to record the examinations in the on-shift exam record for each shift.

All CMM operators shall wear a high-visibility vest, and the MWC shall be visible at approximately mid-chest height. The mine operator developed a policy regarding CMM operators' attire and MWC placement. The policy was posted with other MSHA plan postings for all mine personnel to see. The mine operator retrained all miners and foremen using Matrix trainers on how to conduct a proper static and dynamic test, and proper placement of the MWC.

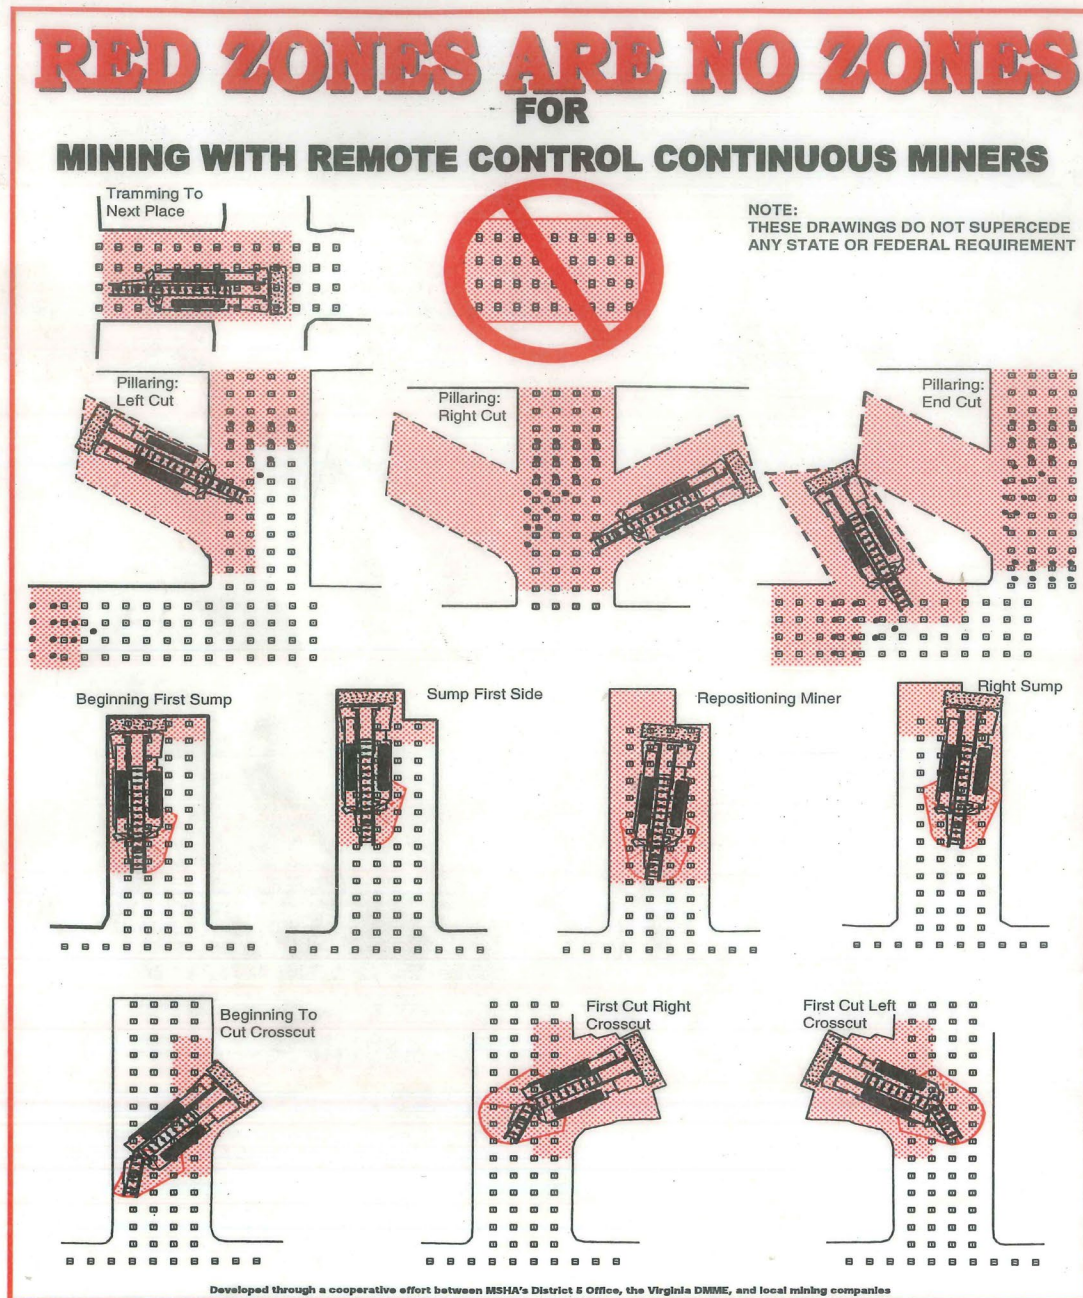
APPENDIX E- Red Zone Image from Roof Control Plan

with the move shall be positioned in an area outby any part of the continuous mining machine while the machine is being trammed.” Red zone illustrations on page 22 of the RCP address the red zone provisions. The RCP states "Red Zones are No Zones!" For further reference, illustrations of red zones around CMMs can be found in Appendix E.

The RCP’s red zone provisions were not followed. The accident occurred when the victim was in the red zone and became pinned between the CMM and the coal rib while tramping the CMM to the working place. Investigators determined that this contributed to the accident.

Corrective Actions: The mine operator retrained miners on the following provision of the approved RCP: Page 19, item 4, specifies that during place changing, including re-positioning of the continuous mining machine within the working place, all persons involved with the move shall be positioned in an area outby any part of the continuous mining machine while the machine is being trammed. Additionally, the illustration on page 22 states: “Red Zones are No Zones.”
