REPORT OF INVESTIGATION

Fall of Face, Rib, Pillar or Highwall Accident Fatality Report  
May 19, 2026

Bailey Mine  
Consol Pennsylvania Coal Company LLC  
Wind Ridge, Greene County, Pennsylvania  
ID No. 36-07230

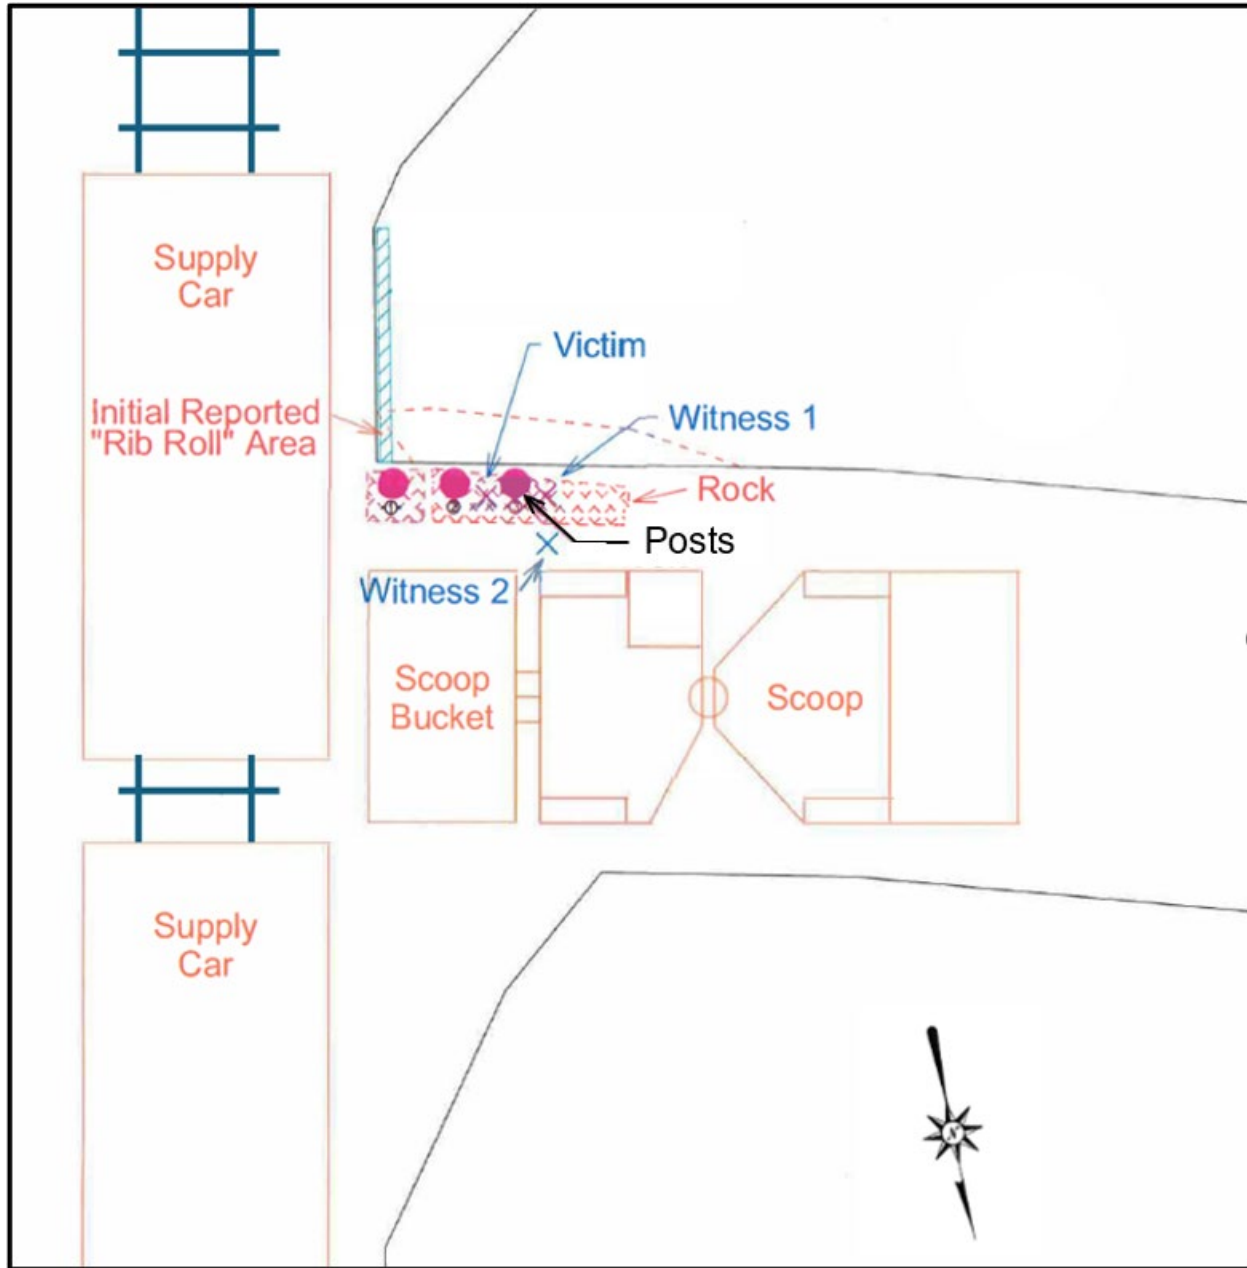
## APPENDIX A – Map of the Accident Location

Wolfe and Rampero began installing the third post while Schultz handed them the cap blocks and wedges. Wolfe began driving the wedge above the third post when a large piece of rock fell from the rib and pinned him to the mine floor. Schultz and Rampero dove out of the way of the falling rock. Once the dust cleared, Schultz could see Wolfe underneath the fallen rock. Schultz checked Wolfe's pulse but did not detect one. Schultz immediately ran toward the 7 South Mains power center to find help. For further reference, a map of the accident location can be found in Appendix A.

The operator did not adequately support or otherwise control the mine rib in the No. 6-7 crosscut at 24 block in 7 South Mains. On May 19, 2026, an assistant shift foreman was fatally injured when a large section of rib fell out and pinned him to the mine floor. The victim and two contractors were in the process of setting posts to barricade off the area to prevent travel along the rib line. The barricade was being constructed as a corrective action to a hazard noted in the pre-shift book on the previous shift. The size of the rock measured 96 inches long, 30 inches wide, and ranged from 18 to 26 inches thick.

The posts (pink) were set left to right.

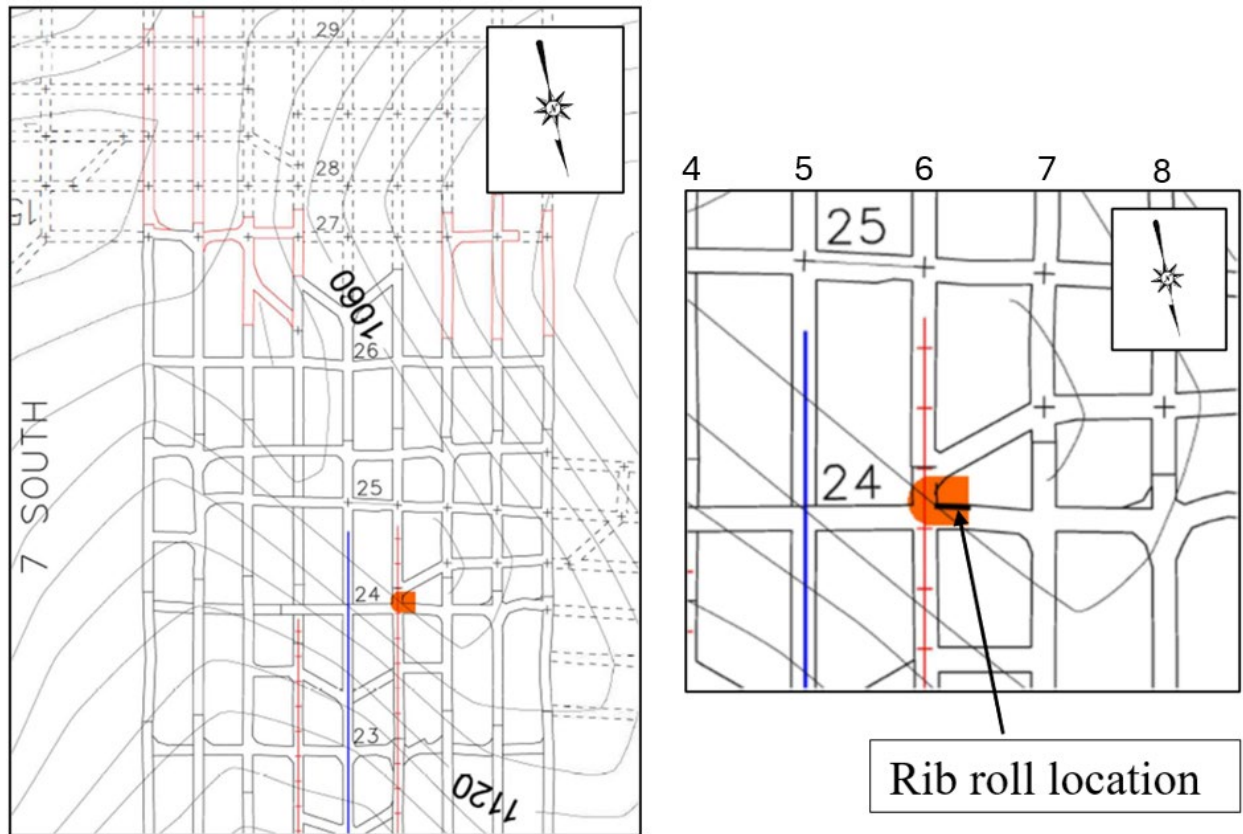
## APPENDIX C – Location of Accident

The accident occurred on the 7 South Mains section in the No. 6-7 crosscut at 24 block. This crosscut is adjacent to the track which is used to transport supplies to the 7 South Mains sections. This crosscut was mined in January 2026. The depth of cover at the accident location was approximately 1,060 feet and the mining height was 9 feet. For further reference, a map of the location of the accident can be found in Appendix C.

The depth of cover in the orange highlighted area was approximately 1,060 ft.
