REPORT OF INVESTIGATION

Machinery Accident Fatality Report  
May 20, 2026

Boyd Company (C1571)  
Louisville, Kentucky

Combs Branch Job  
Pine Branch Mining LLC  
Hazard, Perry County, Kentucky  
ID No. 15-16883

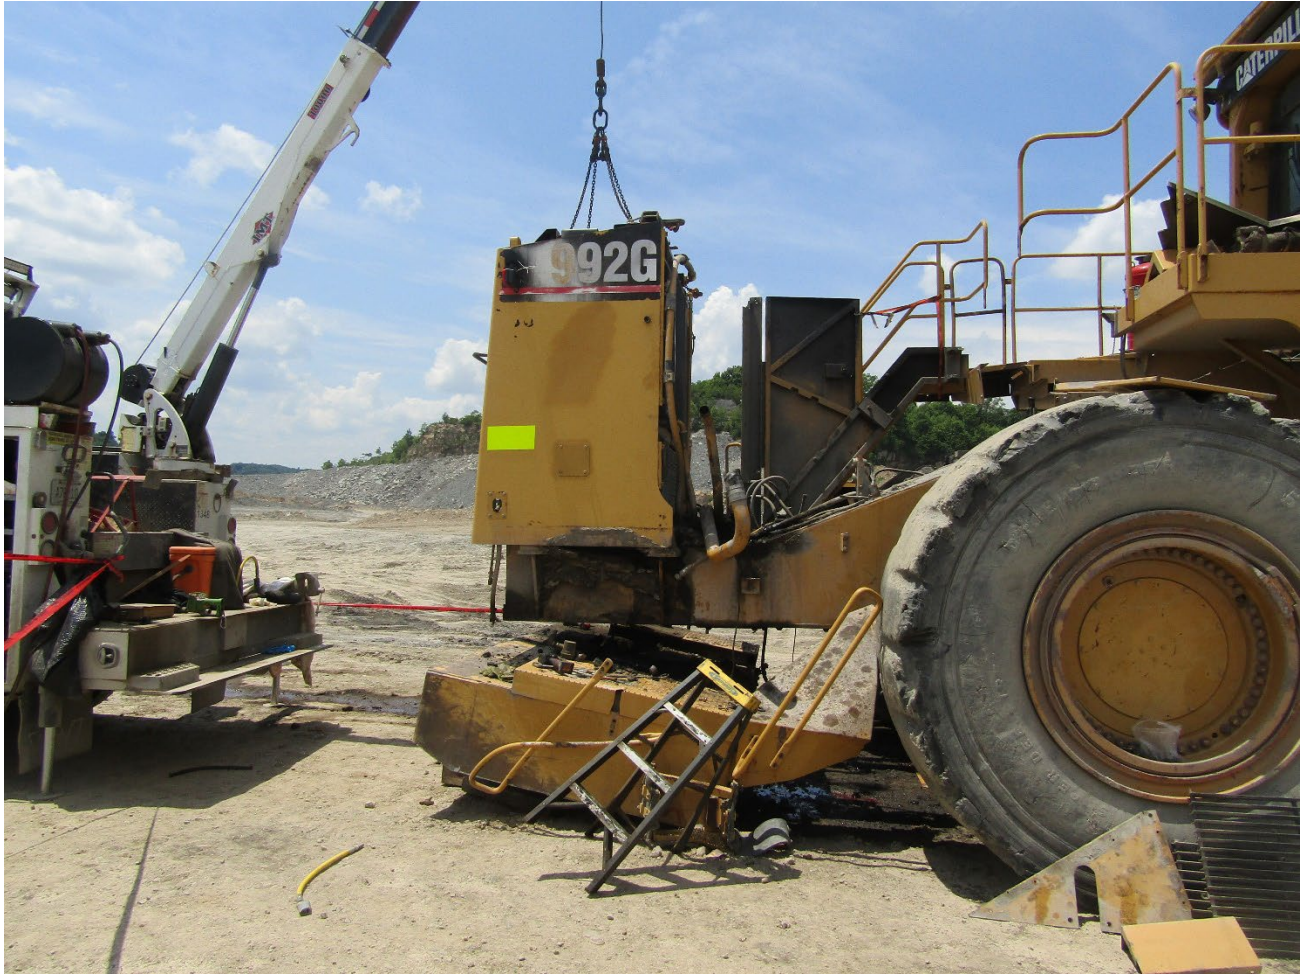
On May 20, 2026, at 10:21 a.m., Preston Pollard, a 25-year-old contract mechanic field technician with 1 year of mining experience, was fatally injured when the counterweight he was removing from a front-end loader fell on him.

The accident occurred because: 1) the counterweight was not blocked against motion prior to performing repairs, and 2) training was inadequate for the engine and radiator guard removal.

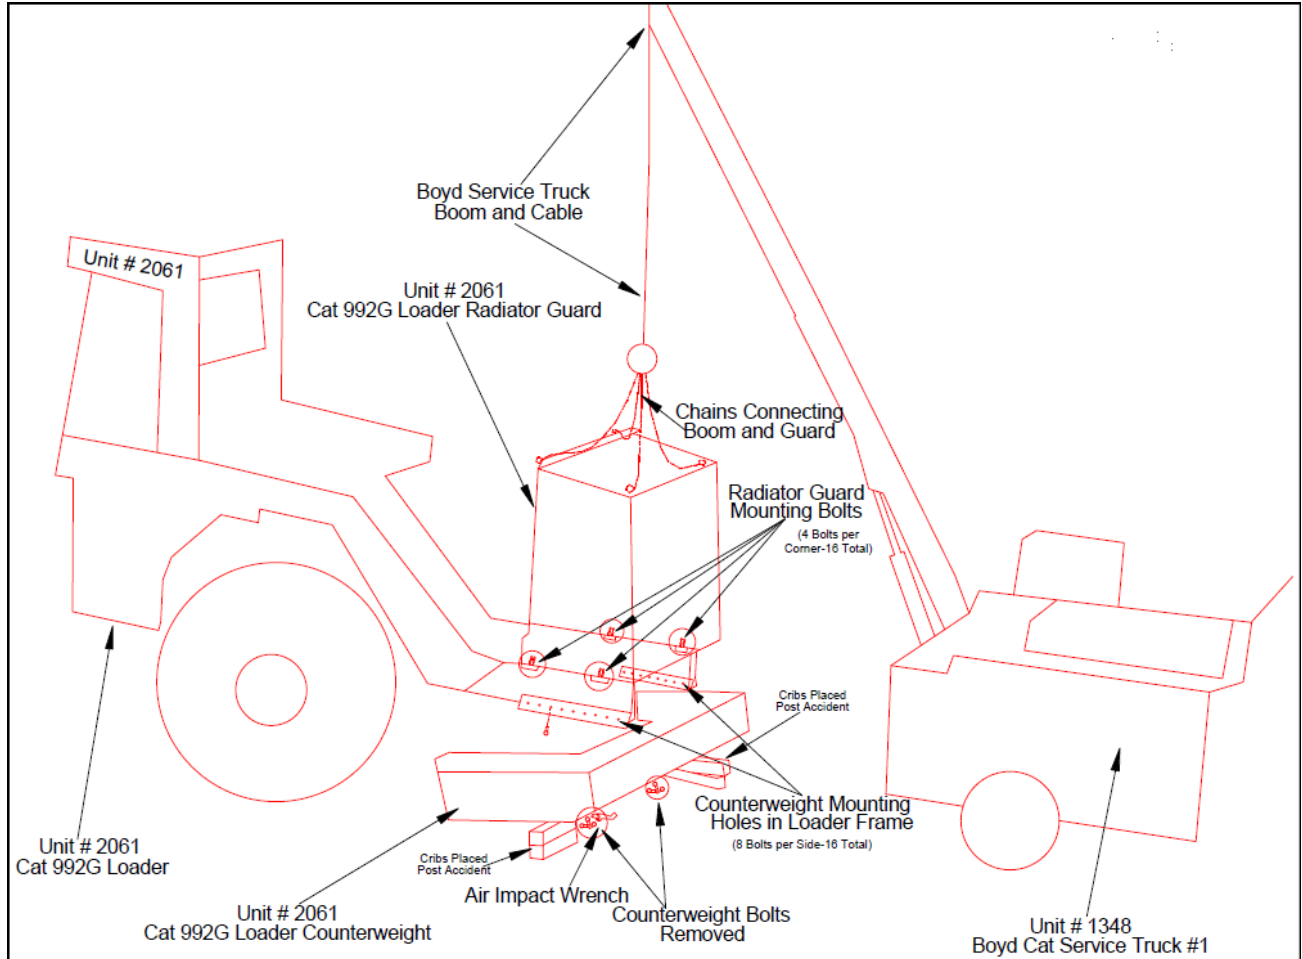
## APPENDIX B – Post Accident Sketch

The mechanic truck that was connected to the radiator guard was a Western Star service truck, Company No. 1348. For reference, a sketch of the configuration of the front-end loader and mechanic truck from after the accident is shown in Appendix B.

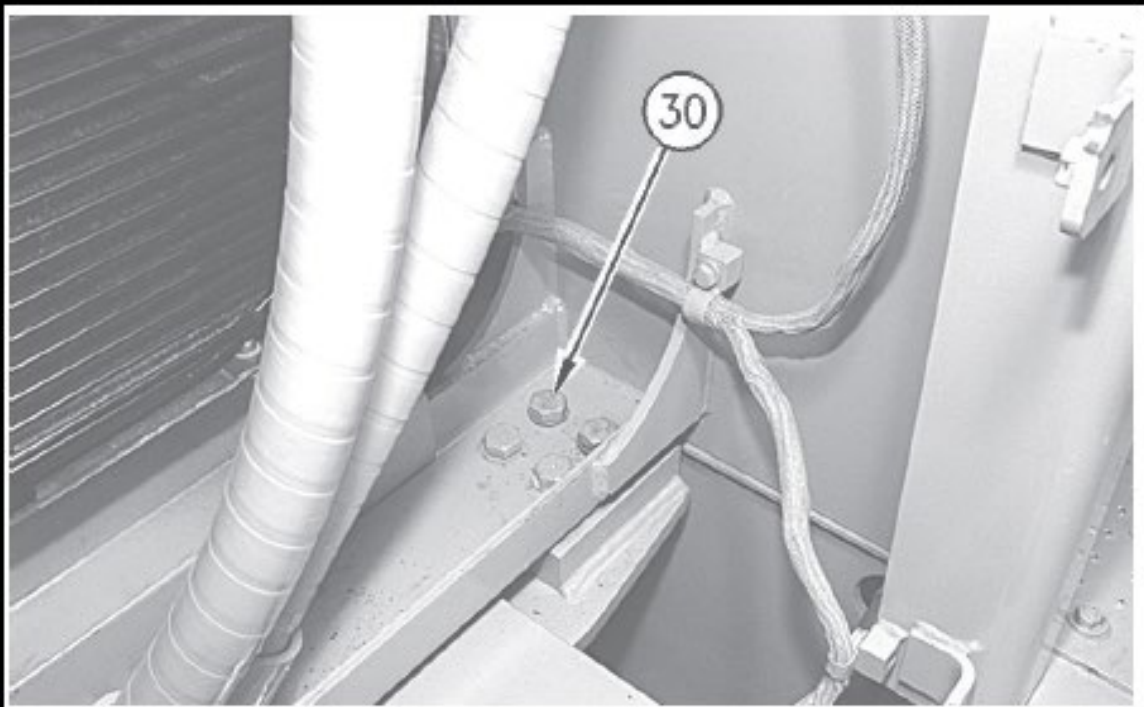
APPENDIX C – Service Manual Photograph

Boyd Company's established work procedures required mechanic field technicians to review and follow the manufacturer's service manuals and the Service Information System (SIS) for safe repair procedures. The equipment manufacturer's recommended maintenance procedures and SIS were not followed during the engine and radiator guard removal on the front-end loader, when a field technician removed the bolts used to secure the front-end loader's counterweight, causing the counterweight to fall. Per the manufacturer's service manual procedures and SIS, these bolts were not to be removed during the removal of the radiator guard. The manufacturer's service manual titled "Disassembly and Assembly-854G Wheel Tractor and 992G Wheel Loader Engine Supplement" provides step-by-step instructions for the disassembly and removal of the radiator guard. These instructions state, "Remove bolts (30) from four radiator mounting brackets." A photograph which clearly indicated the location of these bolts is provided in the manual. For reference, this photo can be found in Appendix C. The instructions also state, "Attach a suitable lifting device to radiator guard (31). The weight of the radiator guard (31) is approximately 1,670 kg (3,680 lbs.)." The investigator determined that the contractor did not block the counterweight against motion, which contributed to the accident.

**29. Remove bolts (30) from four radiator mounting brackets.**
