REPORT OF INVESTIGATION

Electrical Accident Fatality Report  
September 13, 2025

Ste. Genevieve Facility  
Tower Rock Stone Company  
Sainte Genevieve County, Missouri  
ID No. 23-00781

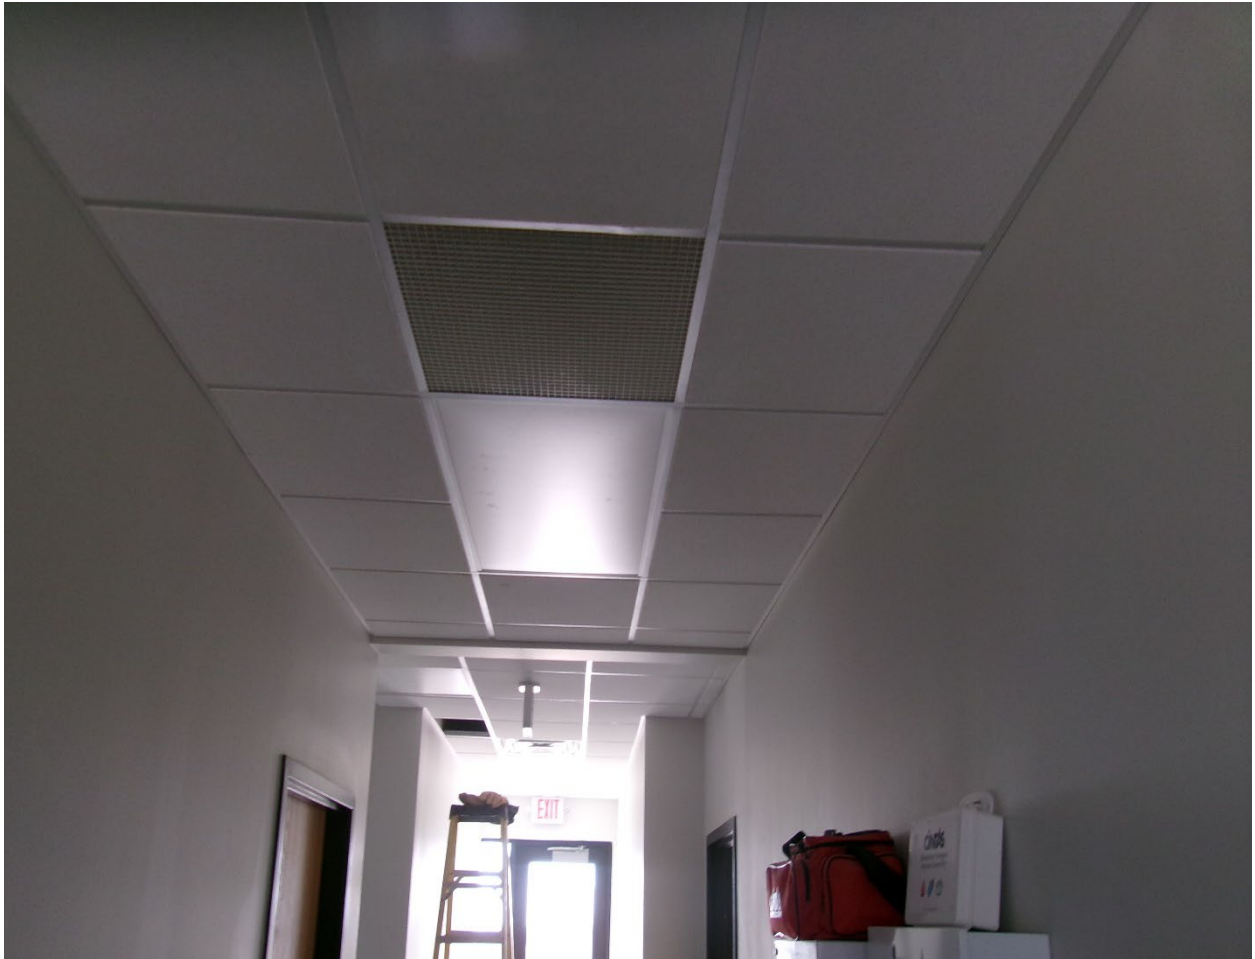
## APPENDIX A – Hallway Light Fixture

At 6:30 a.m., Johnson and Conrad noticed a light in the hallway that was not on and needed to be changed out (Appendix A). They turned off the wall switch in the hallway before starting work. As Johnson began to unwire the light fixture by removing the wire nuts, he heard arcing that indicated that the light was still energized. Johnson stopped work, went to the basement to the main lighting panel (Appendix B), and de-energized circuit breaker 34. This de-energized all the 277-volt alternating current (VAC) first-floor lights and activated the first-floor emergency lighting.

When the emergency lights came on, Johnson realized that the hallway light fixture that he was working on had remained energized when they turned off the wall switch in the hallway until circuit breaker 34 was de-energized. Johnson and Conrad replaced the hallway light fixture, and Johnson went back to the basement to re-energize circuit breaker 34 to verify that the light was fixed. Once the light came on, Conrad yelled down the stairwell next to the light; and said it was fixed. Conrad and Johnson went to the production supervisor's office and saw that a light in the office was not on (Appendix C). They turned off the production supervisor's office wall switch and began replacing the light fixture in the office. Johnson helped Conrad get the old light fixture down and placed it along the wall in the office. Johnson handed Conrad a new light fixture.

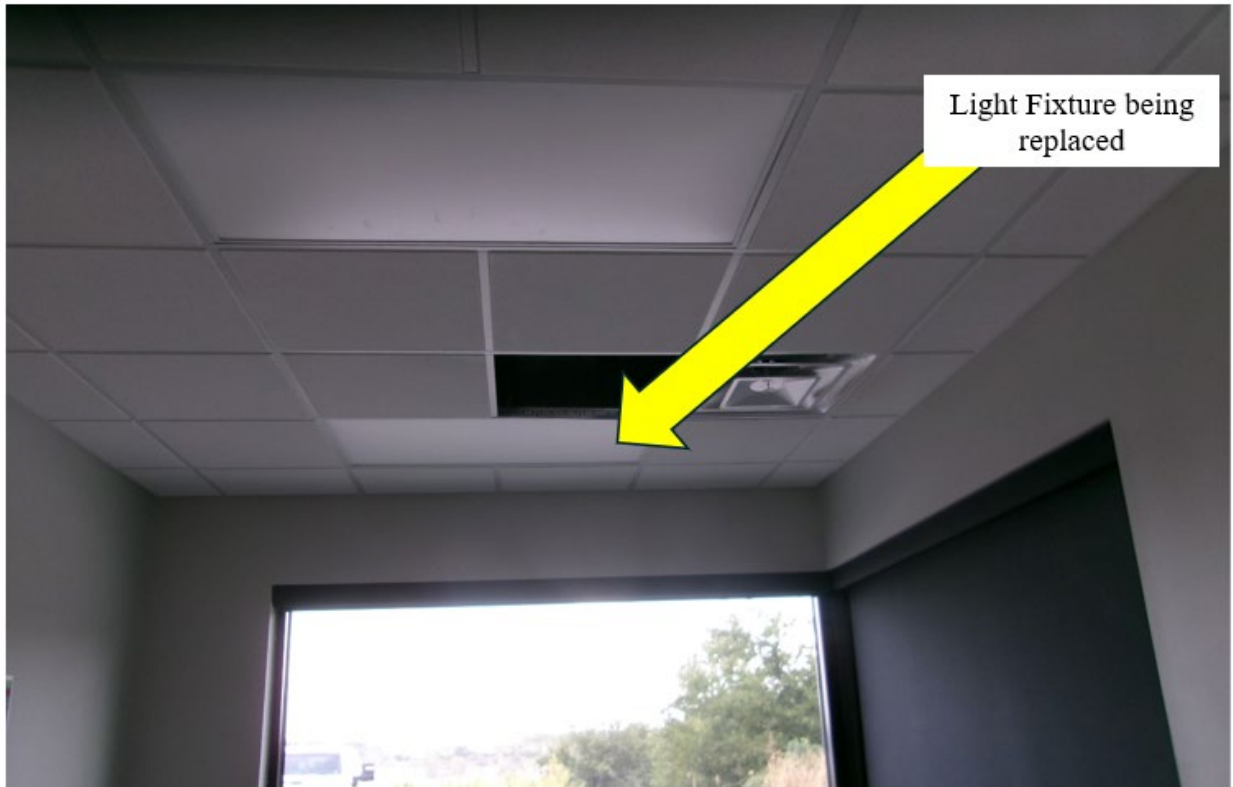
## APPENDIX C – Light Fixtures in the Production Supervisor’s Office

Investigators examined the production supervisor's office where the accident occurred. Conrad used a 7-foot step ladder with fiberglass legs, aluminum steps, and a plastic top. The ceiling height is approximately 8 feet to where the light fixture is located. There are three light fixtures in the office, all controlled by the same light switch. The light fixture farthest from the light switch was being replaced at the time of the accident.

Investigators examined the electrical system and determined that the wiring on the light fixture involved in the accident was partially fed through a junction box to the leads on the new light fixture. The neutral wire was fed through the junction box of the new light fixture with a wire nut over the end of the wire. The black wire was left open with no wire nut and exposed copper conductors (Appendix D), which provided a direct energized path to anyone exposed to the conductor. According to interviews, the light switch was functioning and was used to turn off the other two light fixtures in the office before replacing the light fixture involved in the accident. During on-site testing, the light switch was stuck in the open state (off) regardless of the light switch's physical position.

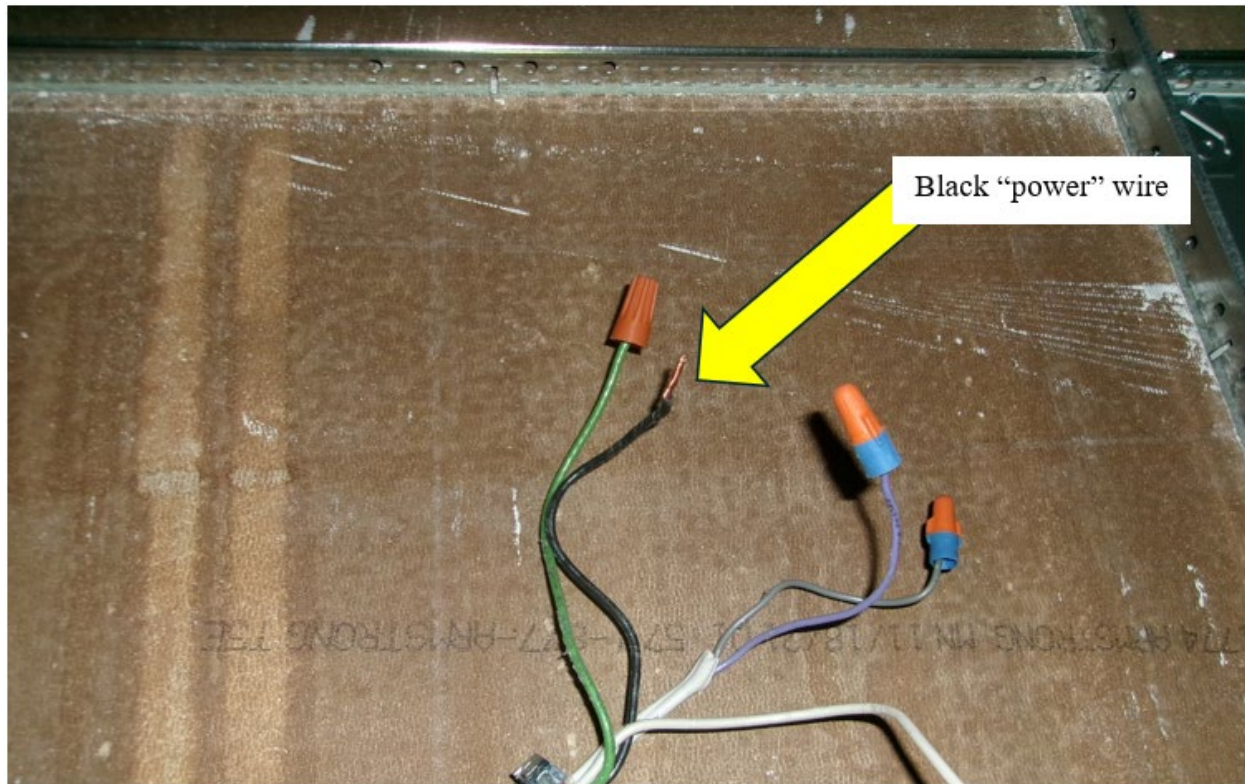
## APPENDIX D – Light Fixture Wiring

The black wire was the power wire, the white wire was the neutral, and the green was the grounding wire. The purple and grey wires were used for the dimmer function of the circuit.

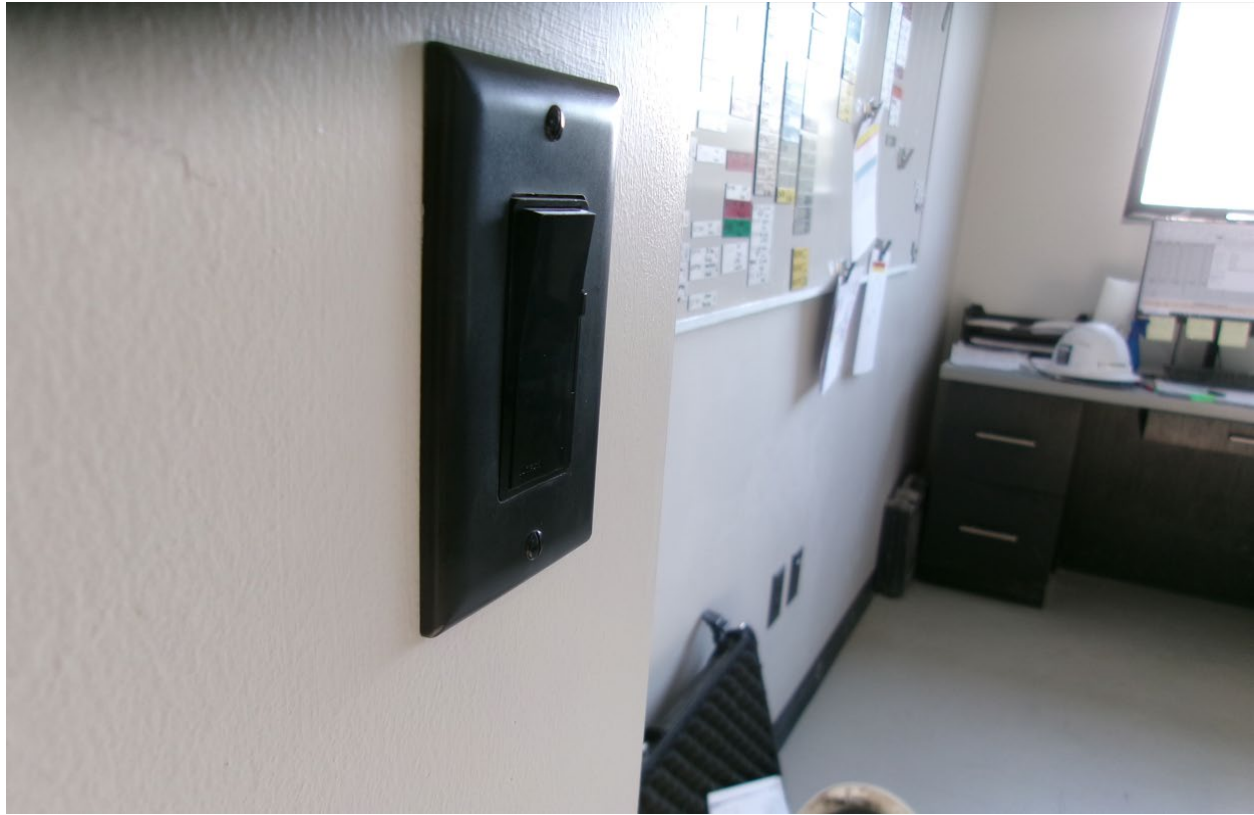
APPENDIX E – Lutron Diva Dimmable Wall Light Switch in Production Supervisor's Office

The light fixture involved in the accident was a Cooper Lighting Solutions Model Metalux 277-VAC fixture. The circuit wiring was a Metal Clad-Light Emitting Diode (MC-LED) cable with armor conduit containing five wires. The black wire was the power wire, the white wire was the neutral wire, and the green wire was the grounding wire. The purple and grey wires were used for the dimmer function of the circuit. The dimmable wall light switch in the production supervisor's office was a Lutron Diva 120-277 VAC switch (Appendix E).

1. The MC-LED cable passed all visual, mechanical, and electrical testing, including insulation resistance testing. There was no evidence of molten copper, thermal damage, arc pitting, or compromised insulation.
2. The Lutron Diva dimmable light switch was found to be inoperative. It measured open (off) regardless of the state of the switch. Internal inspection revealed that the internal 10-ampere fuse was open (de-energized). Continuity testing across the switch's internal latching relay indicated the relay contacts were in a closed (on) state. This indicates the

switch was actively passing 277-VAC line voltage to the load circuit (light fixture) before the switch's circuit board lost power when the internal fuse opened. There was no internal or external visual evidence of thermal cracking, rupture, heat deformation, soot, carbon tracking, or vaporized traces. Evidence indicates the fatal electrical shock and the current that caused the internal fuse to open involved different electrical paths that occurred simultaneously or very close in time.
