REPORT OF INVESTIGATION

Fatal Powered Haulage Accident
December 3, 2021

Brooksville Quarry
CEMEX Construction Materials Florida, LLC
Brooksville, Hernando County, Florida
ID No. 08-00024

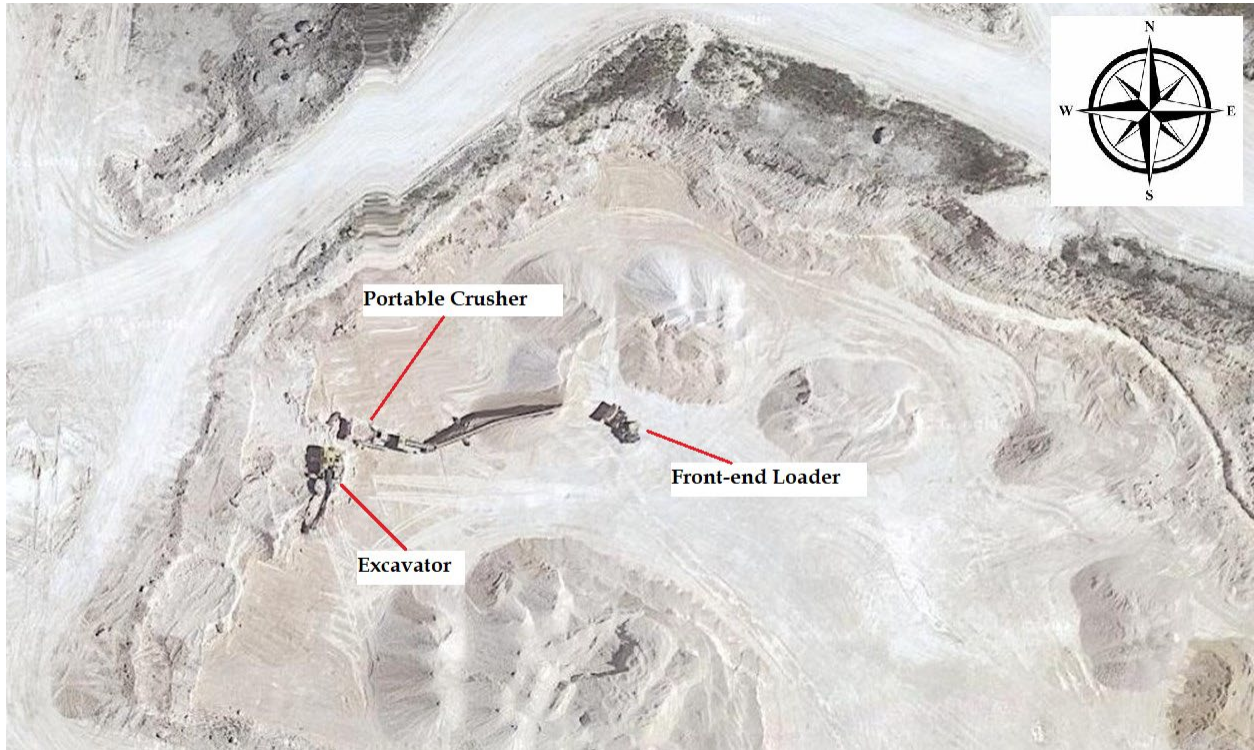
APPENDIX B – Aerial View of the Accident Scene

The accident occurred under the portable crusher located in the Lykes West Pit (see Appendix B). Crum went through a nine-foot-wide opening under the portable crusher that was 54-inches high on the right side tapering down to 30-inches high on the track (left) side. The ground conditions were observed to be rough and irregular, with loose rock present.

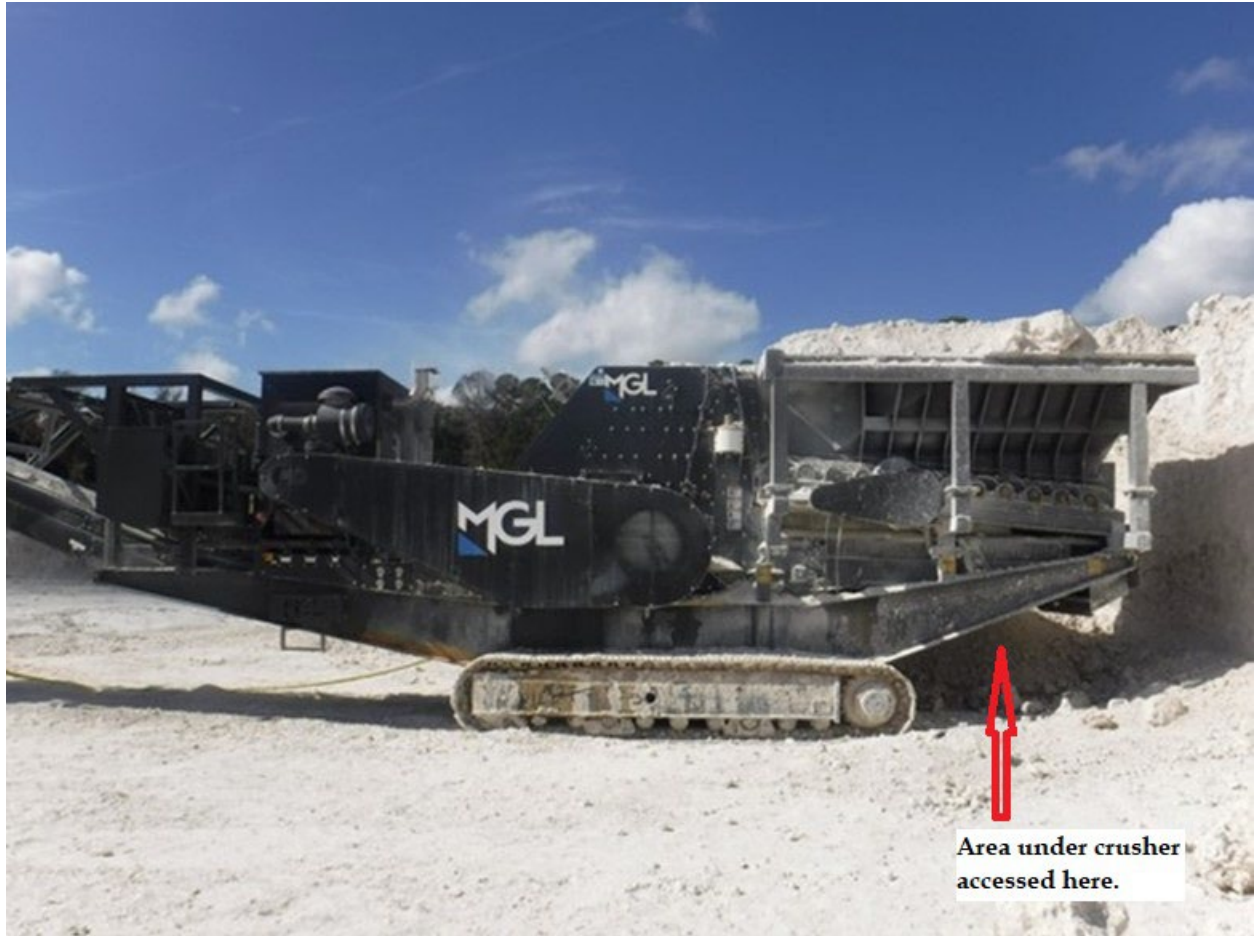
APPENDIX C – Photograph of the Equipment Involved

The portable plant involved in the accident was an MGL Engineering Wobbler Portable Crusher, consisting of a portable crusher and belt conveyors powered by a diesel engine (see Appendix C). The portable crusher was equipped with emergency stop buttons and a remote control that functioned properly when tested. The portable crusher was not de-energized and blocked against

hazardous motion before Crum entered the area underneath, which investigators determined contributed to the accident.

The portable crusher had visible warning signs on the frame, alerting miners of the multiple hazards present, and instructing miners that “absolutely no maintenance or cleaning to be performed while the machine is in operation or while the engine is running.” The warning signs also instructed miners that “all guards must be kept in place.” Based on Crum’s normal duties, as well as information gathered during the investigation, investigators determined that Crum entered this area to check on the belt alignment and clean material from the return idler. The mine operator did not provide a guard for the return idler on the portable crusher feed belt, which investigators determined contributed to the accident. This condition existed for the eight months that the portable crusher was in operation at the mine.

A fatal accident occurred at this operation on December 3, 2021, when a miner became entangled in unguarded moving machine parts of the MGL Engineering Wobbler Portable Crusher. Guards were not provided on the crusher feeder belt conveyor return idler or the crusher discharge belt conveyor tail pulley. This condition allowed the miner to become entangled in the return idler of the crusher feeder belt conveyor. The mine operator engaged in aggravated conduct constituting more than ordinary negligence by not providing a guard to protect persons from becoming entangled in moving machine parts. This violation is an unwarrantable failure to comply with a mandatory standard.

Corrective Action: The mine operator installed guards on the portable crusher to prevent entanglement with moving machine parts.
