REPORT OF INVESTIGATION

Surface
(Construction Sand and Gravel)

Fatal Falling, Rolling, or Sliding Rock or Material of Any Kind Accident
January 3, 2025

Borger Pit
WES AGG, LLC
Borger, Hutchinson County, Texas
ID No. 41-05687

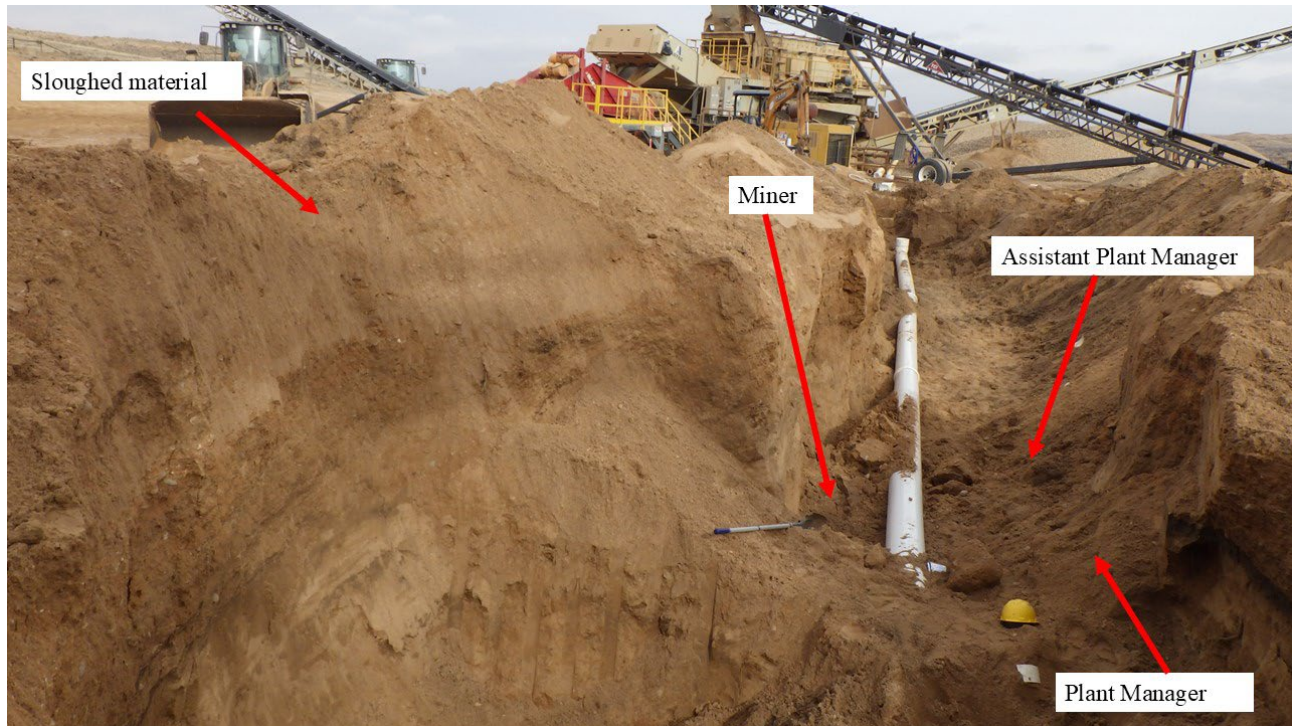
The accident occurred in the trench at the wash plant.

The trench was approximately 87 feet long, 16 feet deep, and 14 feet wide at the top. Approximately 12 feet of the 87-foot-long trench wall was sloped at a 45-degree angle while the remaining 65 feet were vertical. Where the failure occurred, the material excavated from the trench was placed directly on the top edge of the vertical trench wall. The area where the trench was excavated had been previously disturbed by the installation of the old pipe and previous stockpiles over the area. These factors created hazardous ground conditions. Investigators determined the mine operator did not correct hazardous ground conditions, which contributed to the accident. Instead of correcting hazardous ground conditions or preventing miners from being exposed to the hazardous ground conditions, managers Garret and Roberts worked in the trench with Bosquez.
