MNMM Fatal 2007-02

- Fall of Ground Accident
- January 25, 2007 (Washington)
- Lead and Zinc Operation
- Underground Miner
- 43 years old
- 7 years experience

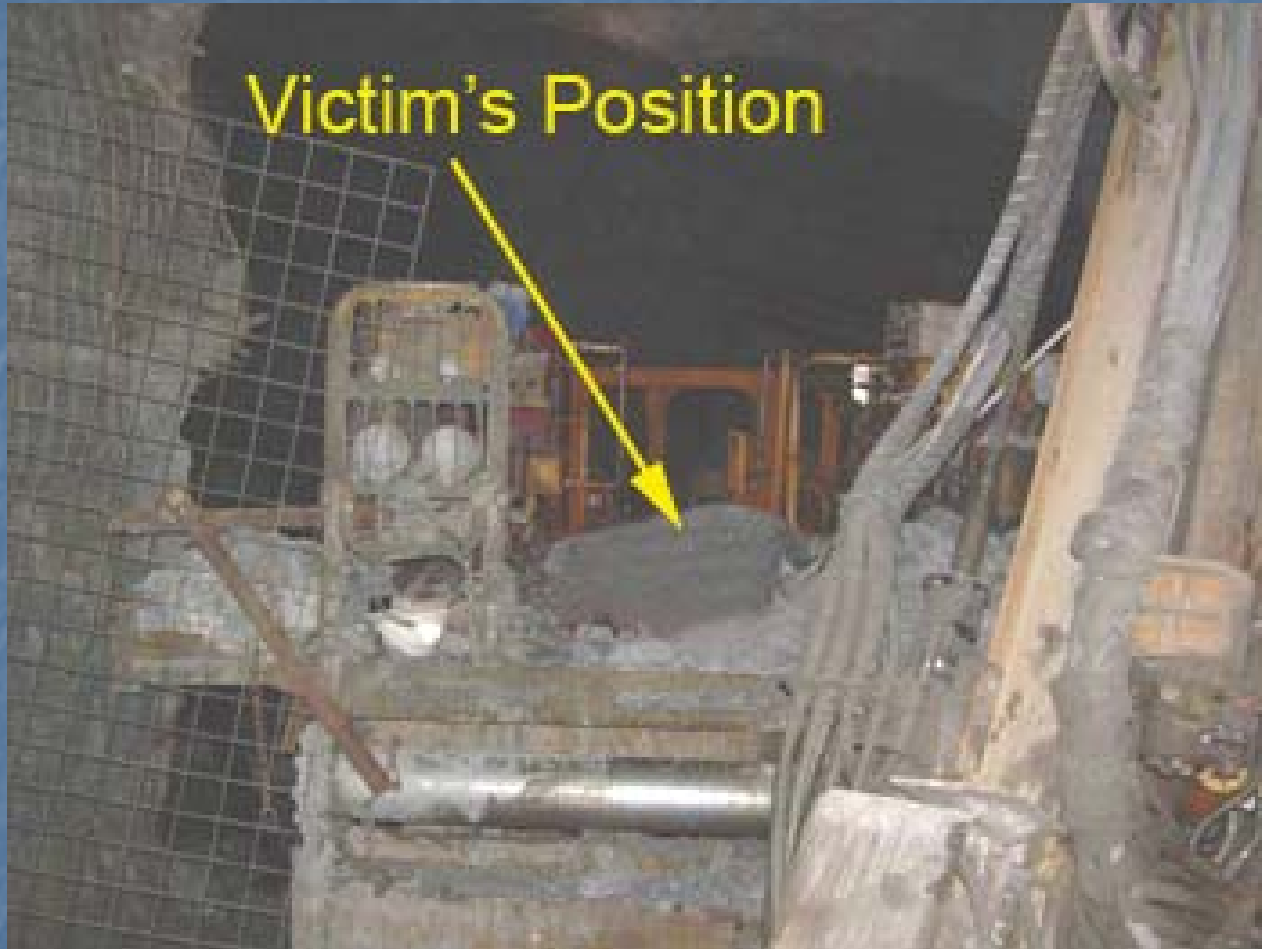
Victim's Position

The victim was fatally injured while operating a roof bolter. He was installing wire mesh when a large rock fell and struck him.

- Management policies and controls were inadequate and did not ensure that newly hired experienced miners were trained before they were assigned to begin work duties. The victim had received site specific training but had not received training on the mine's roof control plan and was unfamiliar with the ground conditions at this mine.
- Management policies and controls were inadequate and did not ensure that persons were protected from fall of ground hazards when they were installing wire mesh. The elevated work platform was not equipped with a canopy; the bolting machine was not equipped with a device to handle the wire mesh; roof support jacks were not provided; and a detailed bolt installation sequence was not being utilized to ensure miners were located under supported ground when installing ground support.

- Examine and test ground conditions prior to performing work.
- Take down or support ground that creates a hazard to persons before performing other work or travel in the affected area.
- Train miners in safe work procedures and hazard recognition, specifically when bolting.
- Stop, Look, Analyze, and Manage, SLAM each task to identify all potential hazards Ensure that all hazards are eliminated so the task can be safely performed.
