**REPORT OF INVESTIGATION**

**Fatal Fall of Ground Accident  
January 25, 2007**

**J. S. Redpath Corp..  
Contractor I.D. No. R83  
at  
Teck Cominco American Inc  
Pend Oreille Mine  
Metaline Falls, Pend Oreille County, Washington  
Mine I.D. No. 45-00366**

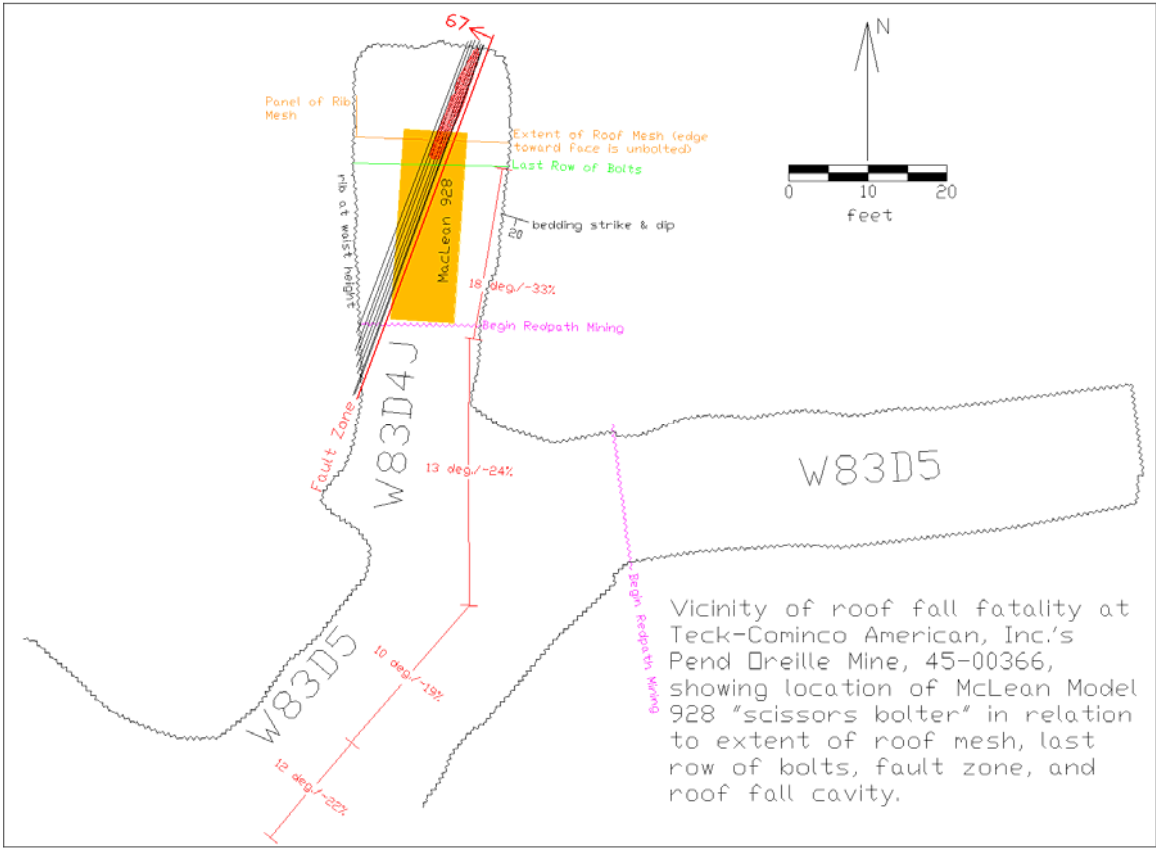
# APPENDIX B

The W83D4J heading was being developed by Redpath. They mined this heading beginning approximately 14 feet north of the 3-way intersection defined by the W83D4J and dog-legged W83D5 headings (Appendix B). The original W83D5 heading was narrowed down and split into the W83D5 drift, mined from the mouth to an extent of 65 feet toward the east-northeast and the W83D4J drift, mined approximately 45 feet due North.

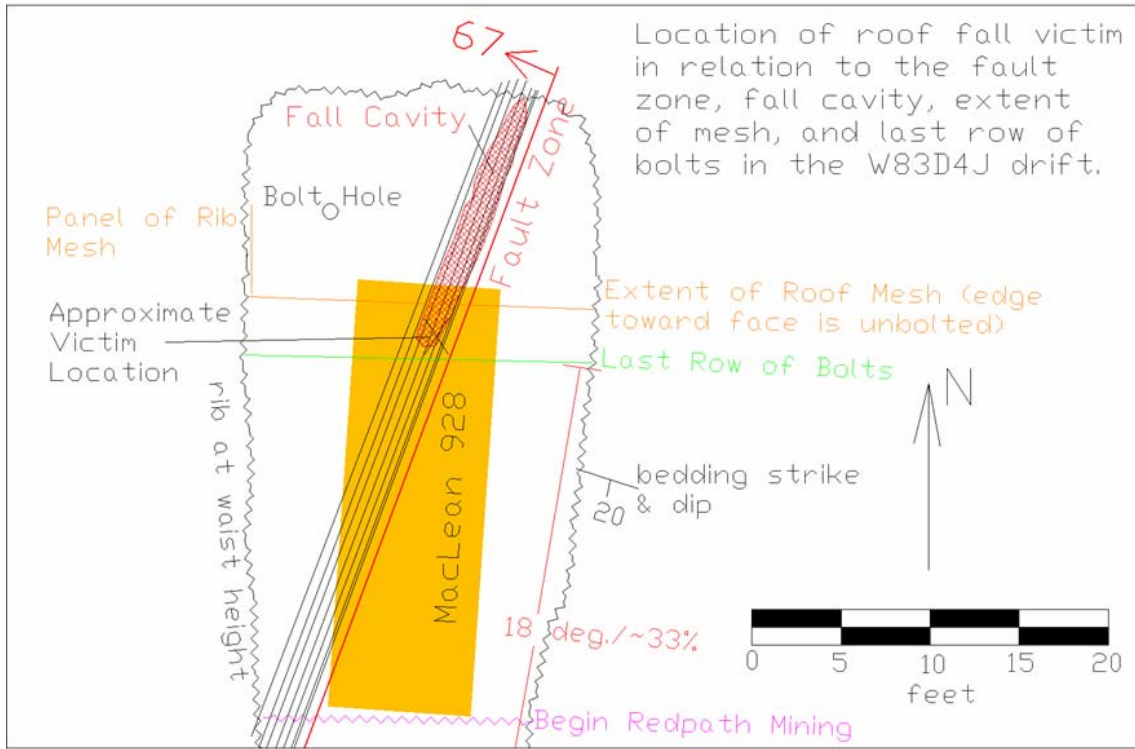
# APPENDIX C

The geology was characterized by thinly bedded dolomite that strikes northwest and dips 20 degrees toward the southwest, with beds inclined toward the mouth of the W83D4J drift. A prominent, two foot wide, fault zone was exposed in the face, angled from the top, right corner downward to the middle of the face where it intersected the floor. The

fault zone strikes approximately N 13 degrees E and dips approximately 67 degrees toward the northwest extending across the back to intersect the left rib about 15 feet from the drift mouth ( Appendix C ). The fault zone was characterized by sheared-out blocks of dolomite, with adjacent bedding planes exhibiting drag motion along the sheared zone. As exposed in the back, the hanging wall block was characterized by a series of closely spaced (2 inches) joints that paralleled the main fault zone.

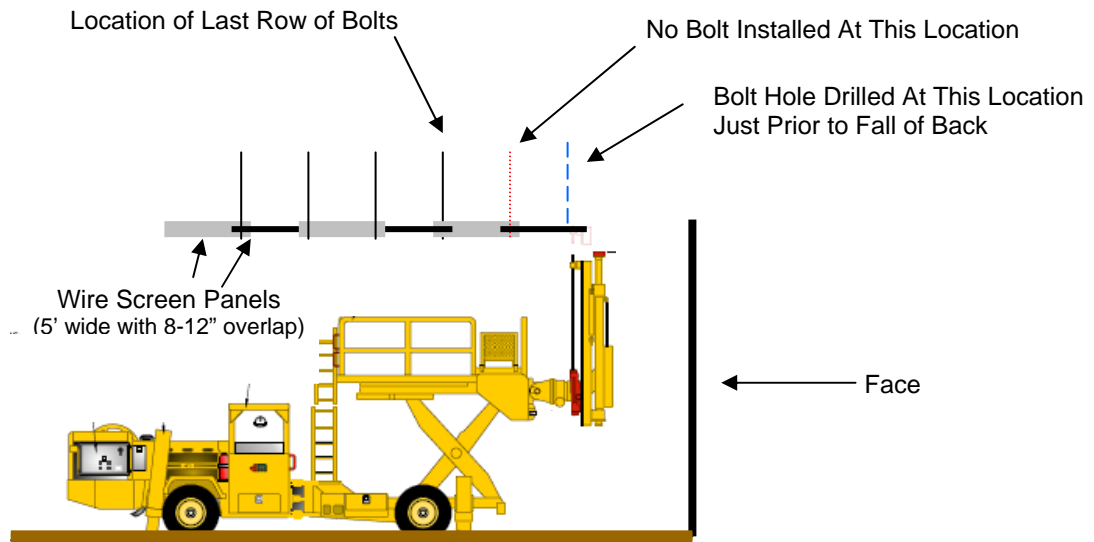
# APPENDIX D

Clark had pushed the roof bolter forward to a location that placed a portion of the roof bolter's work platform beyond the last row of bolts previously installed (Appendix D ). The miners then installed one panel of wire mesh on the left rib with two bolts. At approximately 1:00 a.m., as they continued to install wire mesh, a large rock fell from the roof, striking Markhart and pushing Nelson out of the way.

Approximate relationship of bolter work platform to last row of bolts, bolt being installed, and face position. (Does not show slope of entry)
