MNMM Fatal 2008-12

- Electrical Accident
- August 6, 2008 (New Mexico)
- Potash Operation
- Shift Supervisor
- 38 years old
- 15 years experience

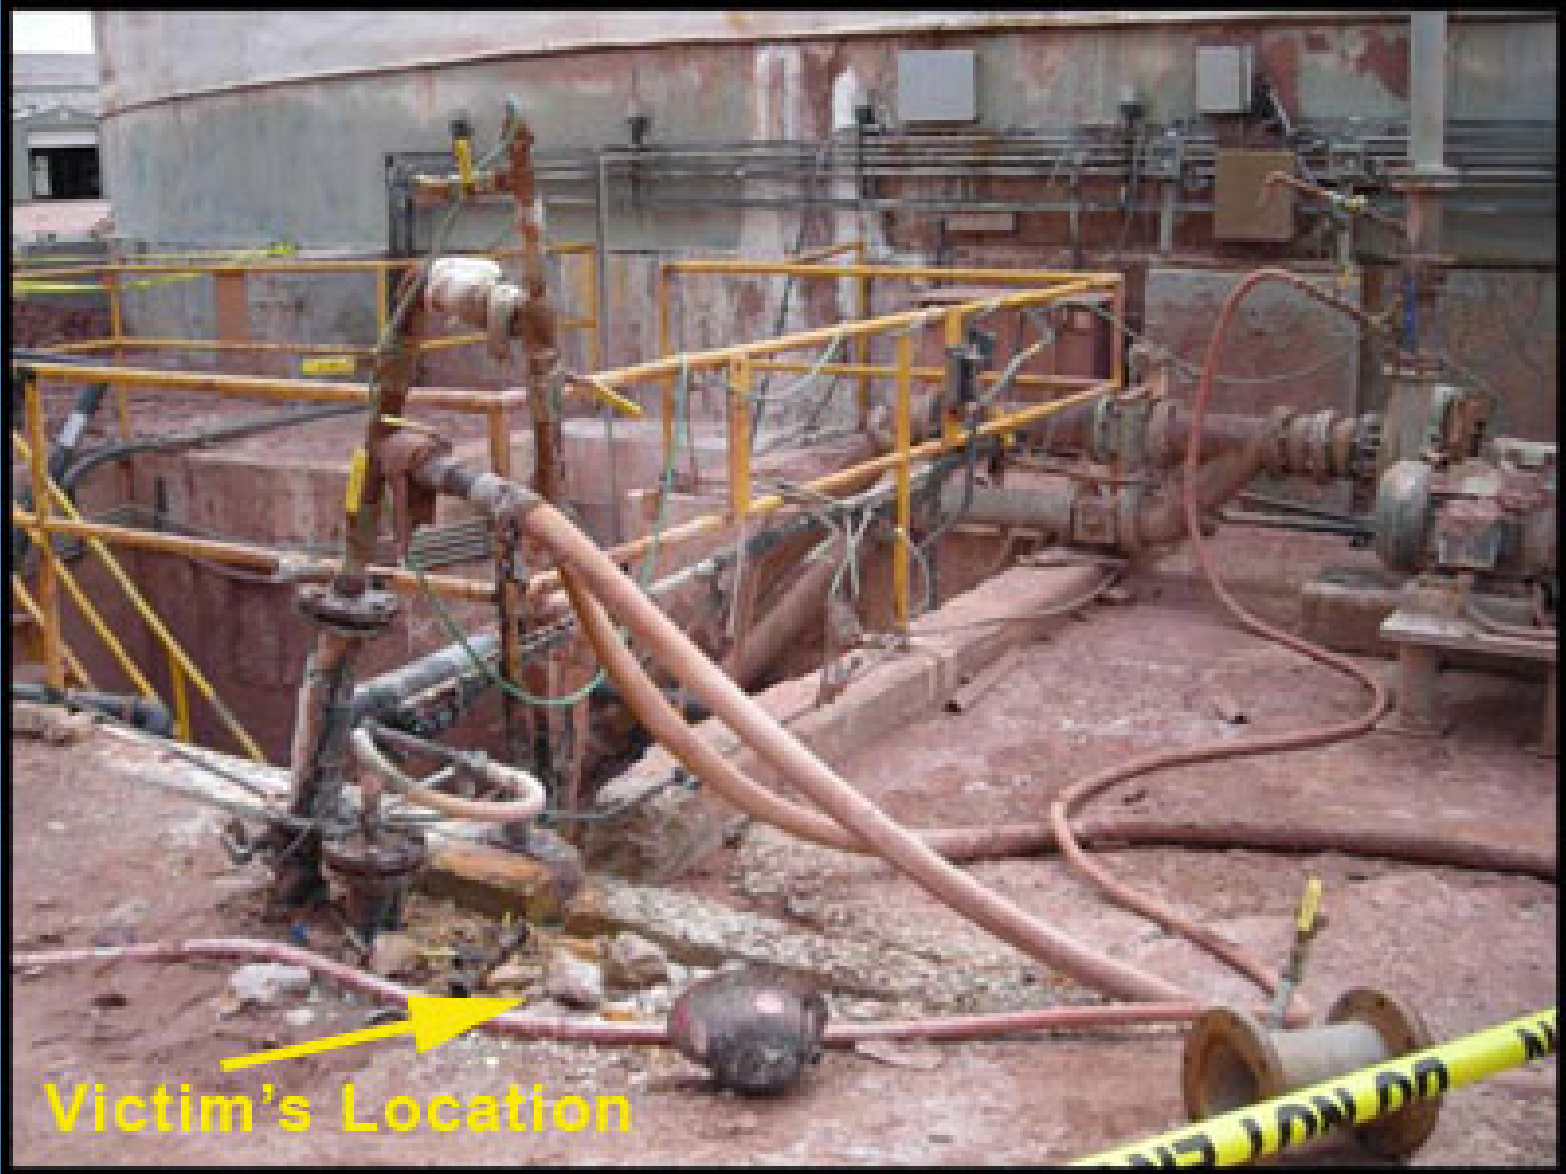
Victim's Location

The victim was fatally injured when he contacted conductors for a heat tape that had been installed in a shared conduit body with the conductors of a 480-volt circuit. Both the heat tape and circuit had been abandoned but neither of them had been removed. The 480-volt circuit was energized and short-circuited to the heat tape causing it to be energized to 277 volts to ground. The heat tape overheated and portions of the heat tape insulation melted away, leaving bare conductors. He contacted the bare heat tape conductors or adjacent energized parts while checking water valves in the area around the heat tape.

Management policies and procedures failed to ensure that all potential electrical hazards were identified and corrected.

- Examine the work area for any potential hazards.
- Label all power switches to identify which units they control.
- Ground all metal enclosing electrical circuits.
- Conduct continuity and resistance tests of all grounding systems.
- Keep workplaces clean and orderly.
- Remove all abandoned electrical circuits.
