REPORT OF INVESTIGATION

Underground Nonmetal Mine
(Industrial Sand)

Fatal Powered Haulage Accident
April 24, 2008

Pattison Sand Company, LLC
Pattison Sand Company, LLC
Clayton, Clayton County, Iowa
Mine I.D. No. 13-02297

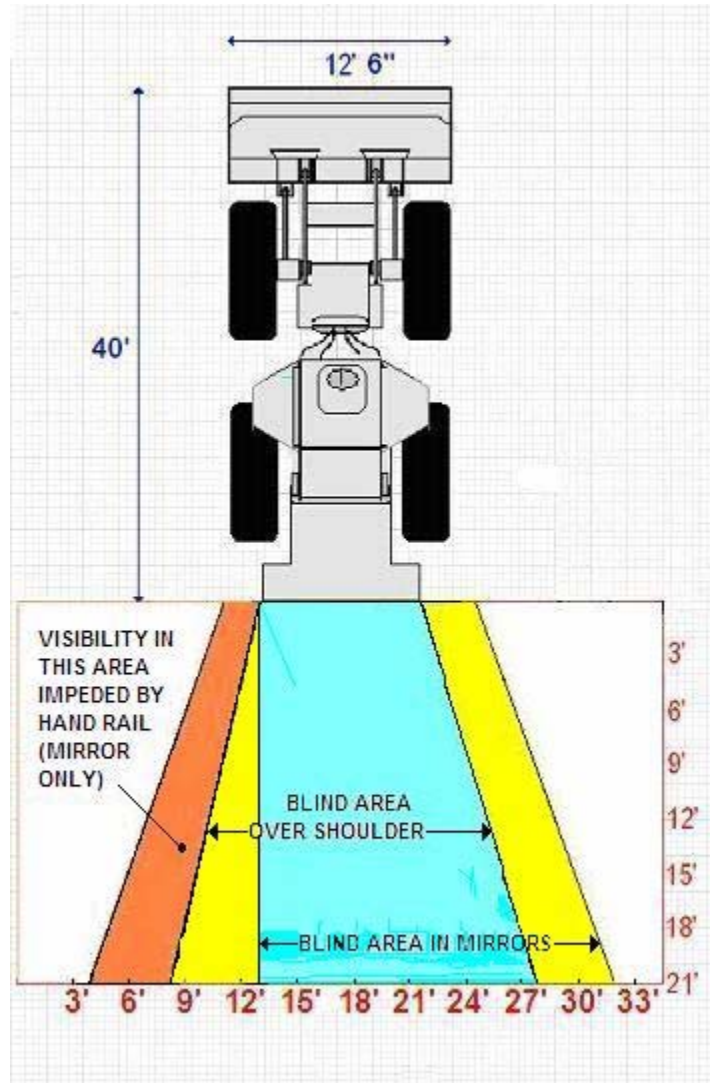
APPENDIX B

The front-end loader was placed in a stationary, unarticulated position so the investigators could determine the visibility to the rear of the machine from the operator's compartment. Appendix B depicts blind areas to the loader operator when using either side mirror or looking over the shoulder. The blind area was greater on the right side of the front-end loader due to the broken mirror. The victim was positioned on the right side of the front-end loader as it backed away from the hopper.

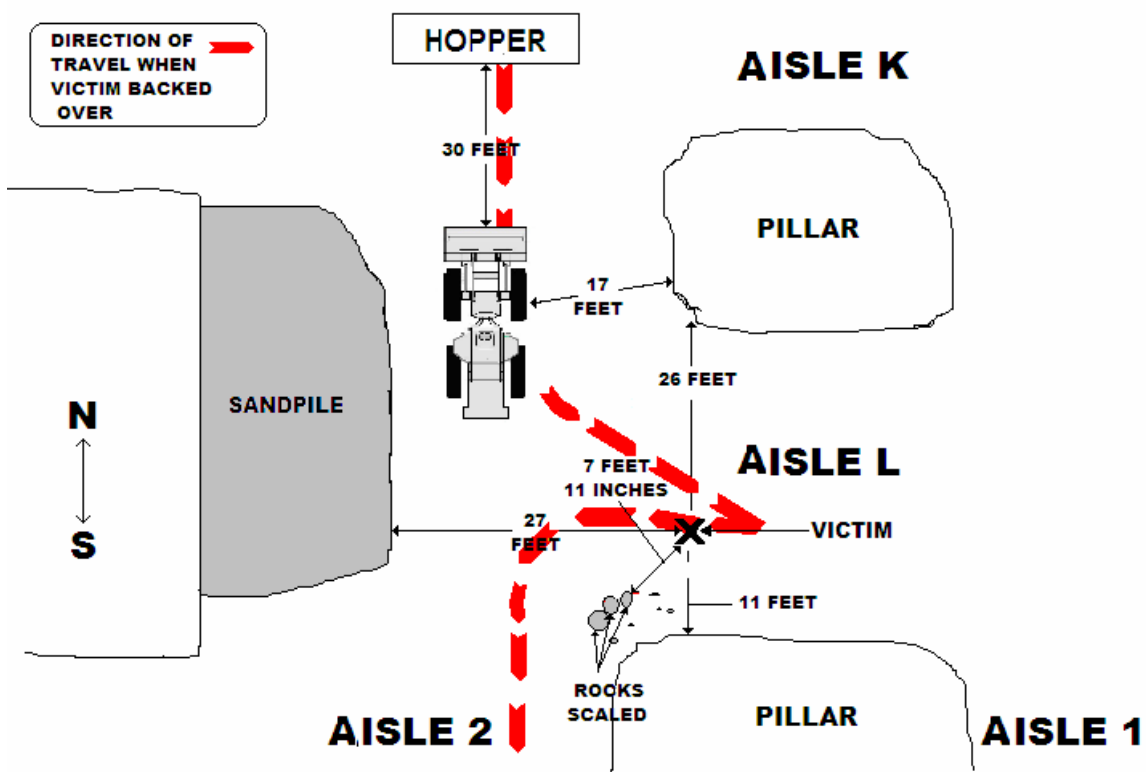
APPENDIX C

The accident occurred underground at the intersection of Aisle 2 and Aisle L. Aisle 2 ran North to South with crosscuts K, L, and M intersecting. The hopper was located in Aisle 2, North of crosscut L. The roadway condition at the accident scene consisted of loose, sandy material. A slight grade existed where the front-end loader backed from the hopper to crosscut L.

The area at the hopper was illuminated with area lighting. Crosscut L, where the victim was struck was darker and shaded.
