REPORT OF INVESTIGATION

SURFACE NONMETAL MINE
(Sand & Gravel)

Fatal Machinery Accident
May 3, 2008

Ahart Hauling
Ahart Gravel and Sand
Almo, Calloway County, KY
Mine I.D. 15-19227

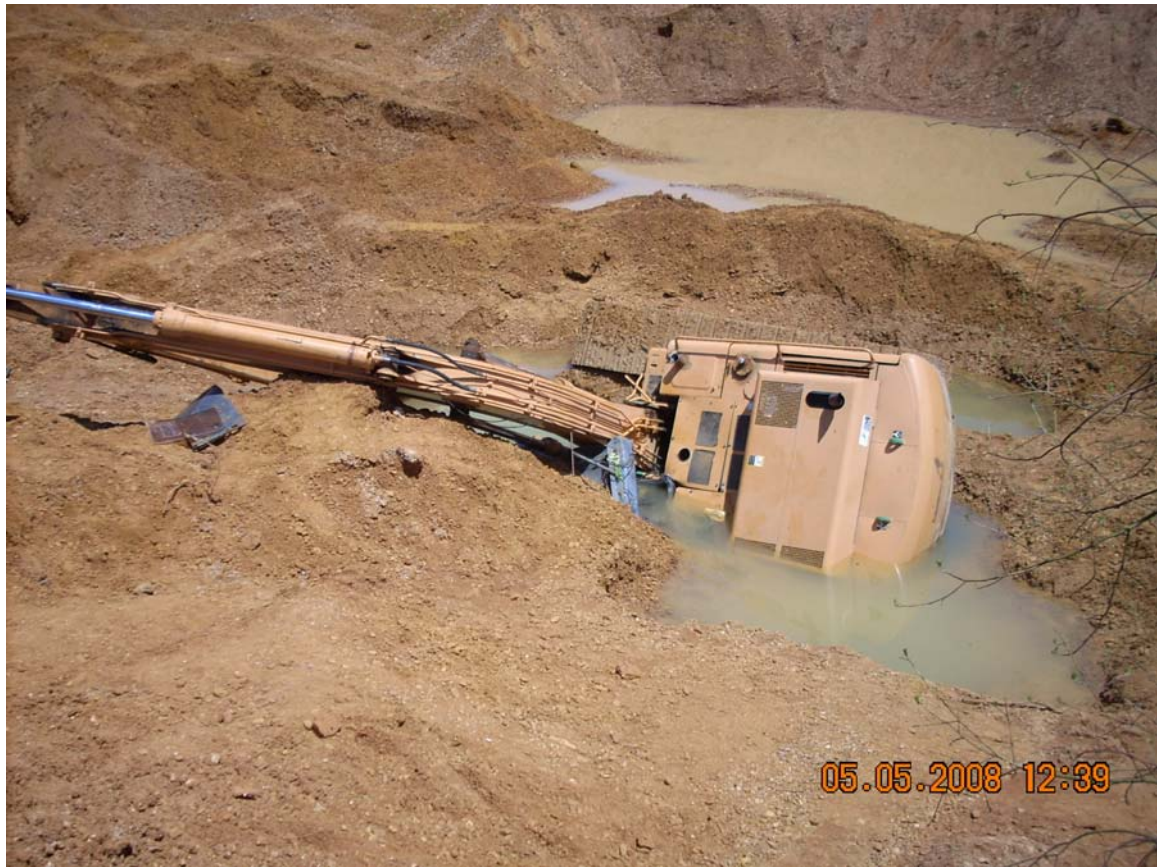
The victim's excavator was leaning toward the west at an angle estimated to be greater than 45° with the boom positioned parallel with the tracks. The boom was facing north and the counterweight was facing south. The boom arm was curled toward the cab of the excavator and the bucket was curled in a slightly open position.

Investigators determined that the victim either trammed the left track of the excavator into the sump hole or the rear portion of the left track was overhanging the sump hole. When the left track of the excavator dropped down into the sump hole, the machine tilted to the left. The cab slammed into the western sidewall of the sump hole partially crushing it and trapping the victim under water.

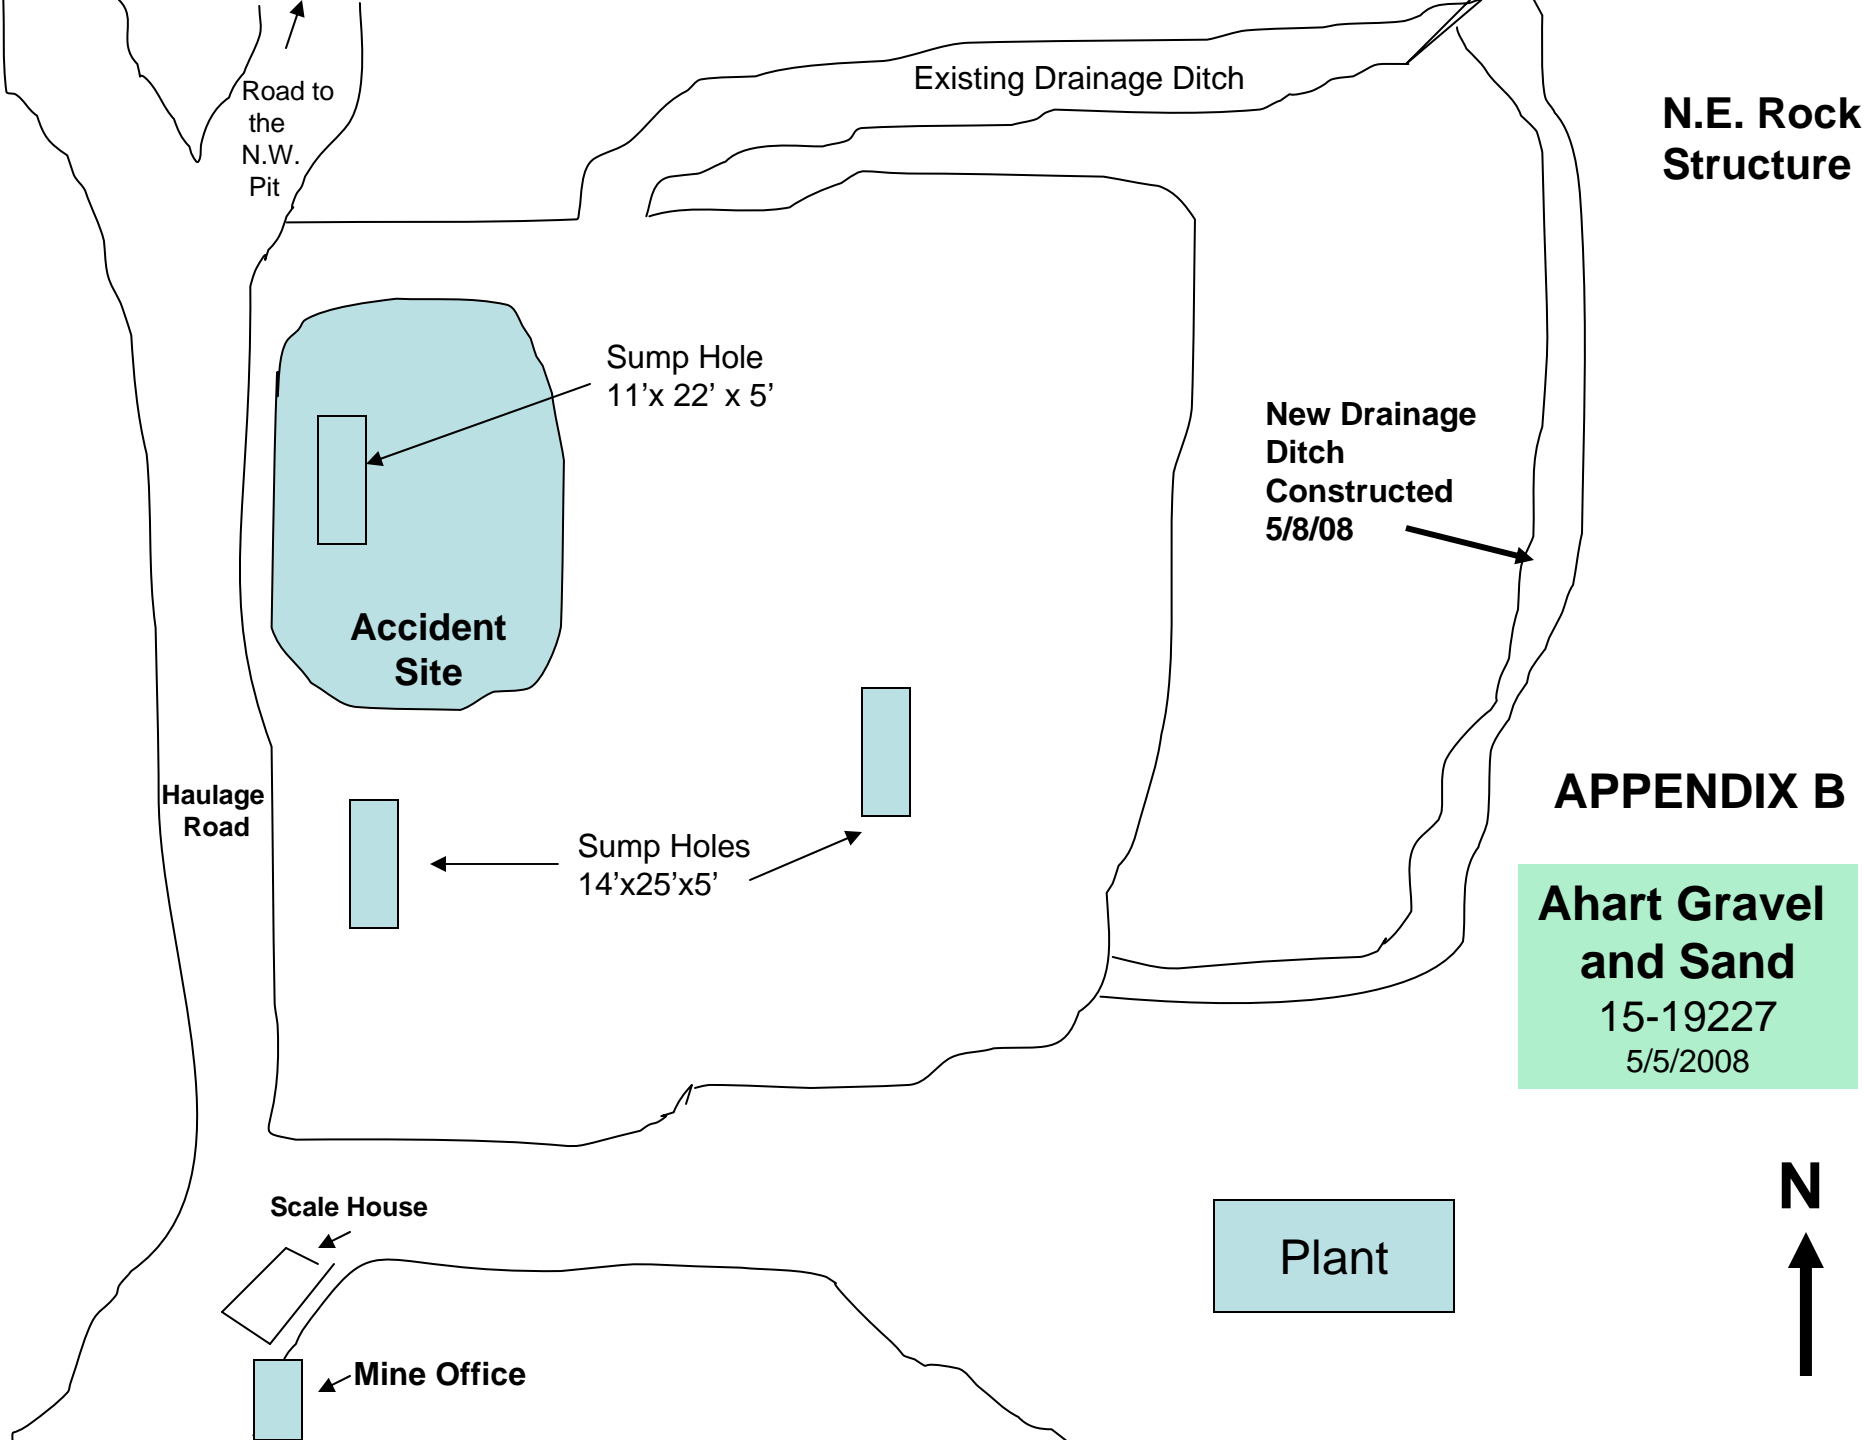
APPENDIX B

The sump hole where the accident occurred was 5 feet wide, 22 feet long, and 11 feet deep. It was oriented in the north-south direction. The sidewalls of the sump hole appeared vertical. A wedge of material, approximately 20 inches high and 20 inches deep, was missing from the top of the southern portion of the eastern sidewall. Investigators could not determine if this material was removed during the excavation of the sump hole or if it fell during the accident. The other two sump holes were 14 feet deep, 5 feet wide, and 22 and 25 feet long respectively. They were covered with approximately 1 ½ feet of cloudy water.

Accident Site

Sump Hole
11'x 22' x 5'

Corrective Action: Management should establish policies and procedures to ensure that persons could safely perform tasks when working on the pit floor. The location of the sump holes should be barricaded or posted with warning signs.

This citation was terminated on June 30, 2008, after the sump hole was filled in and all employees were instructed in placing signs in areas where hazards are not immediately obvious to employees.
