REPORT OF INVESTIGATION

Surface Metal Mine
(Copper)

Fatal Electrical Accident
August 15, 2008

Ray
Asarco LLC
Ray, Gila County, Arizona
Mine I.D. 02-00150

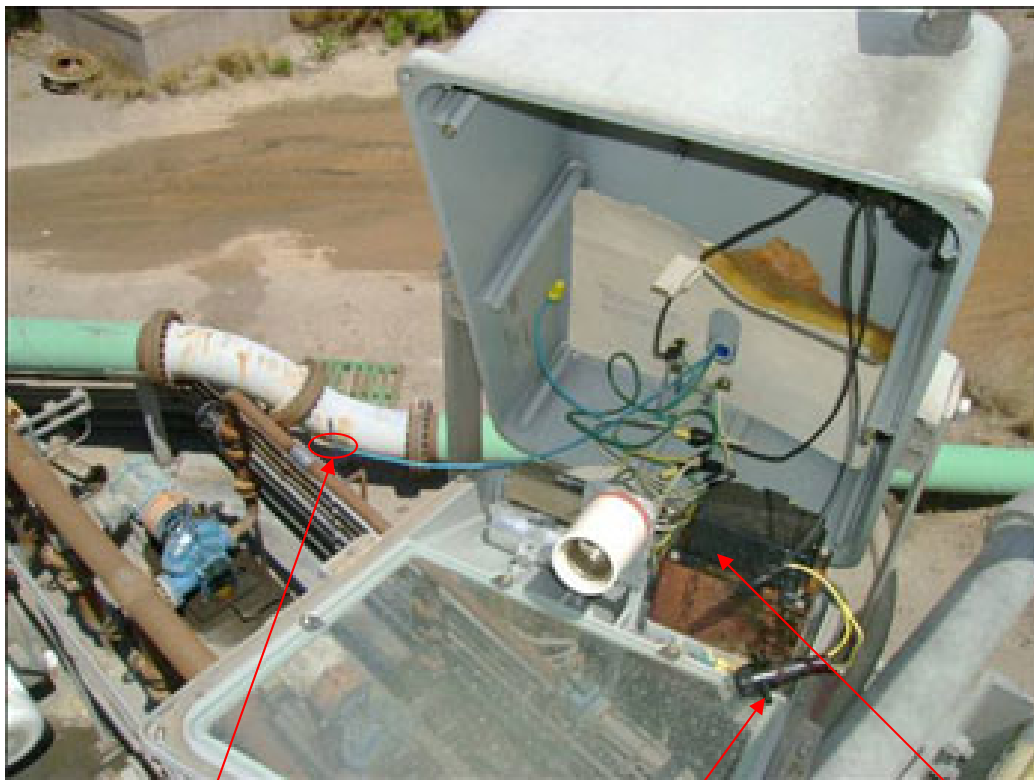
Energized conductor contacted by victim

Ballast

In-line fuse
(the other fuse is inside box and out of view)

Two in-line fuses (5 amperes each) had been added to the existing circuitry inside the light fixture. During the investigation, power was restored to this light fixture and a phase to ground voltage of 268 volts was measured. The victim was exposed to this voltage level at the time of the accident.

An energized conductor had been cut off on the line side exposing the inner conductive material. A pair of cutting pliers was found at the accident scene. Investigators could not determine why the conductor was cut.

Root Cause: Management policies and controls were inadequate and failed to ensure that the electrical circuit was deenergized, locked-out, tagged, and tested before work was performed on the circuit.

Corrective Action: Management should establish policies and controls to ensure that electrical circuits are deenergized, locked-out, and tagged when work is performed on electrical circuits and equipment.
