REPORT OF INVESTIGATION

Fatal Machinery Accident

August 18, 2008

Coolspring Mining Inc.
Coolspring Stone Supply Inc.
Uniontown, Fayette County, Pennsylvania
Mine I. D. No. 36-00155

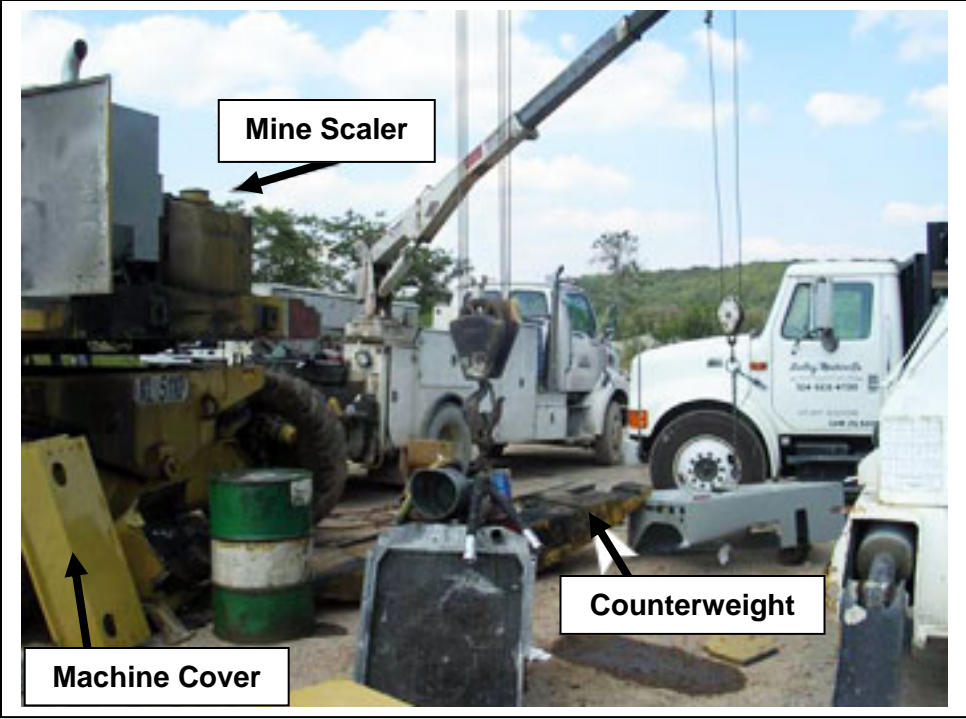
Mine Scaler

Machine Cover

Counterweight

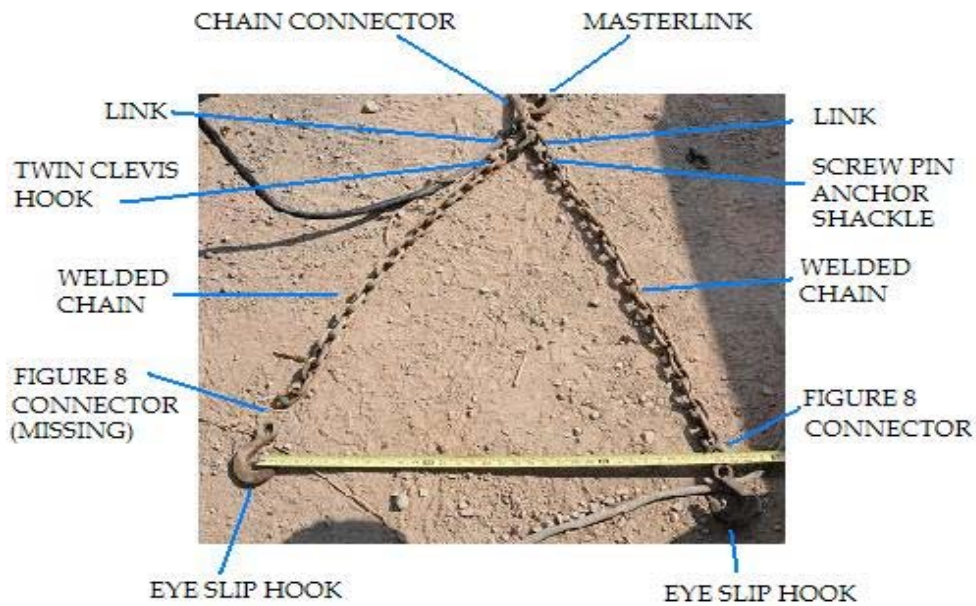
Figure 1. – Approximate configuration of double leg chain sling and identification of components:

The double leg chain sling used to lift the counterweight was assembled from various components. The sling was comprised of an oblong shaped master link and a hinge type chain connector. The double legs were then connected to the chain connector. The first leg was assembled using an oblong link, a screw pin anchor shackle, a 30-inch piece of welded chain, a figure-8 connector, and an eye slip hook. The second leg was assembled using an oblong link, a pin type twin clevis link, a 30-inch piece of welded chain, a figure-8 connector, and an eye slip hook. Both figure-8 connectors failed. (see Appendix C, Figure 1)

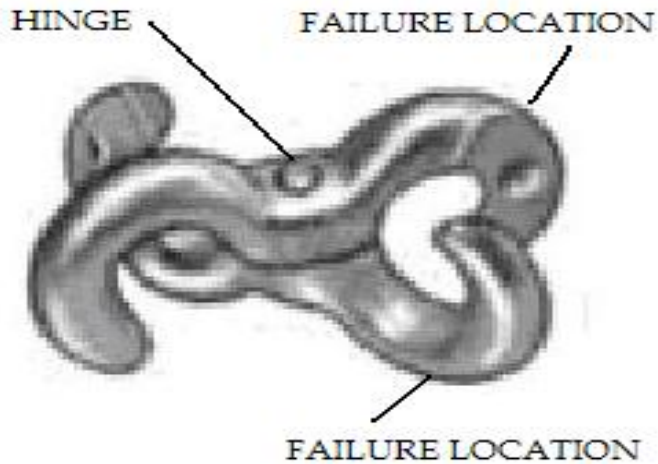
Figure 2. – Figure-8 Connector, typical link:

The figure-8 connectors were used to attach the welded chain to the eye slip hooks. These connectors failed catastrophically causing the counterweight to fall. No manufacturer's identification was found on either of the failed connectors. A "1/2" identifier was embossed on the side of each connector. Investigators were unable determine where the connectors were purchased. Appendix C, Figure 2 shows a typical connector.

Typically this type of connector is used for cable stringing and pulling. It is not to be used for overhead lifting, as a link for a chain, or to repair chain. The work load limit for a 1/2-inch connector was 925 pounds. When the accident occurred, the miners were attempting to lift a 7,000 pound counterweight onto the mine scaler using these figure-8 connectors as integral parts of the chain sling.

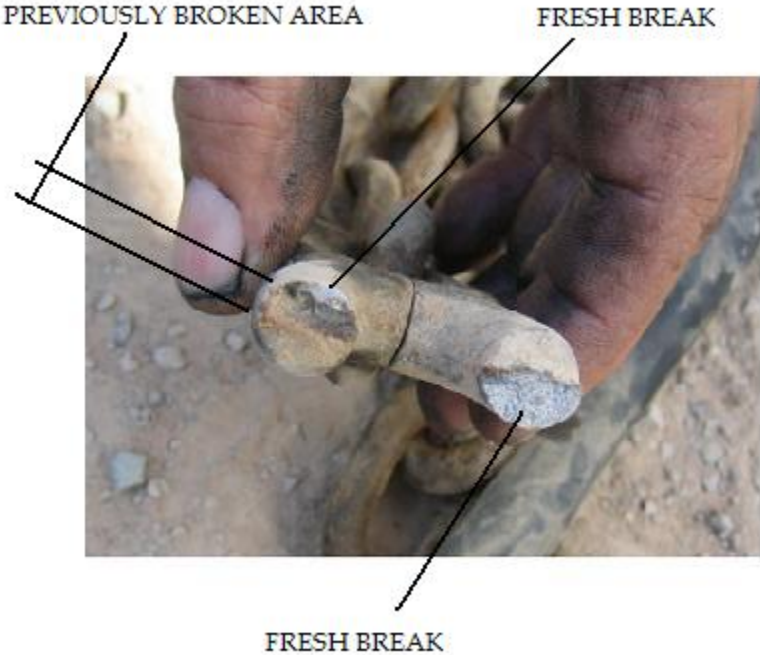
Figure 3. – Broken Figure-8 Connector, end view, breaks:

Investigators determined that, although one connector was partially intact, the link was previously broken. Visible corrosion was observed next to the break that occurred at the time of the accident. The connectors were the only sling components exhibiting severe mechanical damage. (see Appendix C, Figure 3)
