**REPORT OF INVESTIGATION**

**Surface Nonmetal Mine  
(Sand and Gravel)**

**Fatal Powered Haulage Accident  
October 1, 2008**

**Hueni Plant  
Hallett Materials  
Porter, Montgomery County, Texas  
Mine ID No. 41-04217**

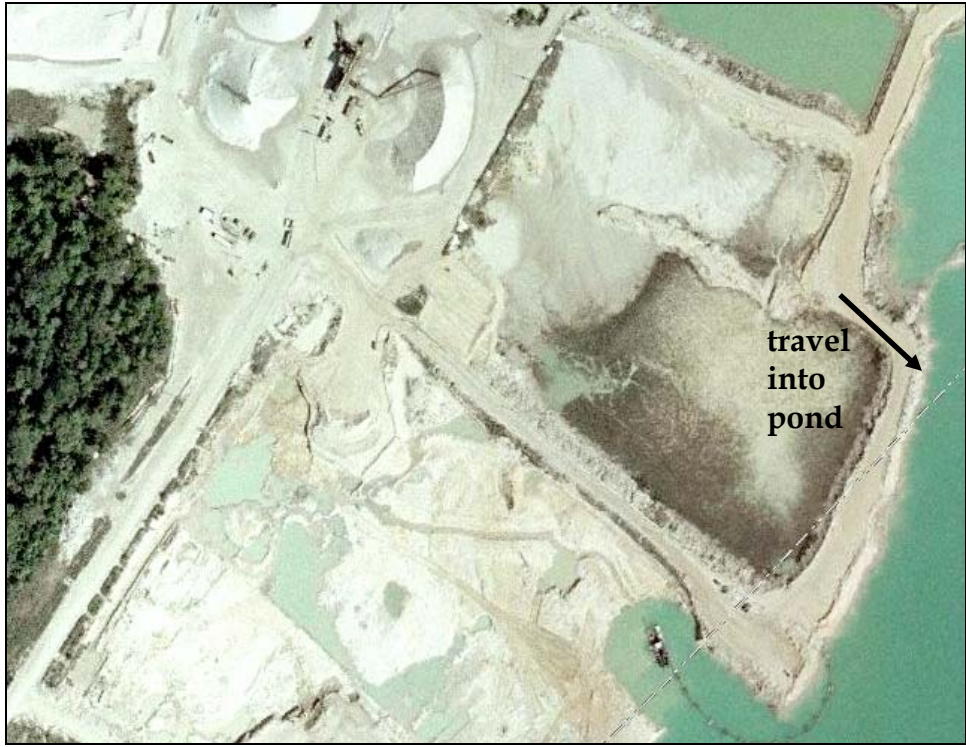
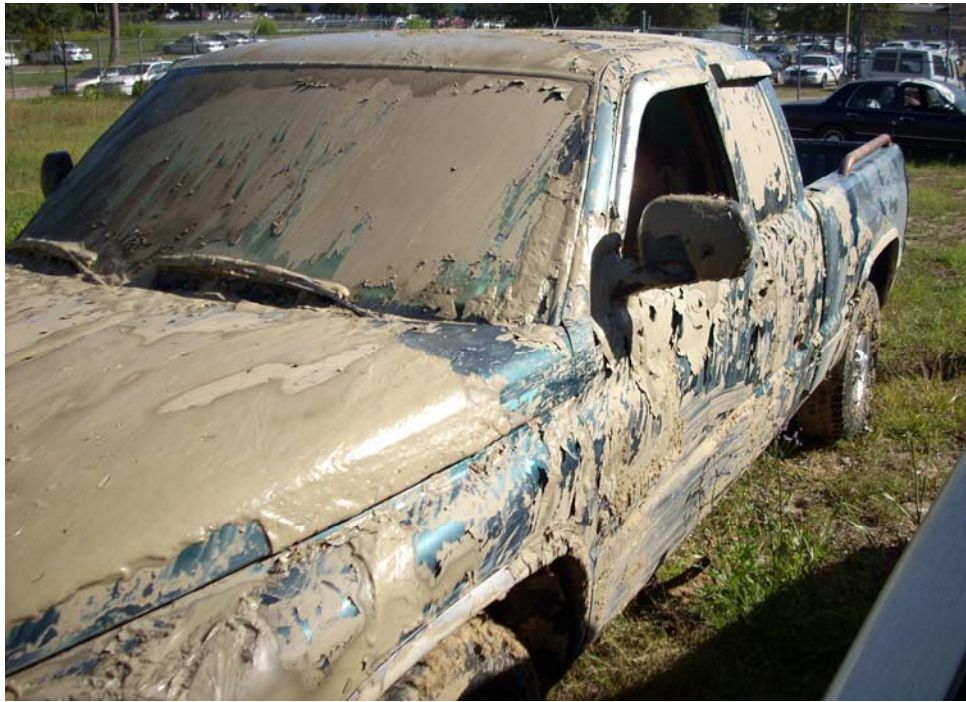
The accident occurred at a curve on a mine road adjacent to the dredge pond. The road had a sandy dirt surface and several turns. There were no indications of skidding, braking, or sudden corrective steering at the location of the accident. The pickup tire tracks led directly into the dredge pond. The berms along the road were more than mid-axle height of the pickup truck.

The pickup truck was found about 80 feet from the bank of the dredge pond in 35 feet of water. It was facing the direction of travel but was submerged in sediment at a 45-degree downward angle. The driver's side window was found open when the pickup truck was recovered.
