REPORT OF INVESTIGATION

Surface Nonmetal Mine  
(Limestone)

Fatal Falling Material Accident

Hummelstown Quarry  
Pennsy Supply Inc.  
Hummelstown, Dauphin County, Pennsylvania  
Mine I. D. No. 36-04291

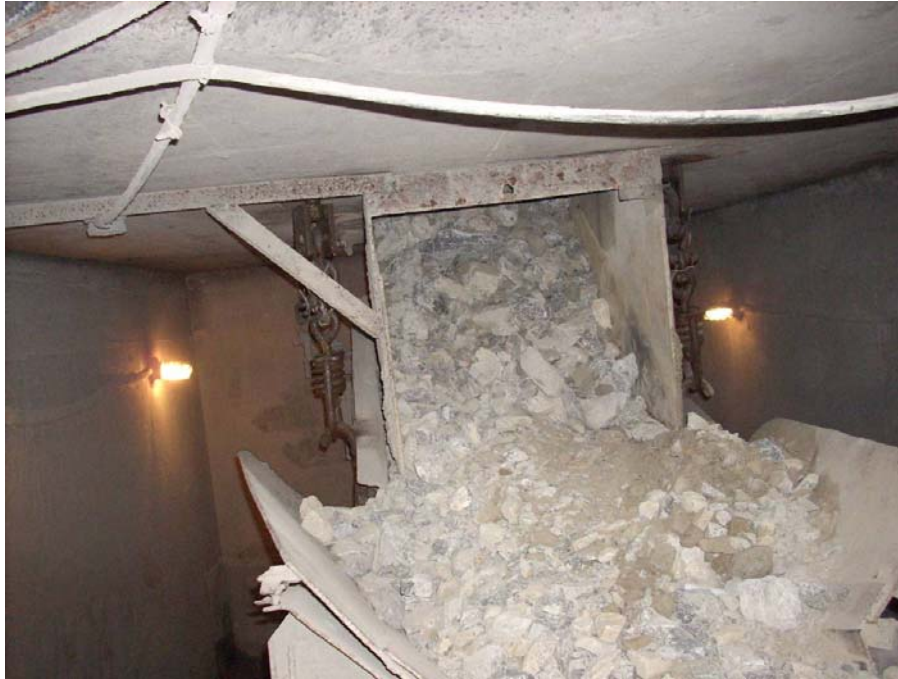
**Chute in surge tunnel below primary surge pile**

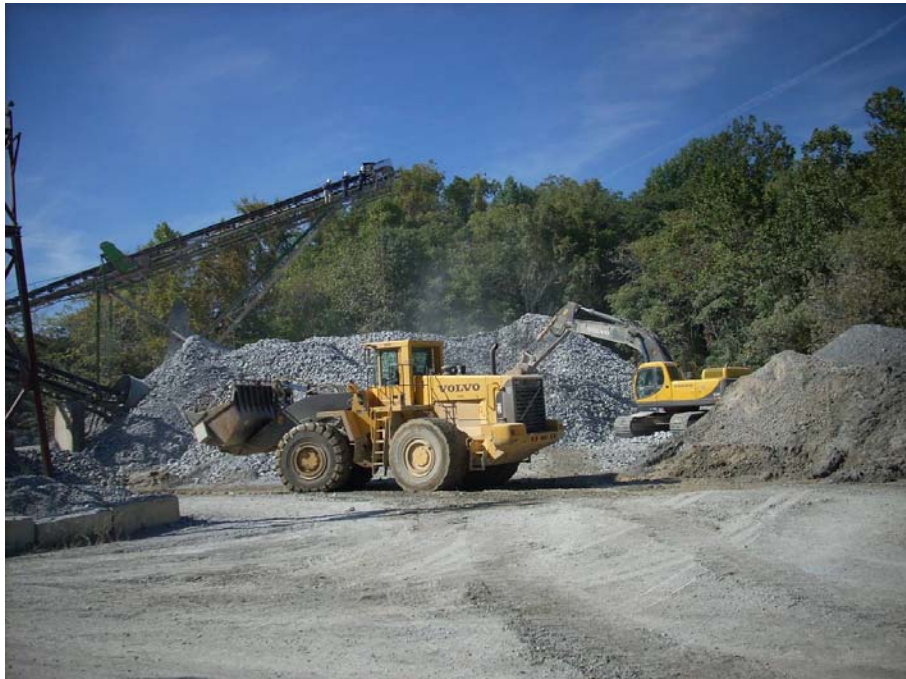
**Removal of surge pile over feeder during recovery**

On the surface, a front-end loader and an excavator were used to remove the primary surge pile in order to gain access to the feeder from above. Once the material was moved away from the feeder, recovery workers re-entered the surge tunnel. Considerable time and care were taken to ensure the safety of the recovery team throughout the entire rescue and recovery operations.

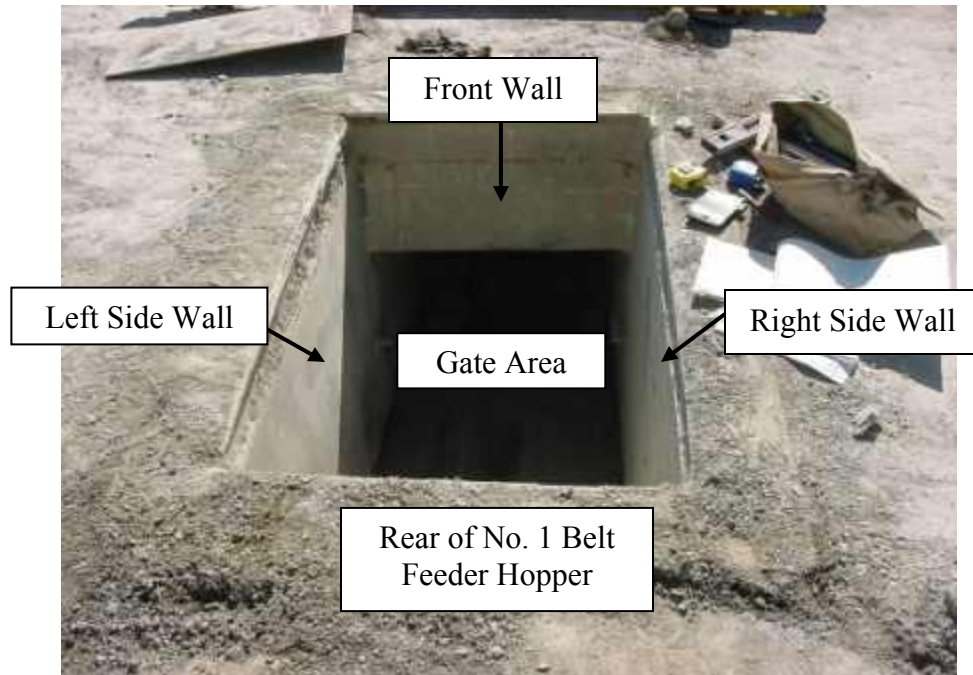
**Figure 1**

The No. 1 belt received crushed product from the primary surge pile via a connecting hopper to a Syntron® Vibratory Feeder, Model F-55 BDT. The hopper's surface opening measured 33 ¼ inches wide by 56 ¾ inches long (see Figure 1). The hopper was lined with wear metal suspended from steel angles which framed the hopper opening. The hopper's side walls were nearly vertical. The rear wall was fabricated with a 13 ¾ inch long vertical section and an 18 ¾ inch long sloping section set on a 57 degree angle measured from the horizontal. The front wall was 54 inches from the top or surface down to the feeder trough with a gate opening at the bottom of 31 ⅛ inches wide by 36 inches high.

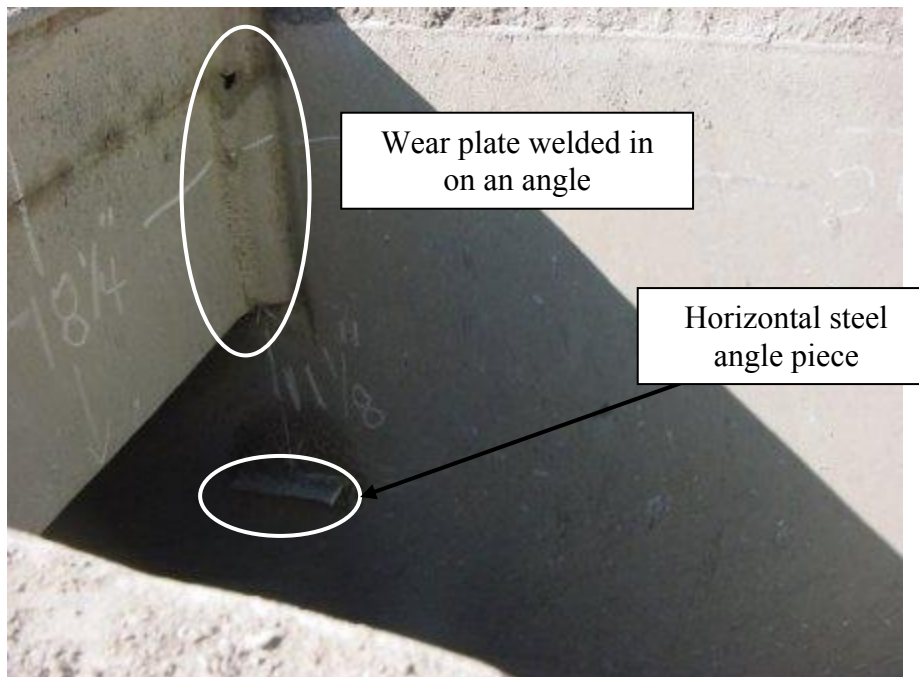
**Figure 2**

A piece of wear plate was in the right corner of the front wall. The plate was 2 ⅜ inches wide running the length of the corner set at 42 degree angle to the front wall and welded to the right side and front walls (see Figure 2).

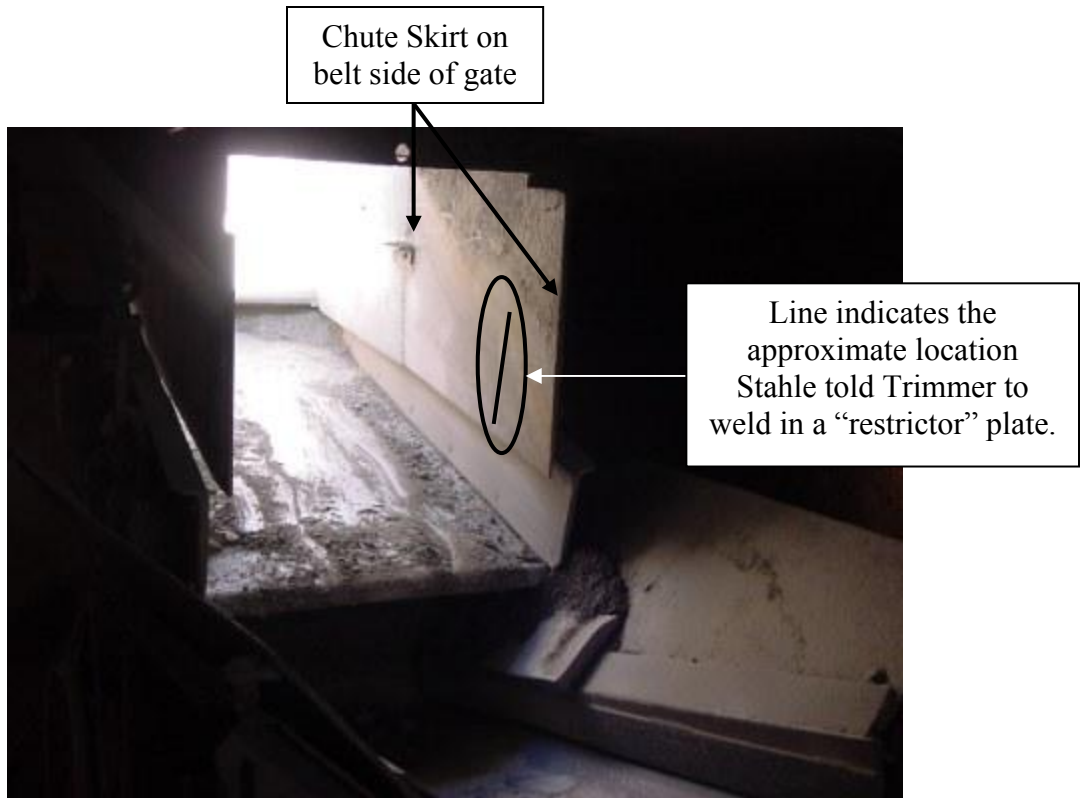
**Figure 3**

The skirt for the chute extended into the tunnel 42 ¾ inches from the front wall in the direction of the No. 1 belt (see Figure 3). The feeder chute was 83 inches long from the hopper rear wall liner to the discharge end where it dumped onto the No. 1 belt. Two short pieces of steel angle were found welded to the sidewalls. They were nearly centered in the gate opening, 11 ⅛ inches from the top of the gate opening (see Figure 2). A piece of steel plate (16 inches wide by 31 inches long by ¼ inch thick) was found on the floor next to the tailpiece covered with stone.

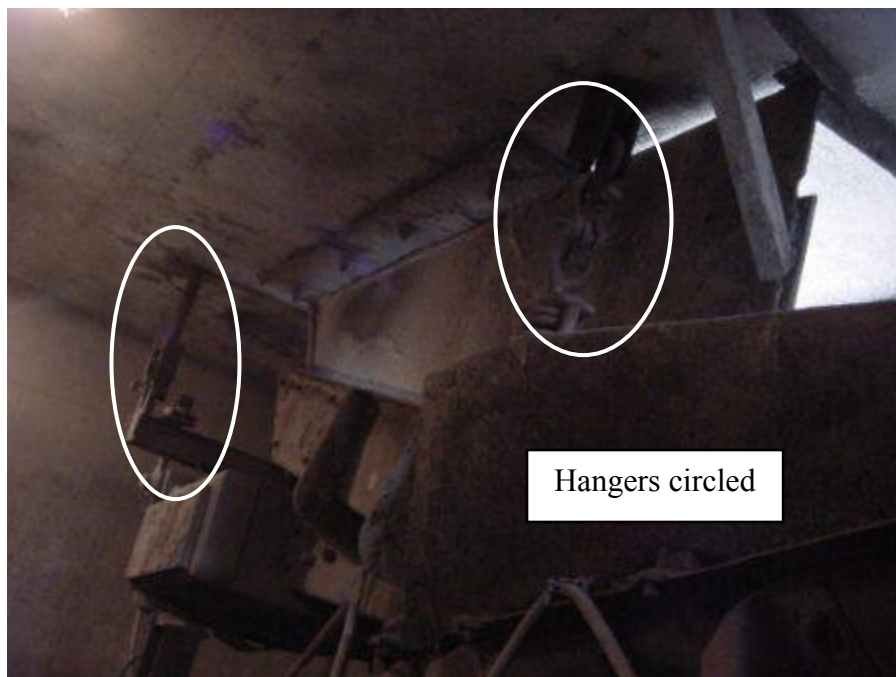
**Figure 4**

Four steel rods located at the feeder's four corners kept it suspended (see Figure 4). The slope of the feeder chute was adjusted by changing the length (adding or removing shackles) of the front mounting points. The feeder chute was found sloping toward the No. 1 belt on a 14 degree angle as measured from the horizontal.

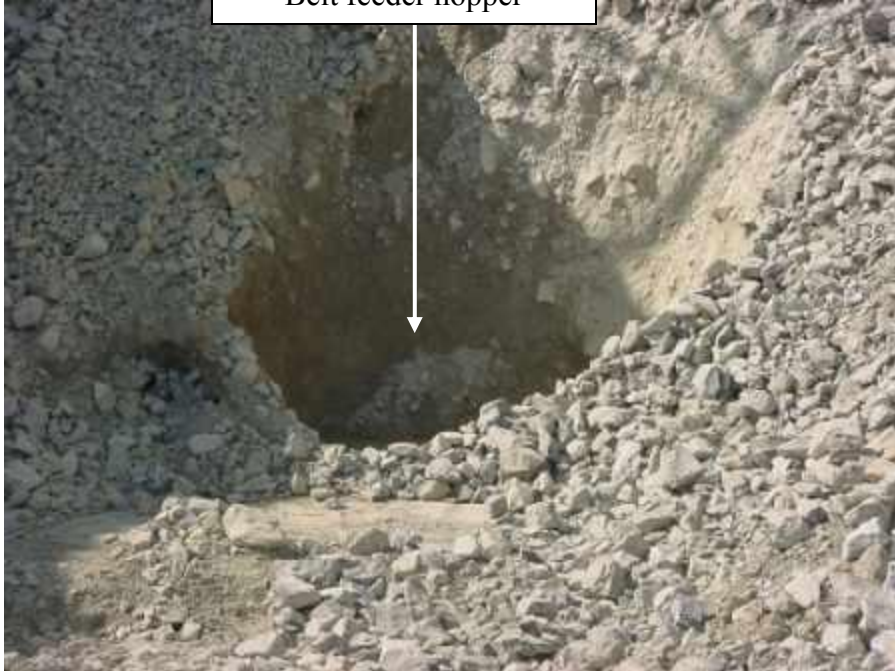
**Figure 5**

Investigators determined that the existing pile was 10 to 15 feet above the right side and rear of the hopper walls. This configuration was high enough for the investigators to visualize what the cone resembled prior to the accident. A photo was taken to show the partial cone shaped pile after the feeder was emptied or "day lighted" (see Figure 5).

Open "day lighted" No. 1  
Belt feeder hopper
