REPORT OF INVESTIGATION

Surface Metal Mine
(Gold Ore)

Fatal Falling Material Accident
October 9, 2008

South Area
Newmont USA Limited
Carlin, Eureka County, Nevada
Mine ID No. 26-00500

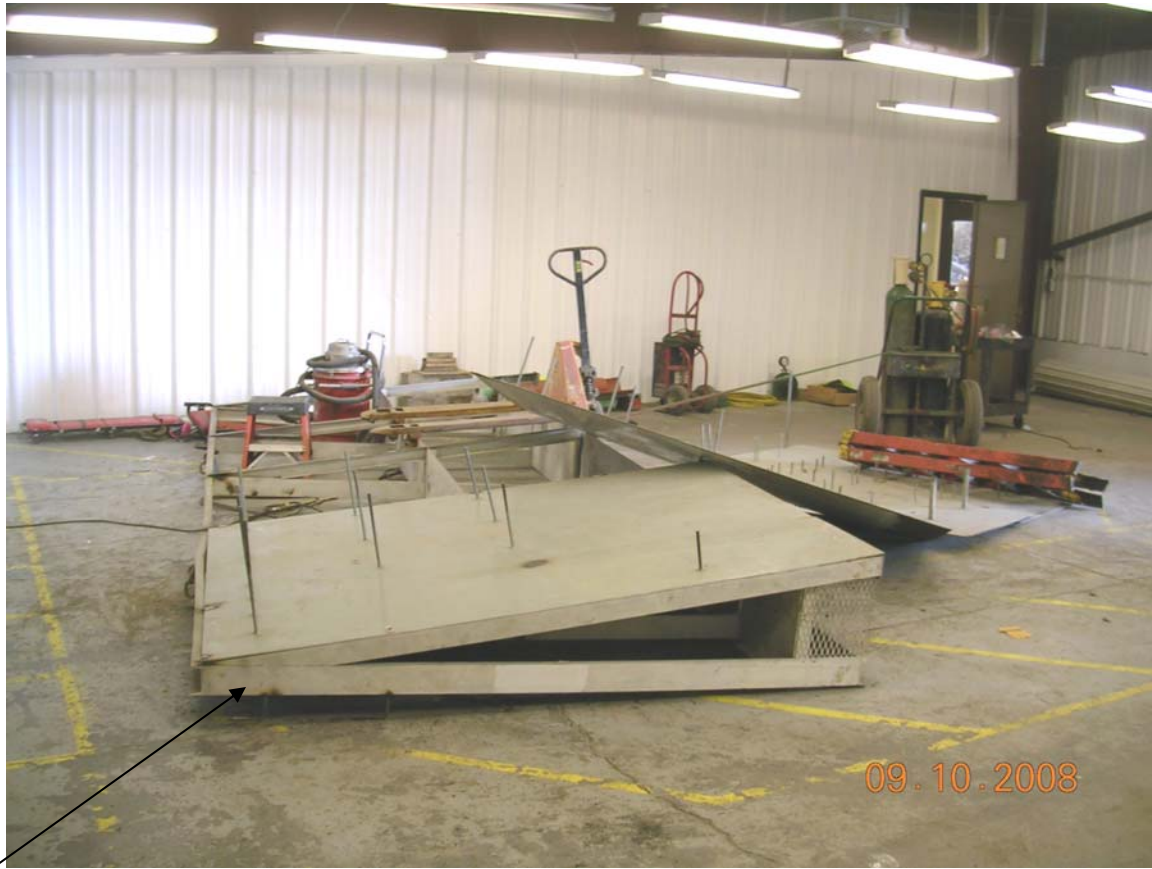
Victim was pinned here
