REPORT OF INVESTIGATION

**Underground Nonmetal Mine
(Marble)**

**Fatal Fall of Roof Accident
October 17, 2008**

**Marble Hill Mine
O-N Minerals (Filler Products) Company
Ellijay, Gilmer County, Georgia
Mine I.D. No. 09-01038**

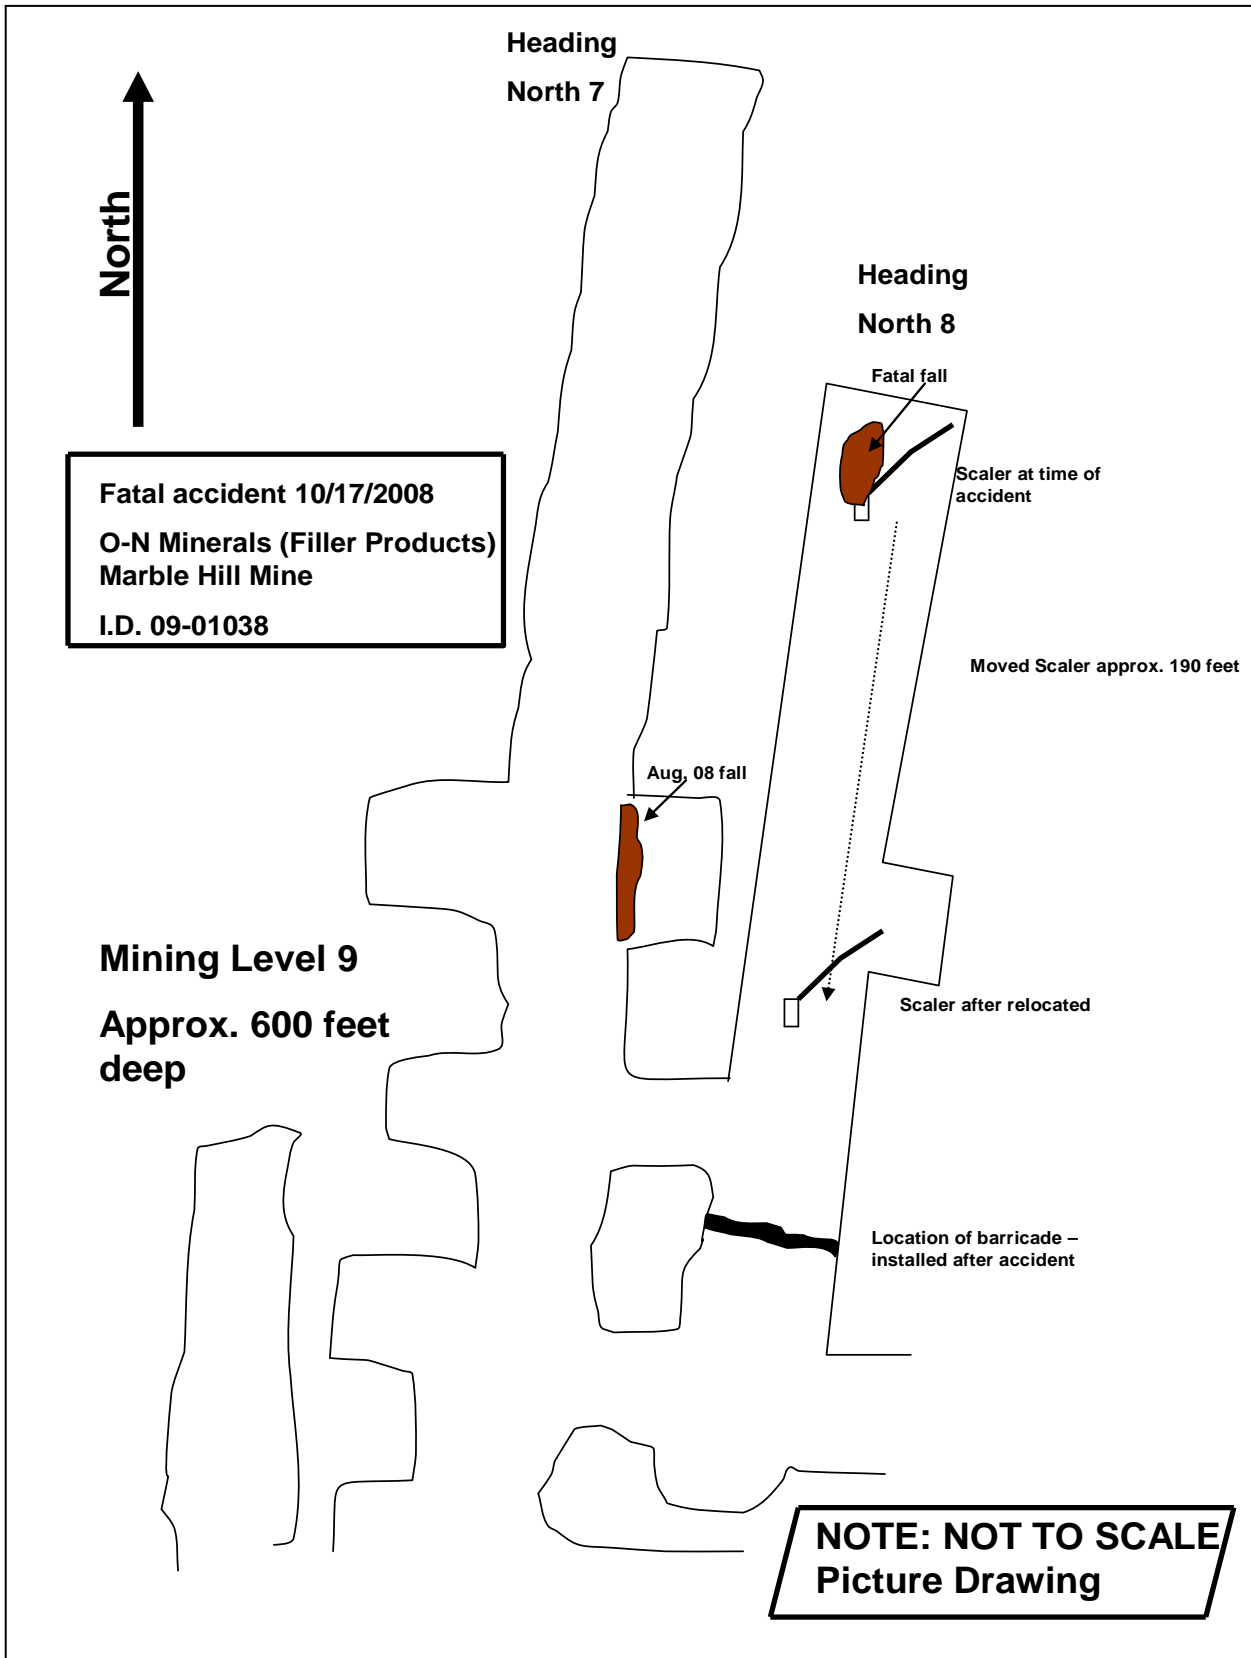
APPENDIX B

The accident occurred on Level 9 North 8 Heading approximately 30 feet from the face. The face was located approximately 200 feet north of the last open crosscut. The fall of roof was a single, triangular block that measured approximately 26 feet long, 4 feet high (at the triangle apex), and 10 feet wide (at the base of the triangle), corresponding to the triangular shaped cavity in the roof.

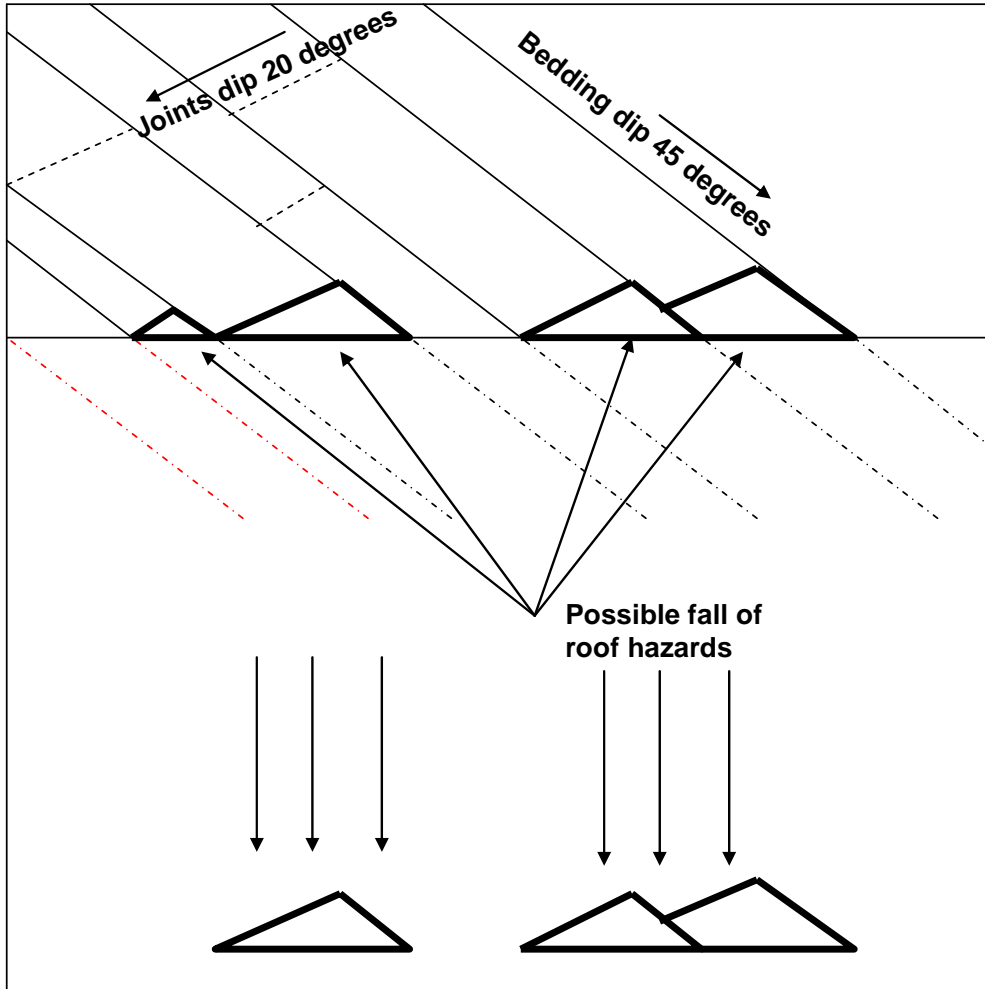
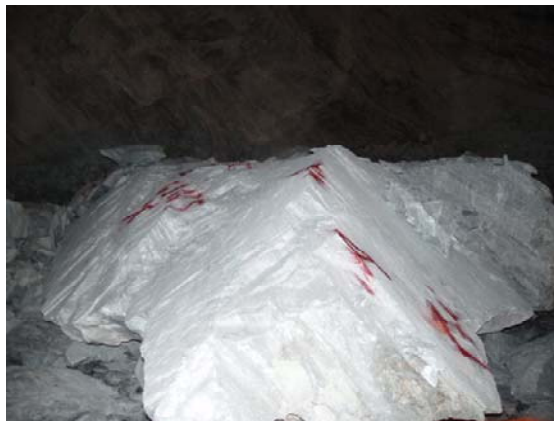
APPENDIX C

The fallen rock broke into four large pieces and several small pieces on impact. The combined weight of the rocks was approximately 42 tons. The fallen block was defined by the intersection of bedding planes that strike N 15° E and dip 45° E, and joints that strike N 20° W and dip 20° W, creating a diamond-shaped cross section of rock. The roof of the drift was characterized by a saw-toothed profile formed by diamond-shaped blocks that had fallen from the roof either during scaling or as a result of blasting.
