REPORT OF INVESTIGATION

Surface Metal Mine
(Copper)

Fatal Fall of Material Accident
October 29, 2008

Copperton Concentrator
Kennecott Utah Copper Corp.
Magna, Salt Lake County, Utah
Mine ID No. 42-01996

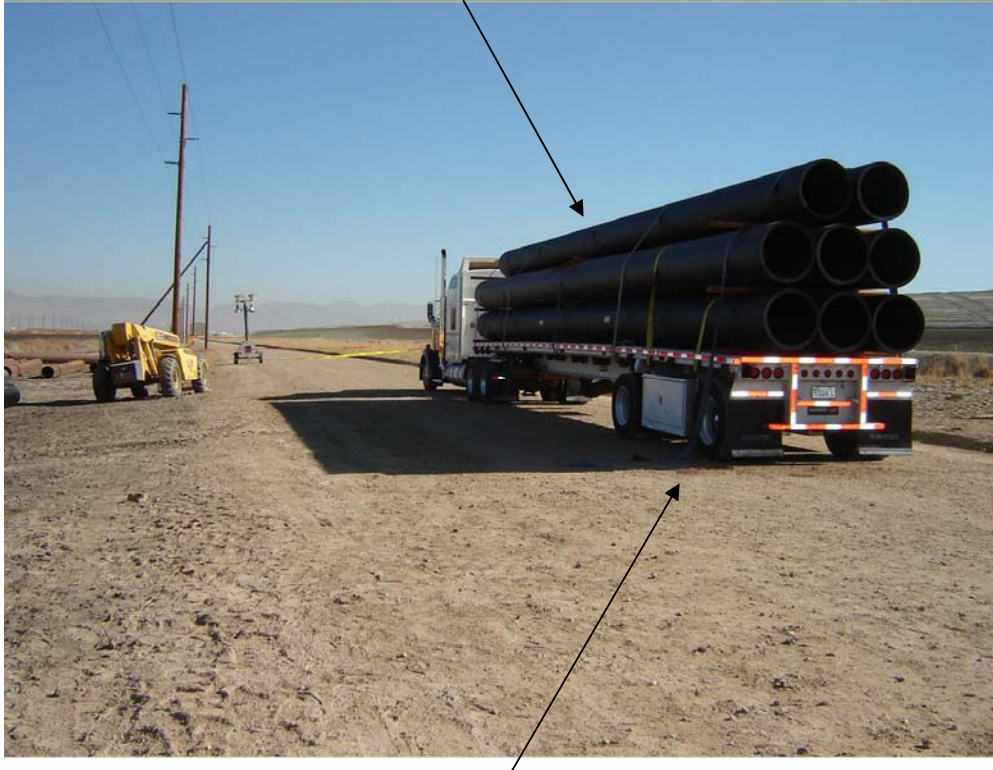
William L. Kay, delivery truck driver, age 81, was fatally injured on October 29, 2008. Kay was unfastening a load of pipe from a flatbed trailer when one 50-foot section of pipe rolled off and struck him. He was preparing to unload nine sections of pipe from the trailer.

Initial position of pipe

Victim location

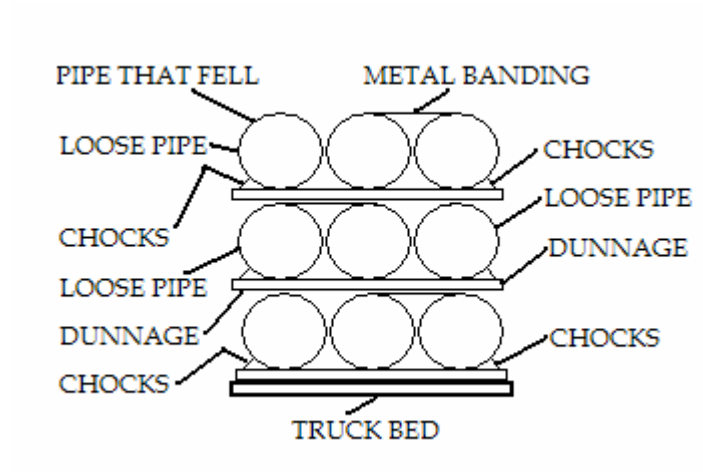
Typical pipe configuration on trailer

A typical trailer load of pipe consisted of nine sections arranged in three rows of three sections each. Two pipe sections in each row were banded together by the manufacturer. Three 2-¼ inch by 3-inch wooden timbers, referred to as dunnage, were placed between each row of pipe to provide stabilization. Chock blocks were typically provided to prevent the sections of pipe from rolling.

However, none of the wooden timbers on the trailer involved in the accident were provided with chock blocks. The load of pipe was secured to the trailer with several nylon ratchet-type straps each rated for 12,000 pounds of weight.

Note: No chocks were provided on the load of pipe involved in this accident

Corrective Action: Contractor management should establish policies and controls to ensure that pipe can be unloaded from trucks in a manner that does not create a hazard to persons.
