# MNMM Fatal 2009-11

- Powered Haulage Accident
- June 11, 2009 (Missouri)
- Underground Lead/Zinc Mine
- Mechanic
- 57 years old
- 31 years of experience

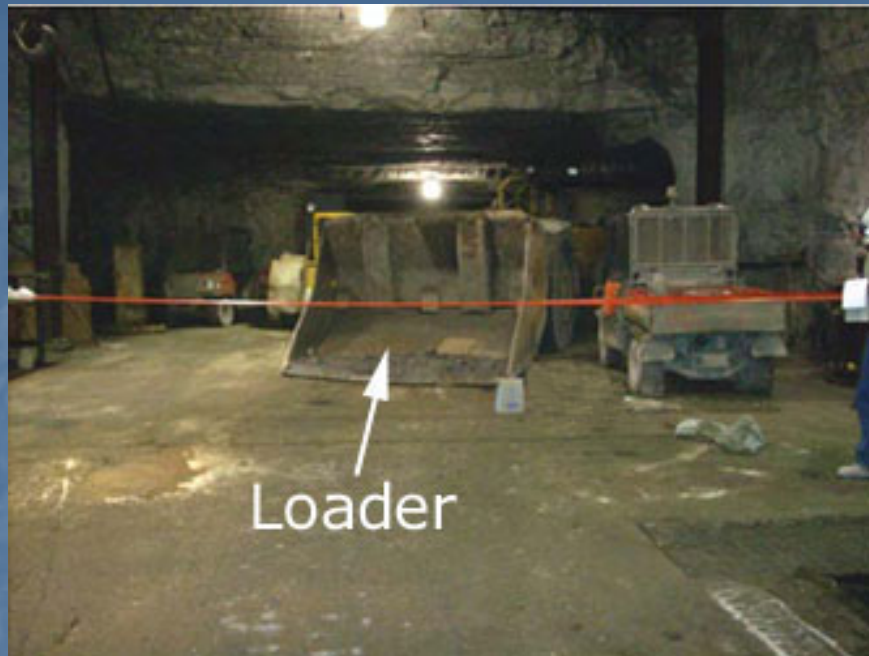
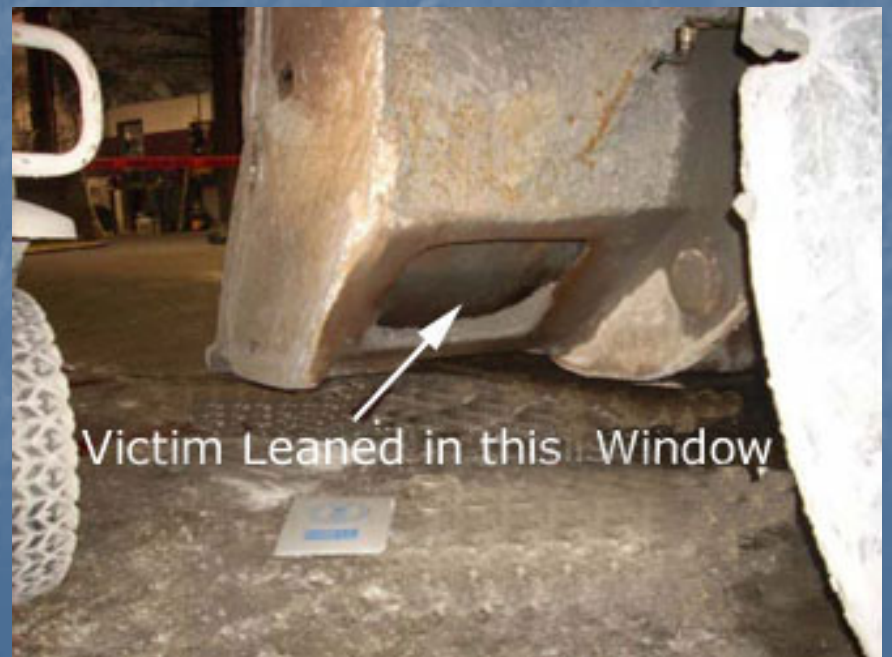
The victim was fatally injured when he was struck by the ejector plate of a loader bucket. He looked in the left ejector plate relief port of the bucket while testing for a hydraulic leak inside the bucket.

The accident occurred because the procedure used to perform maintenance on the loader's hydraulic system did not effectively protect persons from the hazardous motion of the ejector plate.

**Root Cause:** The procedure used to test the loader for a hydraulic leak did not effectively protect persons from hazardous motion of the ejector plate.

**Corrective Action:** Management retrained all persons regarding safe work procedures for performing maintenance and testing on mobile equipment.
