# MNMM Fatal 2009-12

- Fall of Roof Accident
- June 20, 2009 (Louisiana)
- Underground Salt Mine
- Equipment Oiler/Greaser
- 52 years old
- 25 years of experience

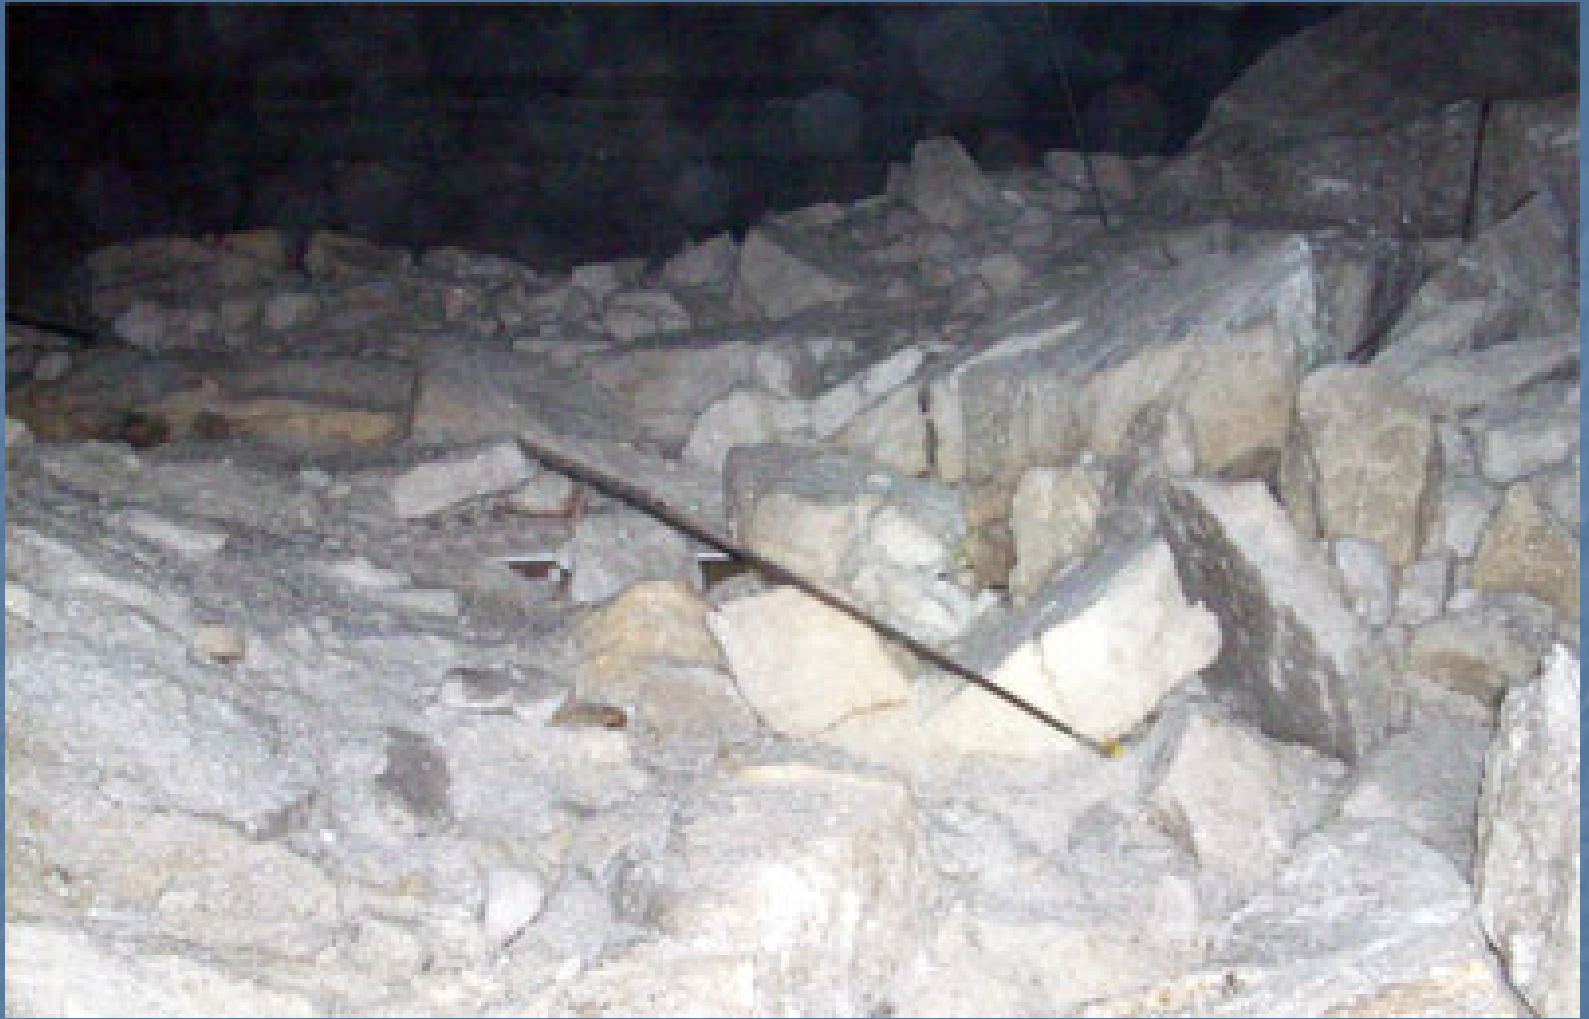
The victim was cleaning equipment when the mine roof fell and fatally injured him. The fall was about 50 feet long by 20 feet wide and up to 3 feet thick. Another miner working nearby was not injured.

The accident occurred because the ground support system for the mine was not designed, installed and maintained to control the ground where persons worked or traveled. The roof rock broke below the anchorage zone of the roof bolts and pulled several of them out of the roof leaving the expansion shells in the bolt holes.

**Root Cause:** Roof bolts were not properly installed in the area of the roof fall.

**Corrective Action:** The entry and crosscut leading into the fall area were scaled and additional roof bolts were provided as necessary. Miners were instructed to test the installed torque of the required number of roof bolts each shift. Management will monitor roof bolting operations to ensure that roof bolts are properly installed and torqued.
