Fatality #8 - May 1, 2009

Machinery - Texas - Construction Sand and Gravel

Santana Dredging Corporation - Santana Dredging Corporation

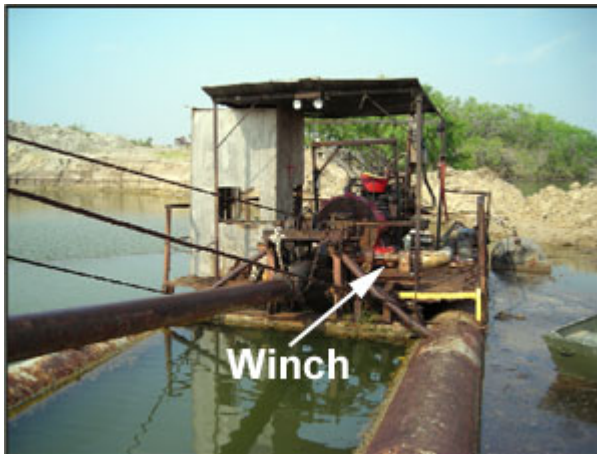
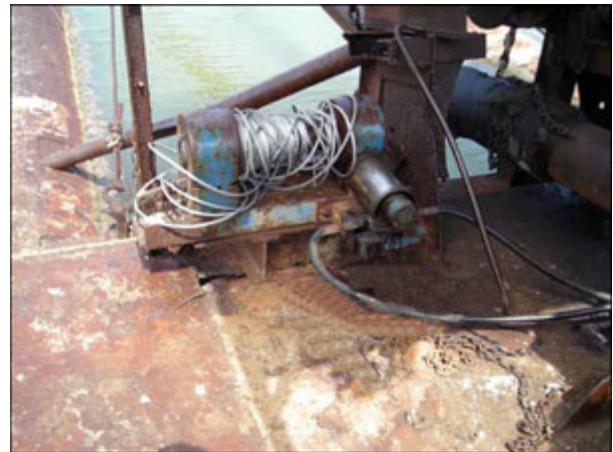
METAL/NONMETAL MINE FATALITY - On May 1, 2009, a 59-year old dredge operator with 3 years of experience was fatally injured at a dredging operation. The victim was trying to manually guide the wire cable onto one of two positioning winches on the dredge when he became entangled in it.

- Conduct a complete pre-operational inspection of equipment that includes checking winches and cables.
- Install new winch cables to reel in the same direction as the old cable.
- Inspect winches to confirm proper reeling of the cable.
- Assign two persons to perform maintenance tasks on dredges.
- Block equipment against hazardous motion before performing maintenance tasks.
- Label valve bank levers to indicate direction of movement.
- Do not wear loose clothing when working near moving machine parts.
