**Fatality #11 – June 11, 2009**  
**Powered Haulage - Missouri - Lead-Zinc Ore**  
**Doe Run Company - Viburnum #29 Mine**

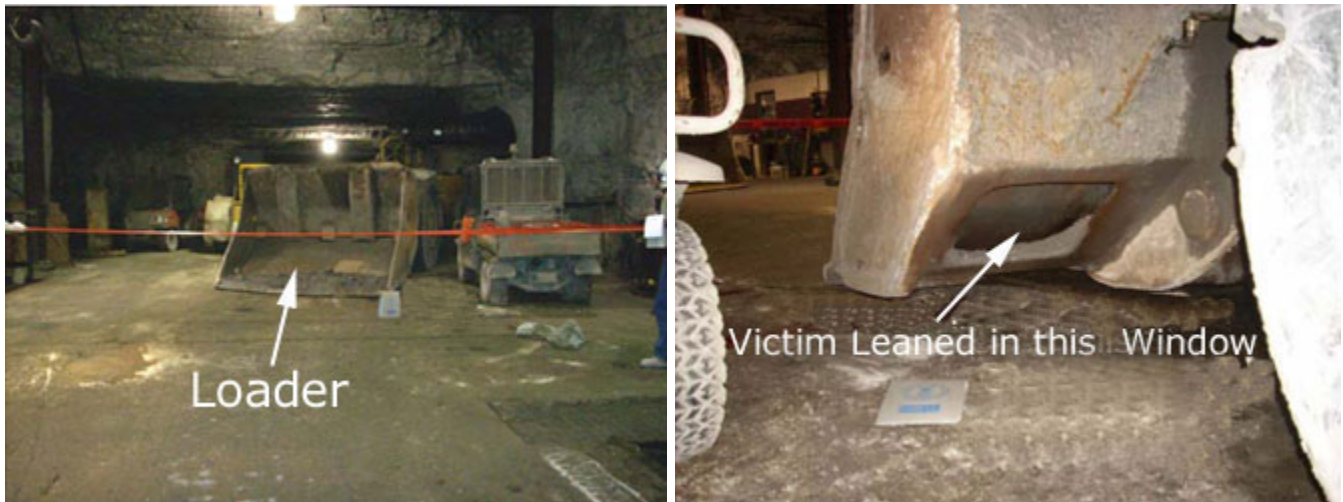
**METAL/NONMETAL MINE FATALITY** - On June 11, 2009, a 57-year old mechanic with 31 years of experience was fatally injured at an underground lead/zinc mine while checking for a hydraulic leak on a loader. The victim leaned into the ejector plate relief port in the back of the loader bucket. The ejector plate of the bucket was retracted, crushing him against the back of the bucket.

- Train persons to recognize work place hazards.
- Establish safe work procedures before a task is performed.
- Securely block equipment and components against hazardous motion at all times while performing maintenance work.
- If equipment and components are to be moved, always verify persons are aware and in a safe location prior to movement.
- Consult and follow the manufacturer's recommended safe work procedures for the maintenance task.
