REPORT OF INVESTIGATION

Surface Nonmetal Mine
Sand and Gravel

Fatal Electrical Accident
April 7, 2009

Hallett Materials
North Des Moines Plant
Des Moines, Polk County, Iowa
Mine ID No. 13-01202

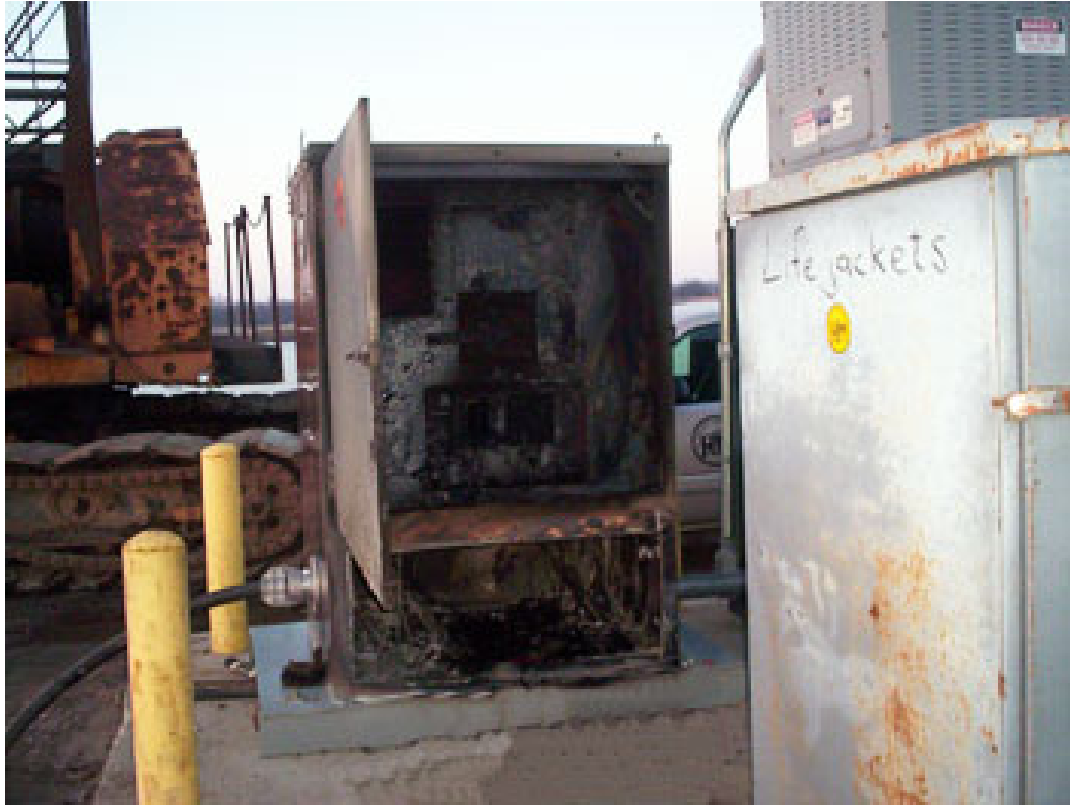
Tadd M. Bainum, Supervisor, age 36, was fatally injured on April 7, 2009, when he contacted an energized 4160-volt electrical circuit and was electrocuted.

The accident occurred because policies, procedures, and training did not ensure that the 4160-volt circuit was de-energized, locked out and tagged out prior to performing work on the individual circuit.
