**REPORT OF INVESTIGATION**

**Surface Nonmetal Mine  
(Limestone)**

**Fatal Machinery Accident**

**Master Aggregates, Toa Baja Corp. PTA 3  
Cantera Carolina Pta #3  
Carolina, Fajardo County, Puerto Rico  
Mine I.D. No. 54-00374**

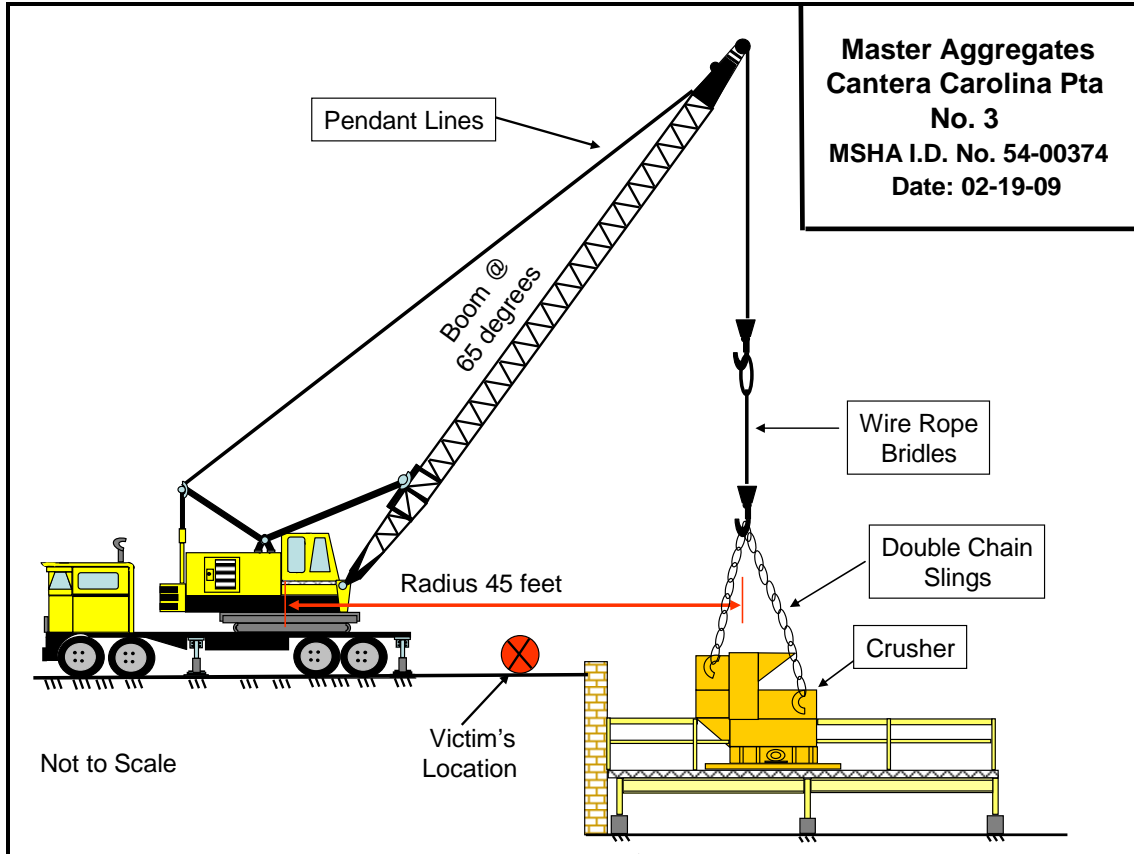
The configuration (Figure 1) at the time of the lift was a 100-foot boom, a 45-foot operating radius (measured during the investigation), and the four outriggers were extended. A 45-foot radius corresponded with a 65-degree boom angle. The crane capacity for this configuration was listed as 32,325 pounds or 16.2 tons.

To compute the total picked load at the time of the accident, the weight of the McKissick load block and rigging tackle had to be included. The manufacturer's literature indicated the load block weighed 610 pounds and the rigging was estimated to be 300 pounds. This made the total pick at the time of the accident 43,310 pounds or 21.7 tons.

The crane's capacity was 5.5 tons less than the total pick of 21.7 tons. Investigators noted that the crane capacity for this boom length and pick radius was from the part of the load chart limited by the stability (tipping) of the crane, rather than a structural failure of the crane.

Figure 1 Lift configuration prior to collapse of boom.

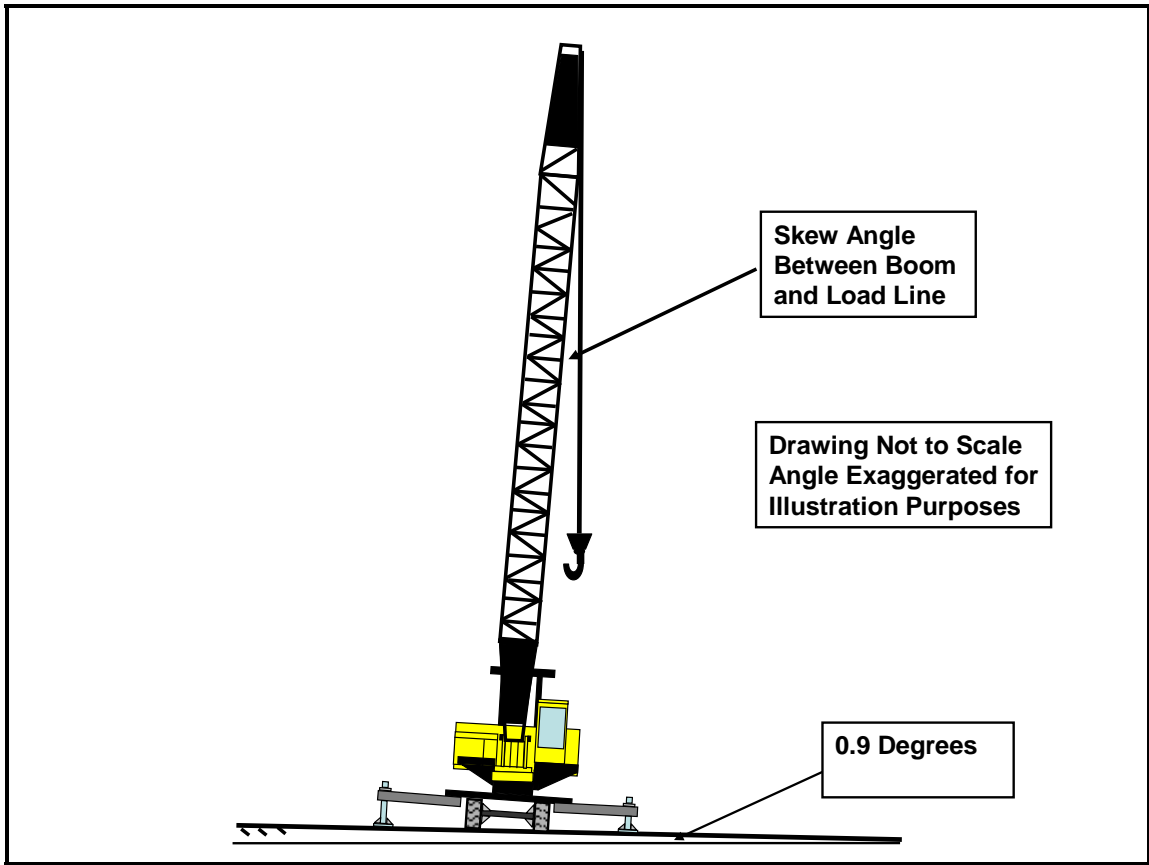
Note number 3 of the crane manufacturer's load chart indicates that side loading of the boom is to be prevented. Side loading occurs when the load to be lifted is not directly centered beneath the boom (Figure 2). Side loading places additional, unnecessary stresses on the boom and its lacings.

After the accident, the butt section of the boom was found to be approximately 2 degrees offset to the right of the centerline of the load. This offset was a consequence of the turntable being out-of-level by 0.9 degrees in the side-to-side direction, with the high side being to the right. Wind can also create side loading on the boom. However, the recorded wind speed at 2:56 p.m. in San Juan, Puerto Rico, (the closest observation point) was only 9.2 miles per hour and blowing toward the east, the same direction the boom was pointing.

**Figure 2** Out-of-level set-up causing side loading.
