REPORT OF INVESTIGATION

**Fatal Fall of Person Accident
April 14, 2009**

**ThyssenKrupp Safway Services, Inc.
Contractor ID No. D034**

**Holcim (US) Incorporated
Holcim Ste. Genevieve Plant
Bloomsdale, Ste. Genevieve County, Missouri
Mine ID No. 23-00284**

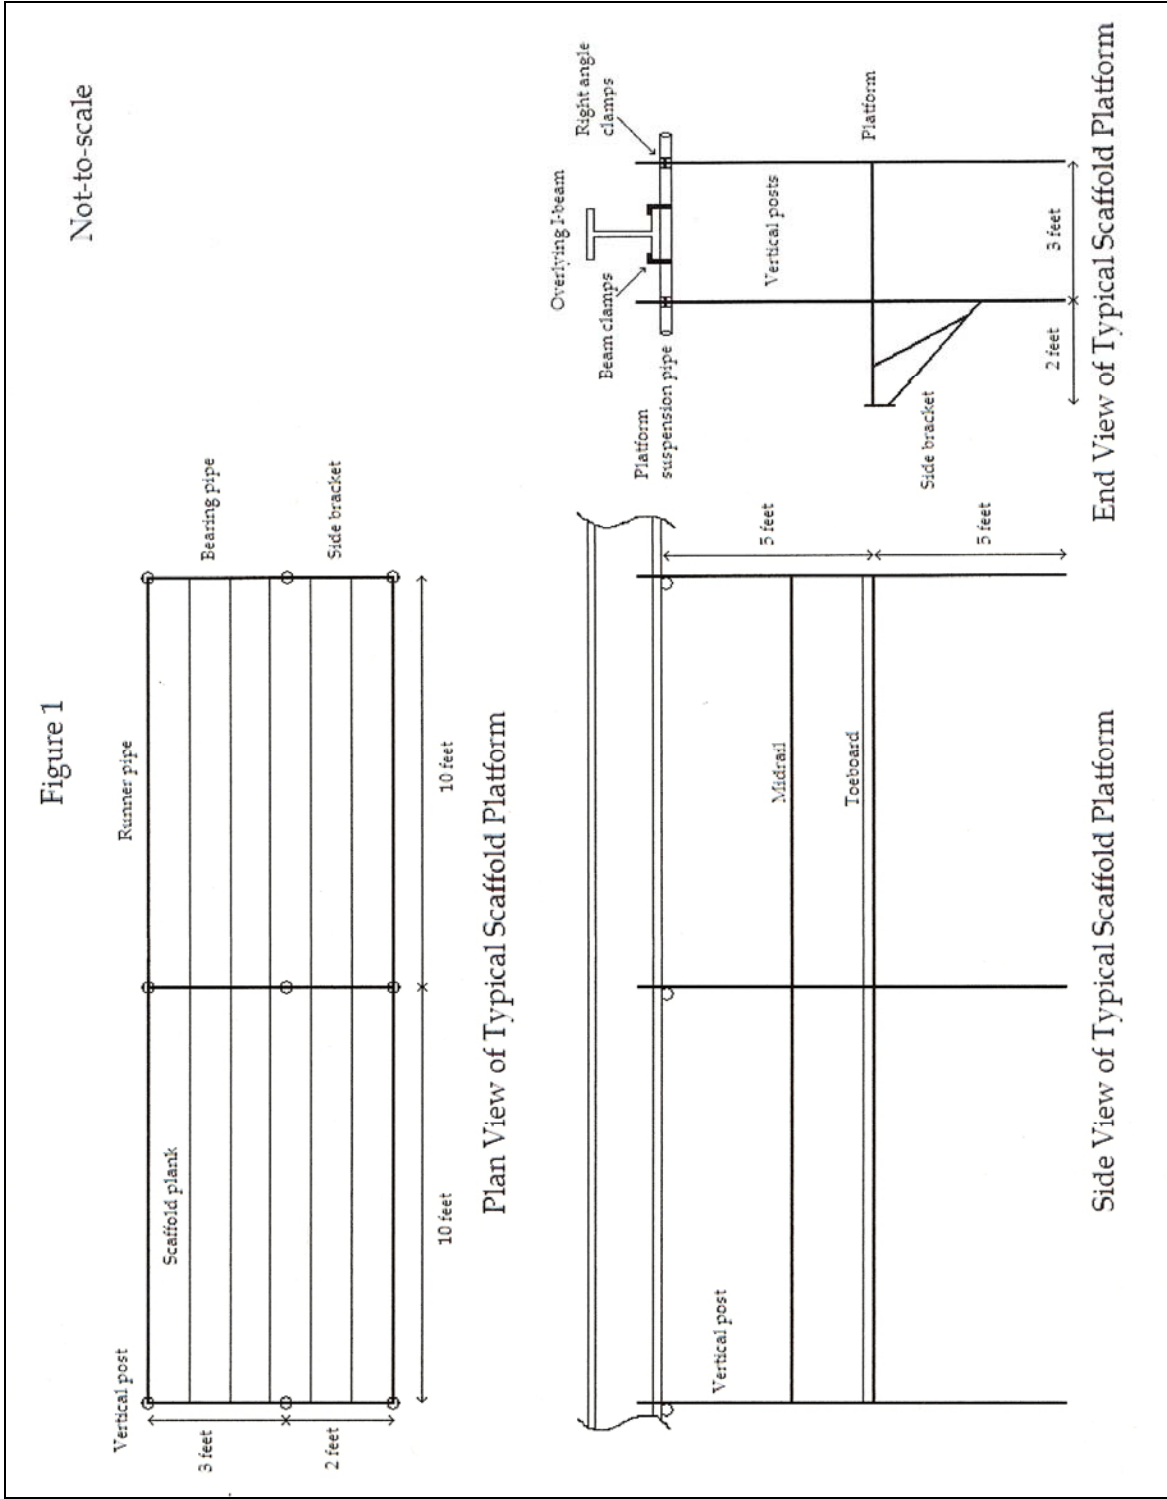
APPENDIX B – Schematic of Typical Scaffold Platform

The Systems™ scaffolding involved in the accident was designed by Safway. The scaffolding, consisting of galvanized steel components clamped together at each junction point, could be suspended from overhead structural steel beams. A typical scaffold platform was 10 feet long and 3 feet wide but could be widened to 5 feet by adding side brackets. Scaffold platforms could be erected end to end as shown on Figure 1 in Appendix B.

Each scaffold platform assembly started with two horizontal suspension pipes clamped onto the bottom flange of structural steel beams keeping the pipes parallel and 10 feet apart. The tops of two 10-foot vertical posts were clamped 3 feet apart onto each suspension pipe. Each vertical post had six evenly spaced ring sets along its length that were used as clamping points for bearing pipes, runner pipes, and side brackets.

A 3-foot long bearing pipe was clamped between each pair of vertical posts at the elevation where the working floor was to be located. A side bracket could be added to each of the vertical posts on one side or the other to widen the platform to 5 feet. A runner pipe was placed along both long sides of a platform to add stability and to

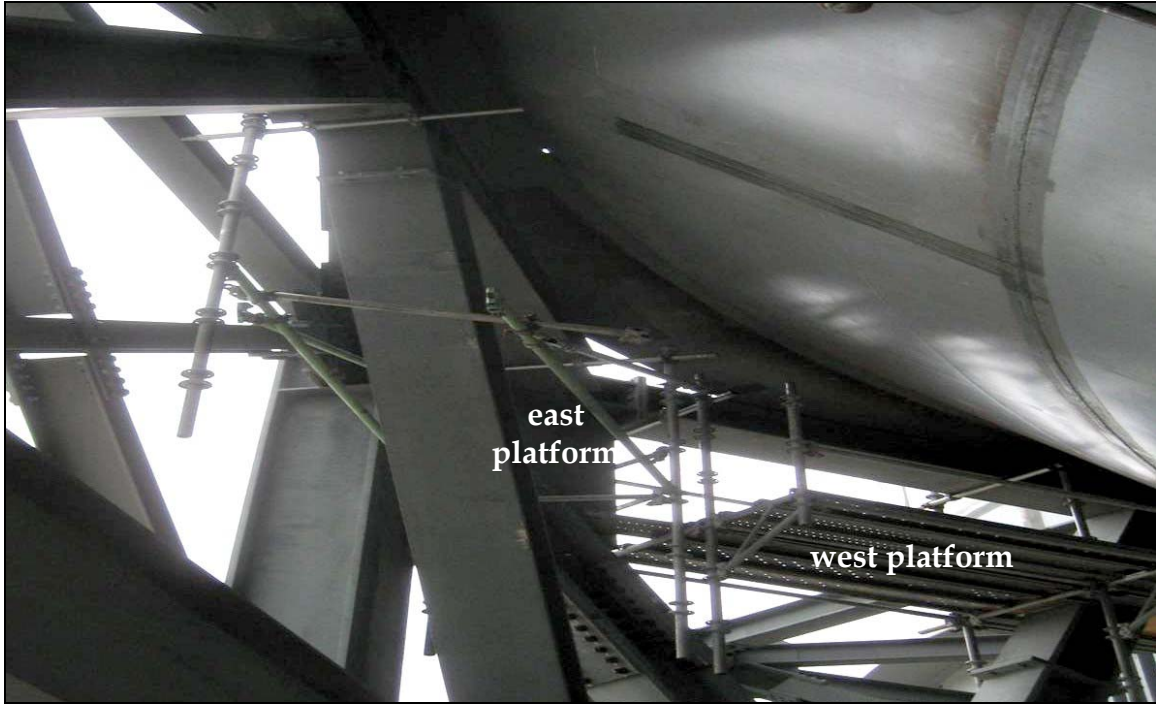
APPENDIX C – Photo Looking Up at Two Scaffold Platforms

Removing the northeast vertical post allowed the northeast corner of the platform to unexpectedly drop about 16 inches. Investigators determined that the clamp holding the northwest vertical post to the north end of the west suspension bar rotated on the suspension bar after Lavite removed the northeast vertical post.

Lavite lost his balance and fell backwards off the scaffold plank on which he was standing. Removing the northeast vertical post left the east platform suspension pipe open-ended at the north end allowing Lavite's lanyard to slip off as he fell backward from the scaffold plank. He fell approximately 75 feet before striking a metal beam about 20 feet above ground level. After impacting the beam below, Lavite's lanyard whipped around the beam and held him there until persons working on the ground were able to remove him a few minutes later.

The two scaffold platforms on the south side of No. 2 fly ash bin (Appendix C) were each 5 feet north-south by 10 feet east-west. They were not placed squarely end to end because of the need to keep them close to the curving wall of the bin. The northeast corner of the west platform was positioned next to the northwest corner of the east platform without sharing any components between the two platforms. They were positioned adjacent to the hopper cone with the bearing pipes, runner pipes, and side brackets clamped to the fourth ring set down from the top of the four vertical posts. The working level (scaffold planks) of each platform was about 5 feet lower than the junction of the hopper cone and the bin wall.

Mid-rails and handrails extended in the east-west direction on the south side of the scaffold platforms. Only a continuous mid-rail was installed on the north side of the scaffold platforms because they were built too close to the hopper cone to accommodate continuous handrails. The scaffold planks were laid in the east-west direction on each scaffold platform. Plywood was used to cover the gaps where scaffold planks could not be placed due to the presence of the diagonal steel beams.

Corrective Action: Sub-contractor management established additional policies to ensure that established safe operating procedures are followed when dismantling scaffolding. Persons performing the task were trained and will be monitored to ensure the procedures are being followed.

Corrective Action: Sub-contractor management established additional policies to ensure that safe tie-off procedures are followed while working where there was a danger of falling. Persons working where there is a danger of falling were trained and will be monitored to ensure the procedures are being followed.
