REPORT OF INVESTIGATION

**Fatal Falling Material Accident
April 21, 2009**

**Tycon Excavating Contractor, Inc.
Contractor I.D. K973**

**Santana Dredging Corporation
Santana Dredging Corporation
Savannah, Hardin County, Tennessee
Mine I.D. No. 40-00827**

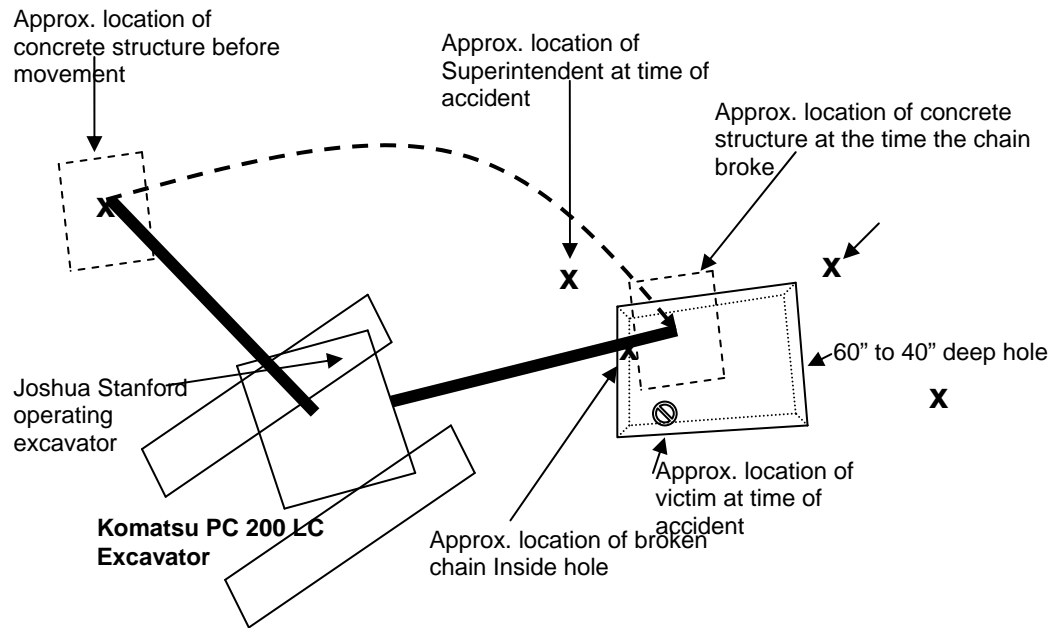
APPENDIX B

About 9:35 a.m., the single chain broke when the catch basin was partially over the hole. The catch basin fell striking the top edge of the hole, overturned into the hole, and pinned Rickey Luna against a sidewall of the ditch. Alexander tried to manually move the catch basin but was unsuccessful. He went for first aid supplies and to get help. Stanford then called for emergency medical assistance. Steven Luna jumped into the hole and checked the victim for vital signs but found none. He took one leg of the sling and connected it to the catch basin. Stanford used the excavator to lift the catch basin and move it out of the way. At 9:50 a.m., emergency medical personnel arrived and transported Rickey Luna to the hospital where he was pronounced dead at 12:14 p.m. by the attending physician. The cause of death was attributed to multiple blunt force trauma.

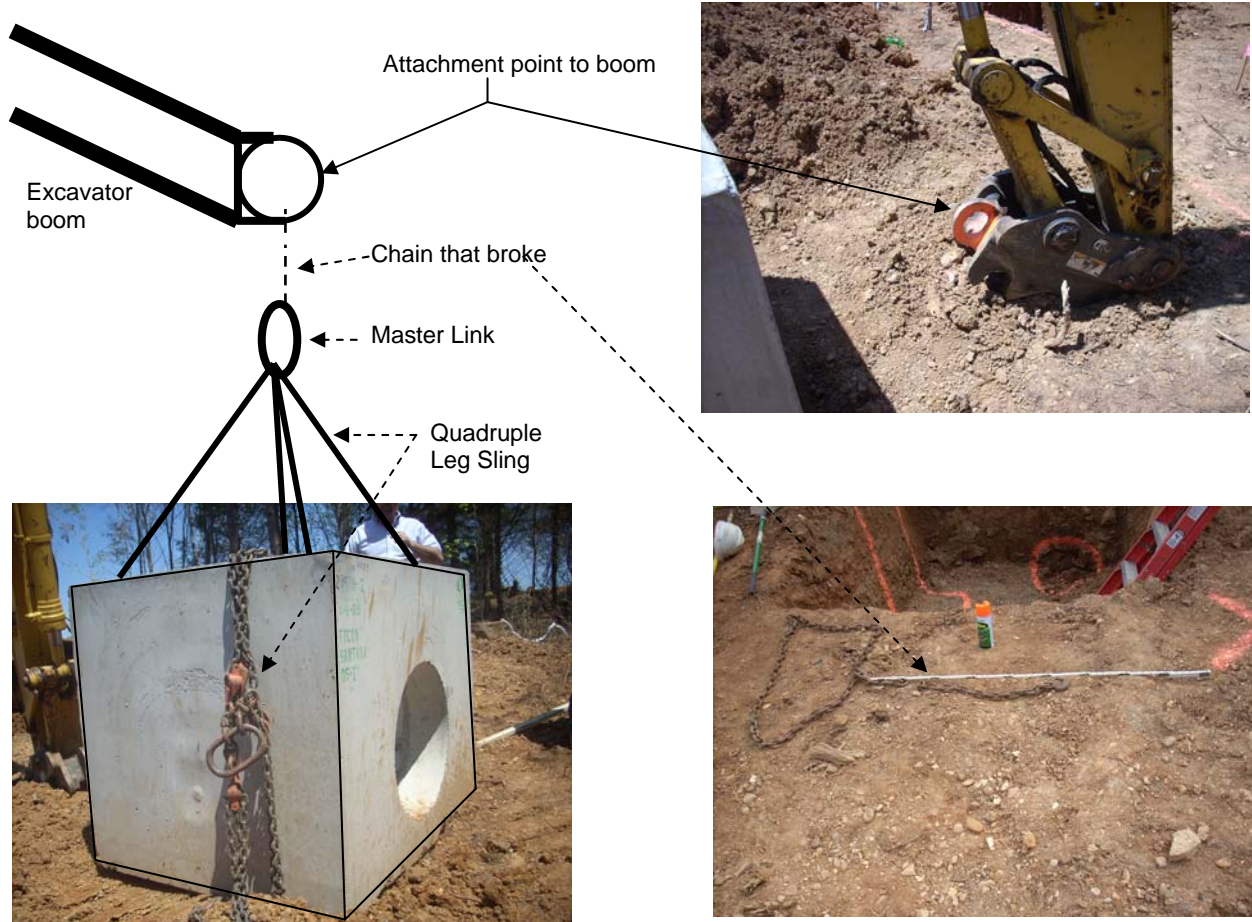
APPENDIX C

Stanford returned with the excavator and dug a hole for the concrete catch basin as Steven Luna monitored the elevation. Steven Luna and Rickey Luna got in and out of the hole to ensure it was square and to check the elevations. Gravel was delivered to the hole and placed into the bottom for stability and proper elevation. Stanford again removed the bucket from the excavator to attach the concrete catch basin to the boom. Steven Luna and Rickey Luna entered the hole to level the rock, check the elevation, and mark the corner location of the catch basin. Alexander used a single chain and a quadruple leg sling to connect the concrete catch basin to the excavator boom.

Stanford tightened the sling and chain so Alexander could check the hooks inside the concrete catch basin to ensure the chains were connected inside the structure. The concrete catch basin was lifted approximately 10 to 12 inches off the ground and rotated toward the hole. Alexander stopped the excavator, checked the bottom of the catch basin, and reached under it to remove some mud. He and Rickey Luna discussed the proper alignment of the catch basin in the hole. Steven Luna then got out of the hole. Alexander walked along side the structure as it was moved to the hole using his hands to keep the catch basin properly aligned.

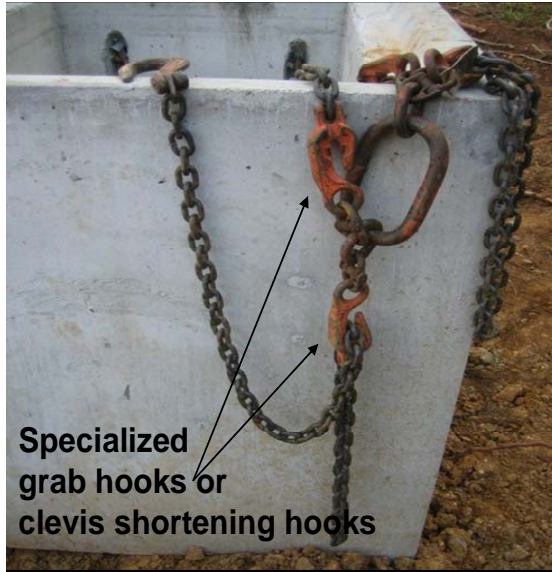
The connector chain involved in the accident was 3/8-inch chain with clevis grab hooks on each end. The grab hooks were designed with a clevis pin and cotter pin combination which was used to attach the hook onto any length of chain. The hooks were also designed to hook and lock onto the chain links on which they were attached. The working portion of the chain was looped through the master link of the chain sling and through the lifting eye on the excavator. The grab hook was used to close the loop. Reportedly, the extra chain on the other end was looped on the chain to keep it out of the way.

Specialized grab hooks or clevis shortening hooks

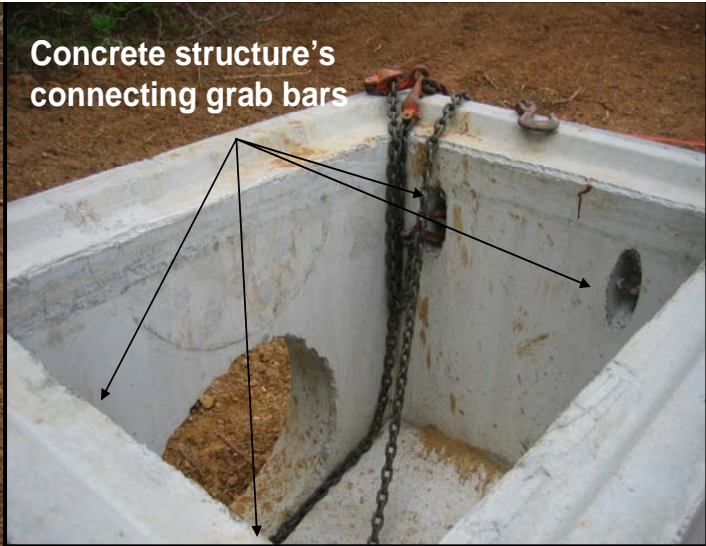
Concrete structure's connecting grab bars

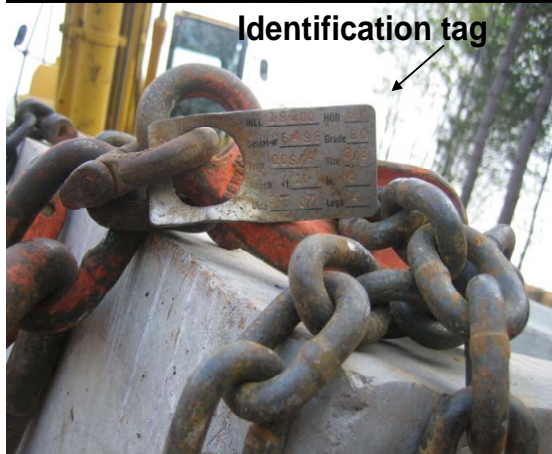
The Custom Sling LLC four-leg chain sling, involved in the accident, was a Grade 80 QOS/A adjustable quad leg sling with an oblong master link. The chains making up the sling were 3/8-inch links embossed with HA 800 markings. The chains were a high strength heat treated alloy steel primarily used as a sling component for overhead lifting but could be used in rigging and tie applications. The sling WLL (Working Load Limit) was 18,400 pounds as specified on the manufacturer's tag located on the sling.

Identification tag

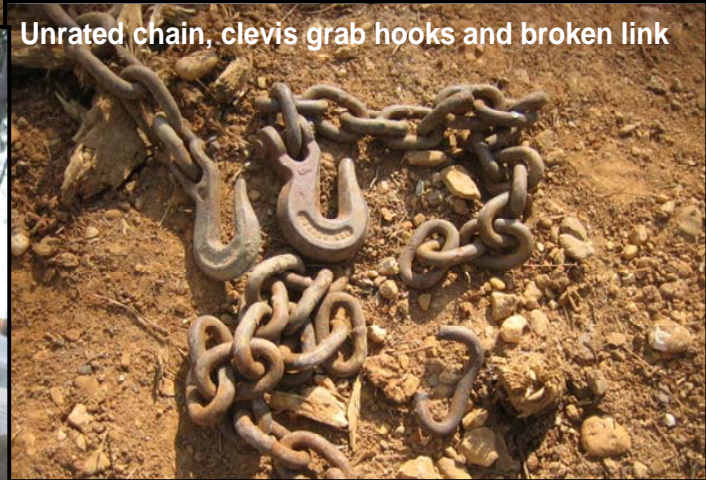
This connector chain did not have any identifying marks or discernible manufacturer's identification that is typically found on Grade 80 and Grade 100 alloy chain. Investigators determined that the connector chain exhibited noticeable wear and distortion in several locations. This wear included bent links, i.e. links that were no longer flat, as well as local deformation indicated by flat shiny spots on the chain, rust accumulation, and corrosion pitting in places.

A single link in the working section of the chain failed catastrophically, causing the catch basin to fall. This type of chain was considered "welded" chain. In the manufacturing process, the individual chain links were formed into the oblong shape using round bar stock. The ends were then welded together to form the links. The link of chain broke at the weld along one side. Investigators could not determine the exact position of the broken link when installed between the excavator lifting eye and the chain sling masterlink. One end of the broken link distorted more than the other. The worn and distorted (bent and twisted) condition of this broken link was similar to the condition of several other unbroken links in this chain.

The National Association of Chain Manufacturer (NACM) Welded Steel Chain Specifications (September 28, 2005) define properties and grades of welded steel chain for industrial and commercial uses. For overhead lifting applications, the NACM specifications state that only Grade 80 or Grade 100 alloy chains should be used. Grade 80 and Grade 100 alloy chains were required to be identified with periodic embossing which included the manufacturer identification mark or symbol, the traceability or date code, and the grade of the chain, at intervals no greater than three feet. These NACM specifications prohibit overhead lifting with any chain whose grade is less than Grade 80. They also prohibit using damaged chain, including chains that have been bent or twisted.

Root Cause: Contractor management did not conduct a risk assessment to determine the potential hazards or to establish safe work procedures prior to lifting the 5,500 pound concrete catch basin. The chain used to support the concrete catch basin was not rated and would not support the load being lifted and moved.

Unrated chain, clevis grab hooks and broken link

Corrective Action: Contractor management established and implemented procedures that require risk assessments to be conducted that identify and correct potential hazards associated with the task to be performed. Safe lifting and rigging procedures were developed and implemented to ensure the safety of all persons working near the lifting area.

Corrective Action: Contractor management established policies, procedures, and controls requiring chains and other rigging to be examined prior to lifting.
