REPORT OF INVESTIGATION

**Fatal Powered Haulage Accident
May 2, 2009**

**Innovative Environmental Construction
Contractor I.D. No. V401**

**Active Minerals International, LLC
Active Minerals Attapulgate Mine
Climax, Decatur County, Georgia
Mine I.D. No. 09-01192**

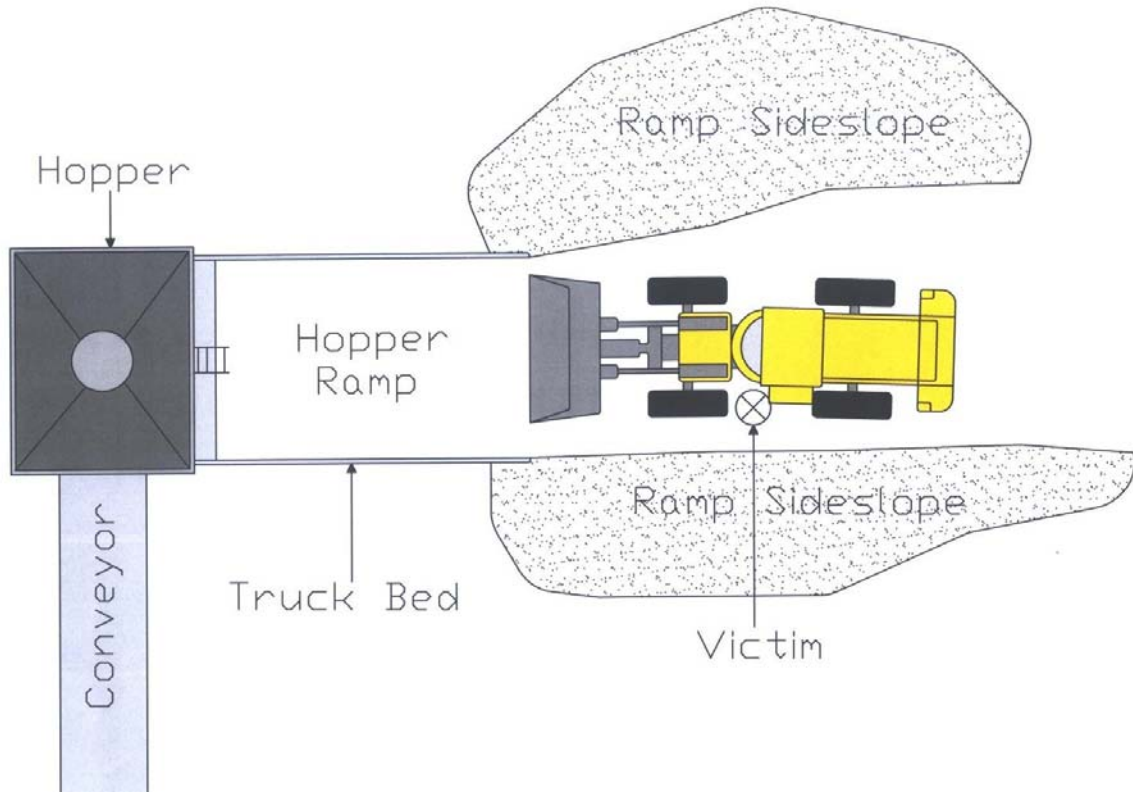
APPENDIX B

The main plant feed hopper ramp where the accident occurred was located between the pit stockpile and the processing facility.

The grades at the feed hopper ramp ranged from approximately 18 percent where the front-end loader was in position to dump the load into the hopper to approximately 11 percent where the front-end loader finally stopped. The ramp was comprised of dry stone and clay material.

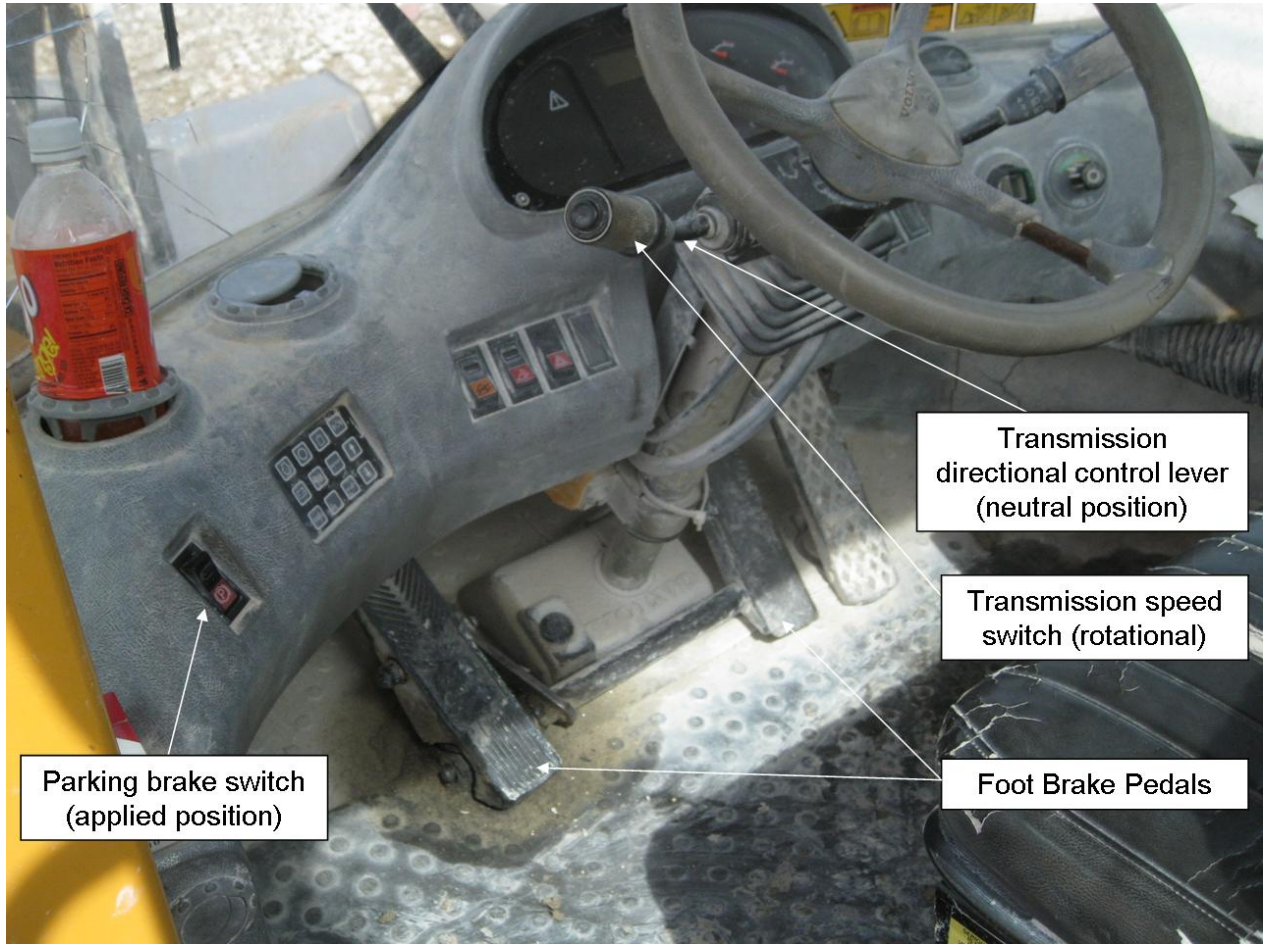
Photo No. 1: General Layout of Cab and Controls

The front-end loader had an electronic controlled power shift (automatic type) transmission with four forward and four reverse speeds and the option of selecting shifting characteristics. A transmission selector lever was located on the left hand side of the steering column for directional and speed control (See Appendix C - Photo No. 1). The directional control was lever activated with three positions: forward (lever moved forward); neutral (lever in center position); and reverse (lever moved rearward). The speed control was a rotary switch having four positions (1st, 2nd, 3rd and 4th) located on the end of the directional control. The loader also had an Automatic Power Shift (“APS II”) rotary switch control positioned in the right side area of the forward dashboard panel for either electronically controlled automatic shifting or manual shifting of the transmission.

The loader cab did not have accommodations for a second person as there was no additional seat or seat belt.

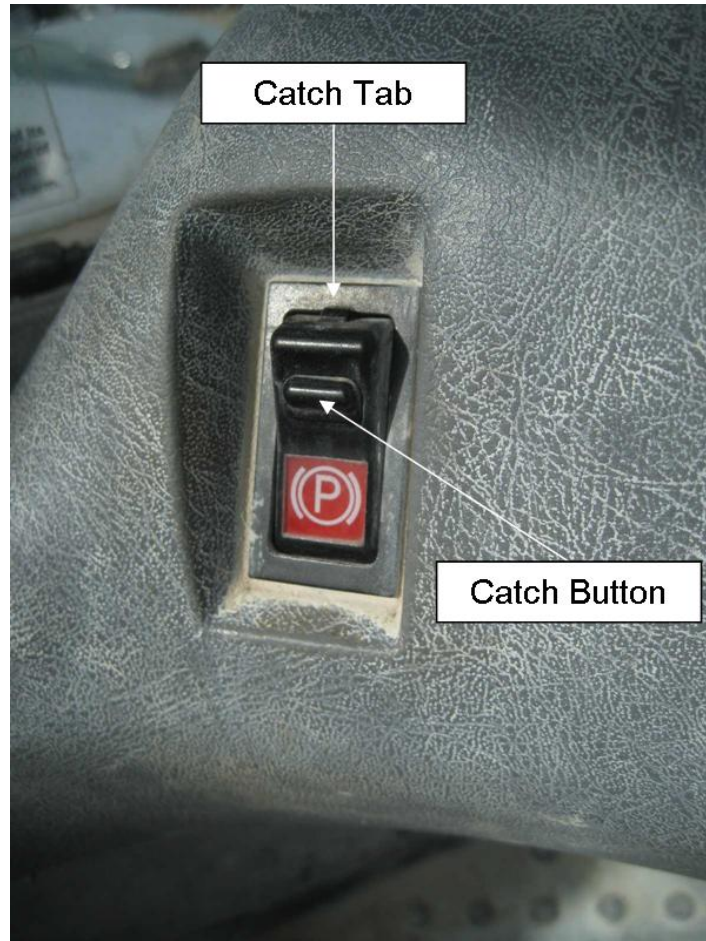
Photo No. 2: Configuration of the Rocker Type Parking Brake Switch in the Applied Position

The front-end loader had a spring-applied, hydraulic-released open caliper dry disc parking brake on the transmission’s output shaft for the front axle. A rocker type switch was inset in the left hand side area of the front dashboard panel. This switch had a locking feature (catch tab) requiring two actions to release the switch (See Appendix C - Photo No. 2). These actions included a downward force on a button on the upper face of the rocker switch to release the locking feature (catch tab) and an inward force to cycle (rock) the switch to the released position.

Hydraulic pressure tests were also conducted on the parking brake system. Investigators determined that the elapsed time for the parking brake pressure to apply or release the parking brake once the switch was cycled to either the applied or released positions was approximately 0.5 seconds.

Tests indicated that the parking brake automatically applied in approximately 0.5 seconds whenever the engine was turned off using the key switch.
