REPORT OF INVESTIGATION

**Fatal Powered Haulage Accident
June 6, 2009**

**Newmont USA Limited
Genesis Mine
Carlin, Eureka County, Nevada
Mine ID No. 26-00062**

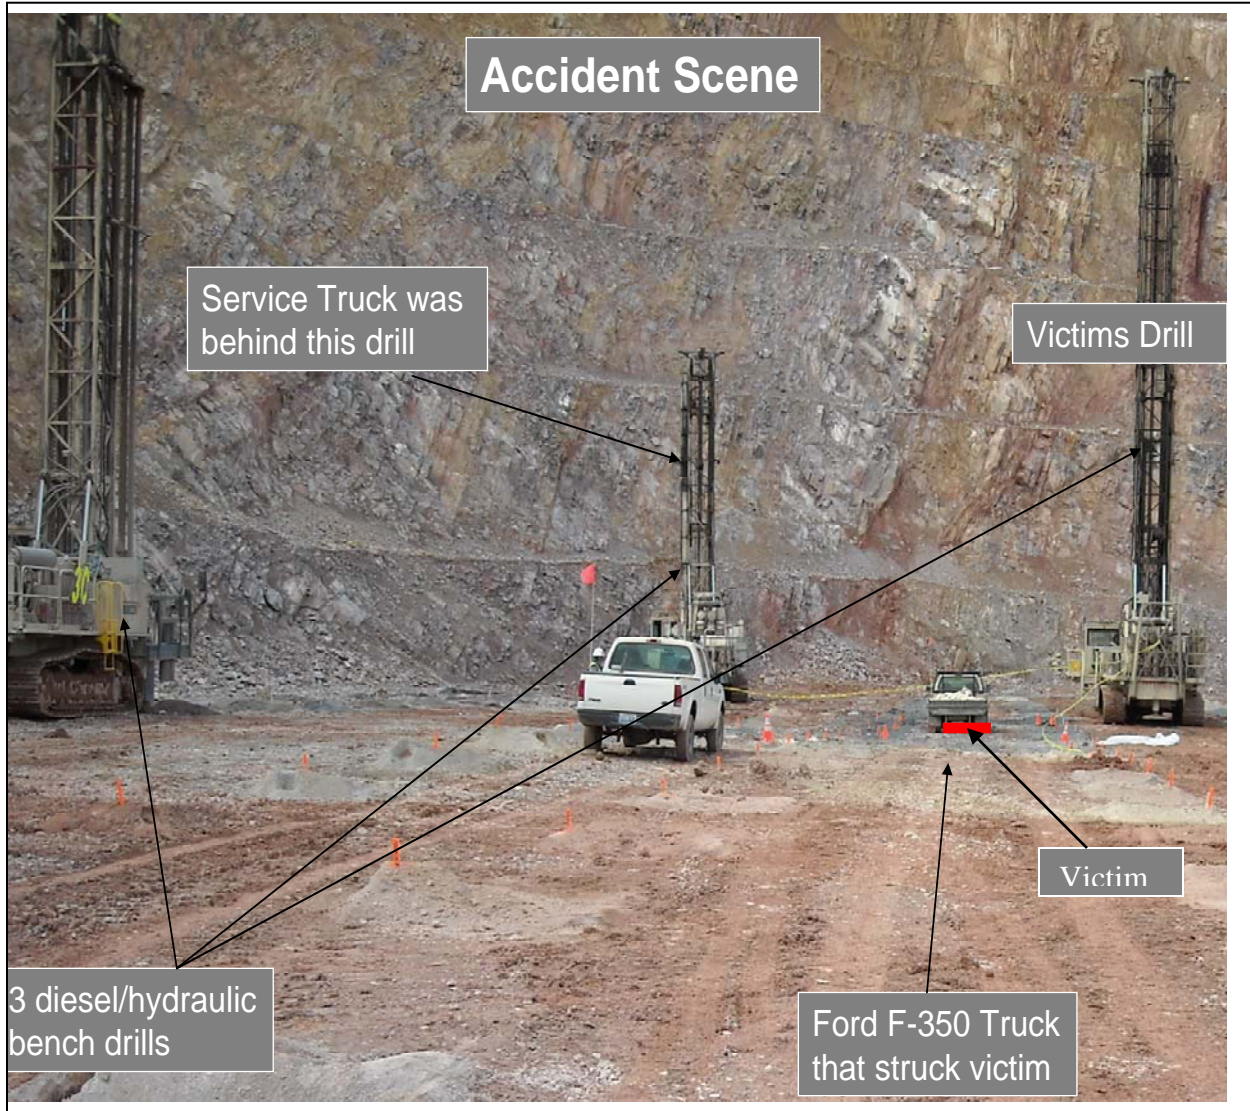
Accident Scene

Service Truck was behind this drill

Victims Drill

Ford F-350 Truck that struck victim

Victim

Steven L. Halverson, Drill Operator, age 57, was fatally injured on June 6, 2009. Halverson was drilling in a pit, exited the drill, and walked in the drilling area when he was struck by a flatbed truck as it backed up. The truck was in the area to collect drill cutting sample bags.

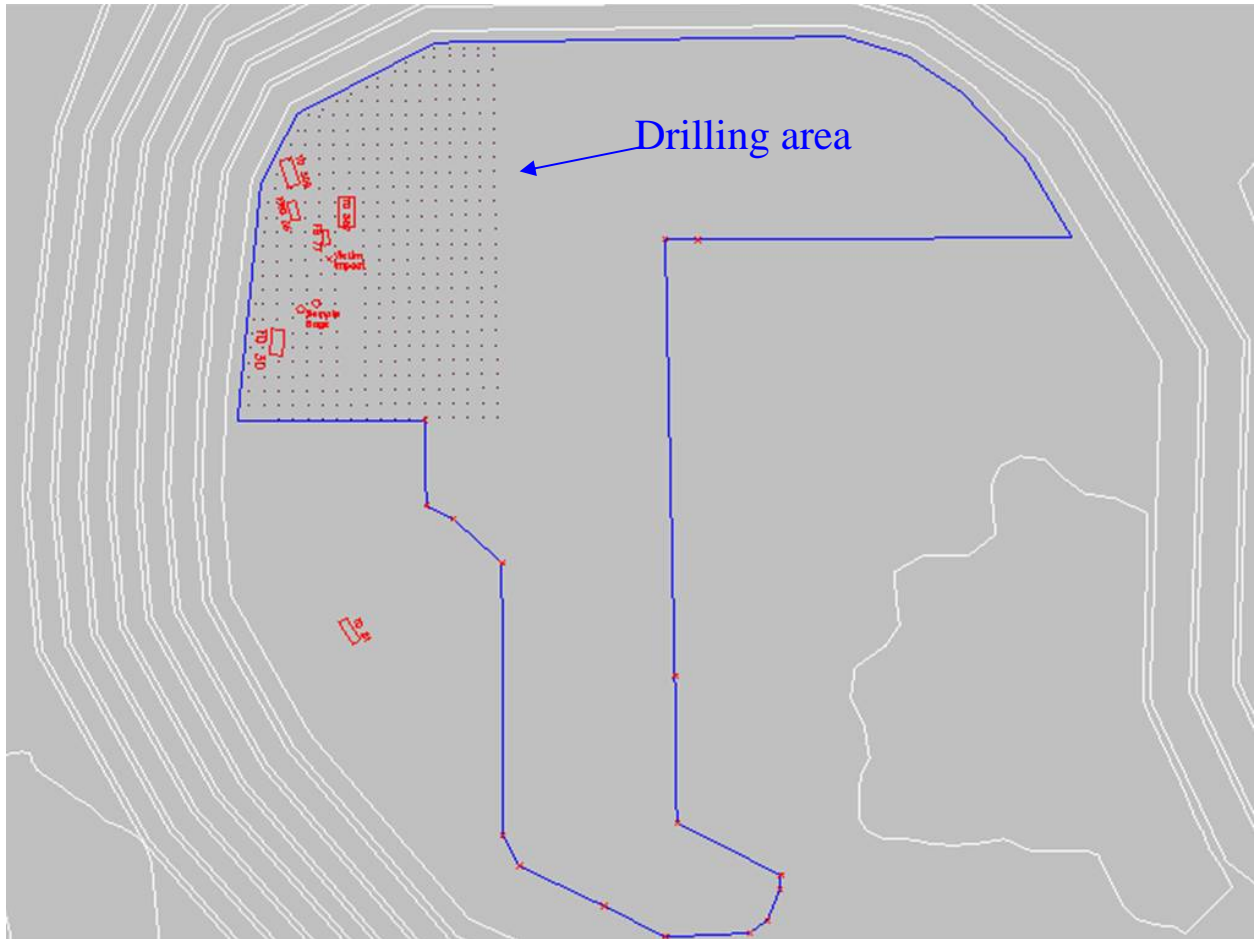
Top View of Accident Scene

The accident occurred in the Lantern Pit on the 5700 level drill pattern. The pit was located about 1 ½ miles from the mine's main entrance gate. The drilling area was level with no standing water.

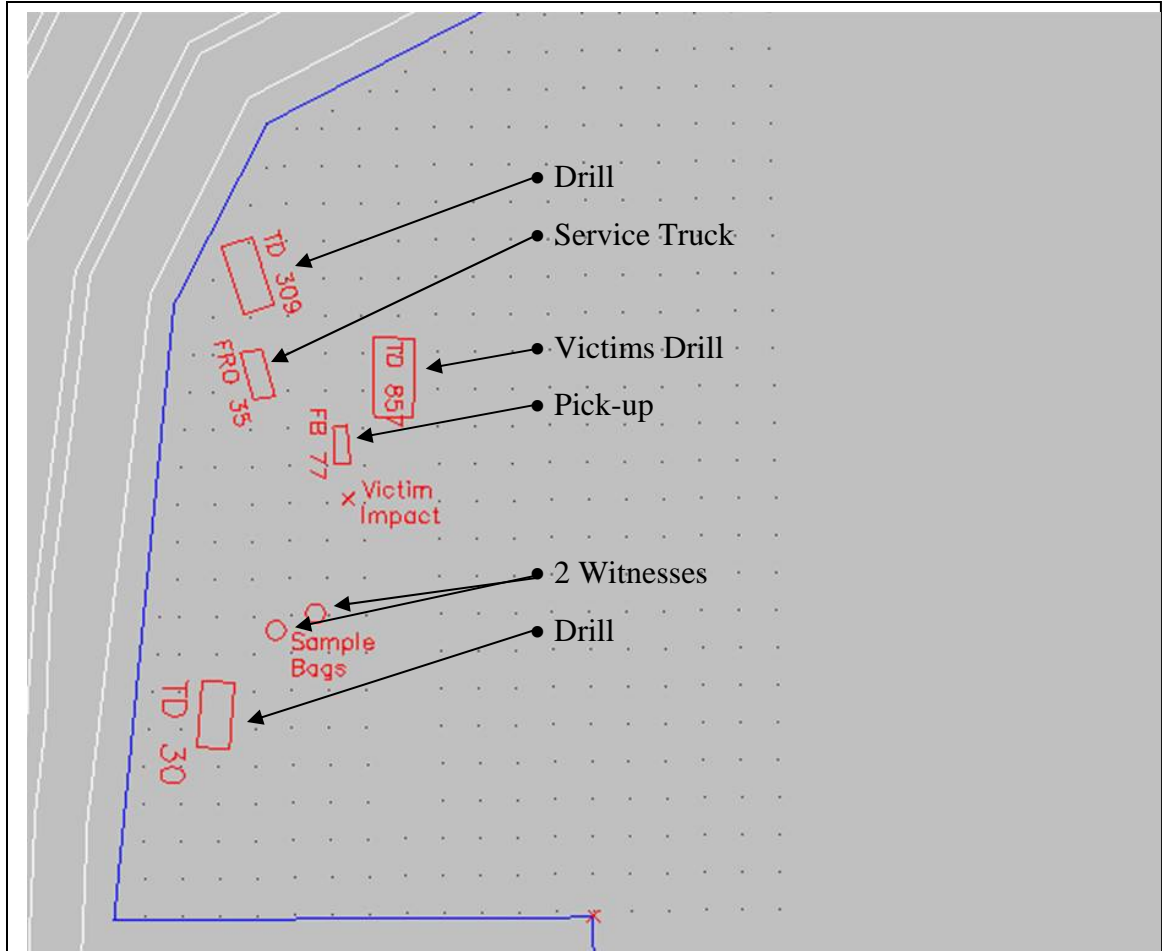
Detailed View of Accident Scene

At the time of the accident, the position of the loaded materials on the truck itself did not significantly obstruct the operator's view through the rear view mirror mounted inside the cab. The truck had backed up at about 2-3mph for approximately 124 feet prior to striking the victim.

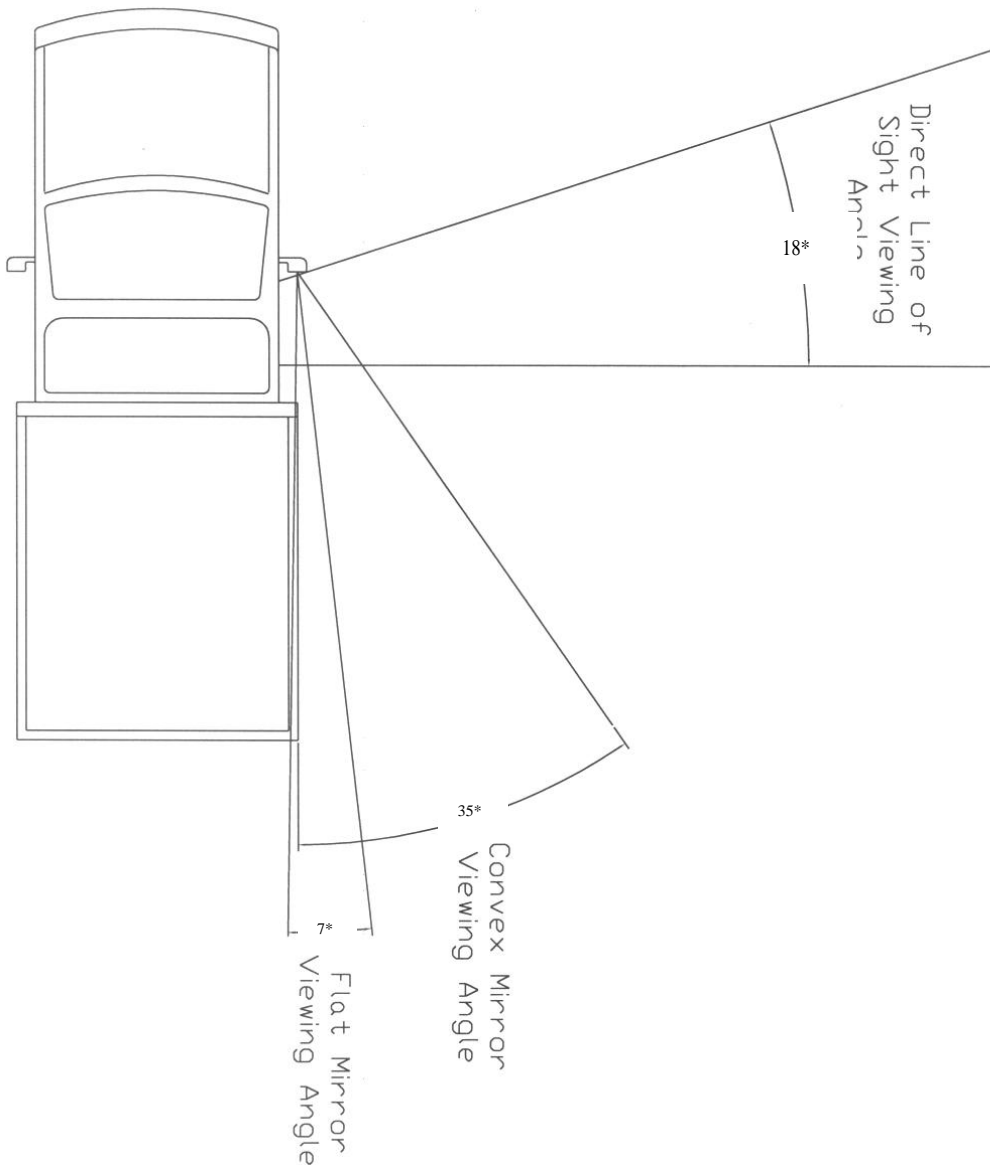
Mirrors and Visibility

The approximate visibility zones for the right side and right rear bed face areas of the truck are shown in Appendix D. The investigators determined that the victim had traveled within the viewing areas of both right side mirror sections while walking to the rear corner of the truck.
