REPORT OF INVESTIGATION

**Underground Metal Mine
(Lead-Zinc Ore)**

**Fatal Powered Haulage Accident
June 11, 2009**

**Doe Run Company
Viburnum #29 Mine
Viburnum, Washington County, Missouri
Mine ID No. 23-00495**

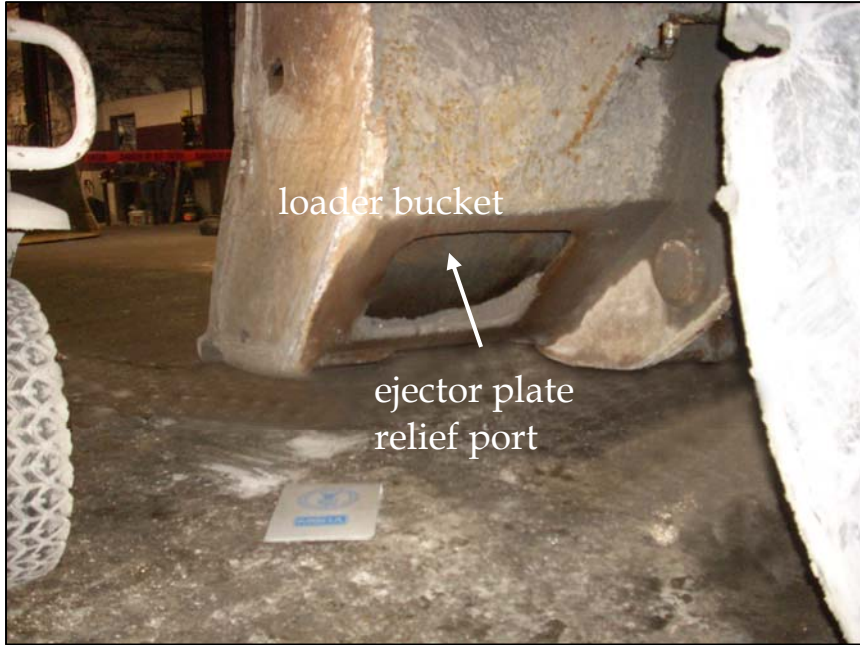
loader bucket

ejector plate
relief port

On June 11, 2009, Joseph I. Roy, Mechanic, age 57, was fatally injured when he was struck by the ejector plate of a loader bucket. He looked in the left ejector plate relief port of the bucket while testing for a hydraulic leak inside the bucket.

The accident occurred because the procedure used to perform maintenance on the loader's hydraulic system did not effectively protect persons from the hazardous motion of the ejector plate.

One 20-inch by 20-inch ejector plate relief port was located on each side of the back of the loader bucket. These ports allowed loose material that accumulated behind the ejector plate to be pushed out of the bucket as the ejector plate retracted.

The hydraulic jacks and associated hoses for the ejector plate were located almost entirely inside the bucket. They were located behind the ejector plate between the two relief ports. To observe the hydraulic hoses through a relief port, mechanics would have to place their head partially into the port and look toward the mid-point of the bucket.

Root Cause: The manufacturer of the loader did not provide any procedures in the service manual to protect persons performing maintenance and testing on the vehicle. Management did not have safe work procedures established for persons performing maintenance and testing on the loader hydraulic system. The procedure used to test the loader hydraulic system did not effectively protect persons from hazardous motion of the ejector plate.

Corrective Action: Management retrained all persons regarding safe work procedures for performing maintenance and testing for hydraulic leaks on mobile equipment.
