REPORT OF INVESTIGATION

**Underground Nonmetal Mine
(Salt)**

**Fatal Fall of Roof Accident
June 20, 2009**

**Morton International Inc.
Weeks Island Mine & Mill
New Iberia, Iberia Parrish, Louisiana
Mine ID No. 16-00970**

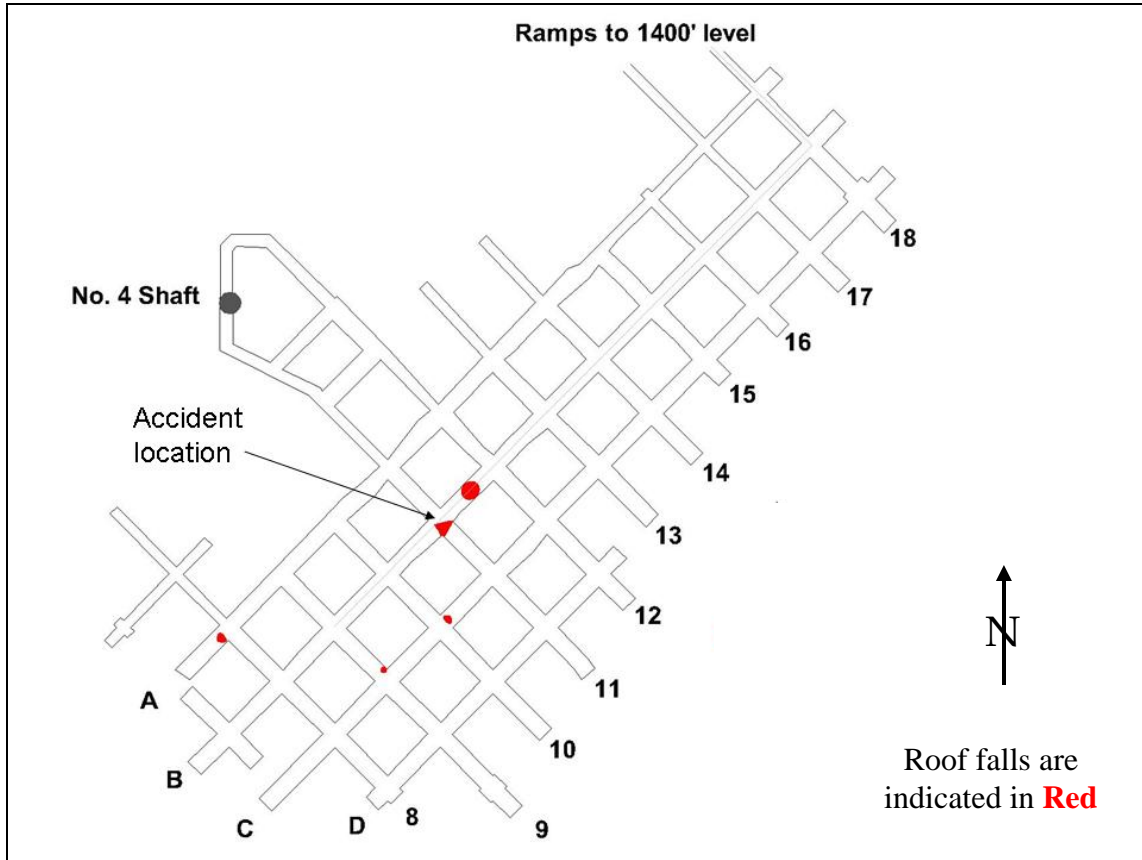
APPENDIX B – 1500 Level Sketch

The roof fall occurred at the intersection of entry 11 and crosscut B on the 1500 level (see Exhibit B). The fall zone extended from the southeast side of the intersection into the crosscut several feet toward the intersection of entry 11 and crosscut C. The section of roof that fell was about 50 feet long by 20 feet wide and up to 3 feet thick.

Several roof bolts pulled out of the overlying strata with the rock that fell in the area of the accident, indicating poor bolt anchorage. Poor anchorage of a mechanical bolt can occur for several reasons, including oversized bolt holes, over spinning the bolt, too much or too little torque, or weak rock at the anchorage horizon.

Corrective Action: The entry and crosscut leading into the fall area were scaled and additional roof bolts were provided as necessary. Miners were instructed to test the installed torque of the required number of roof bolts each shift. Management will monitor roof bolting operations to ensure that roof bolts are properly installed and torqued.
