REPORT OF INVESTIGATION

Surface Nonmetal Mine  
(Dimension Stone)

Fatal Machinery Accident

R Arnold #1 Quarry  
Richard L. Arnold II  
Montrose, Susquehanna County, Pennsylvania  
Mine I.D. No. 36-09316

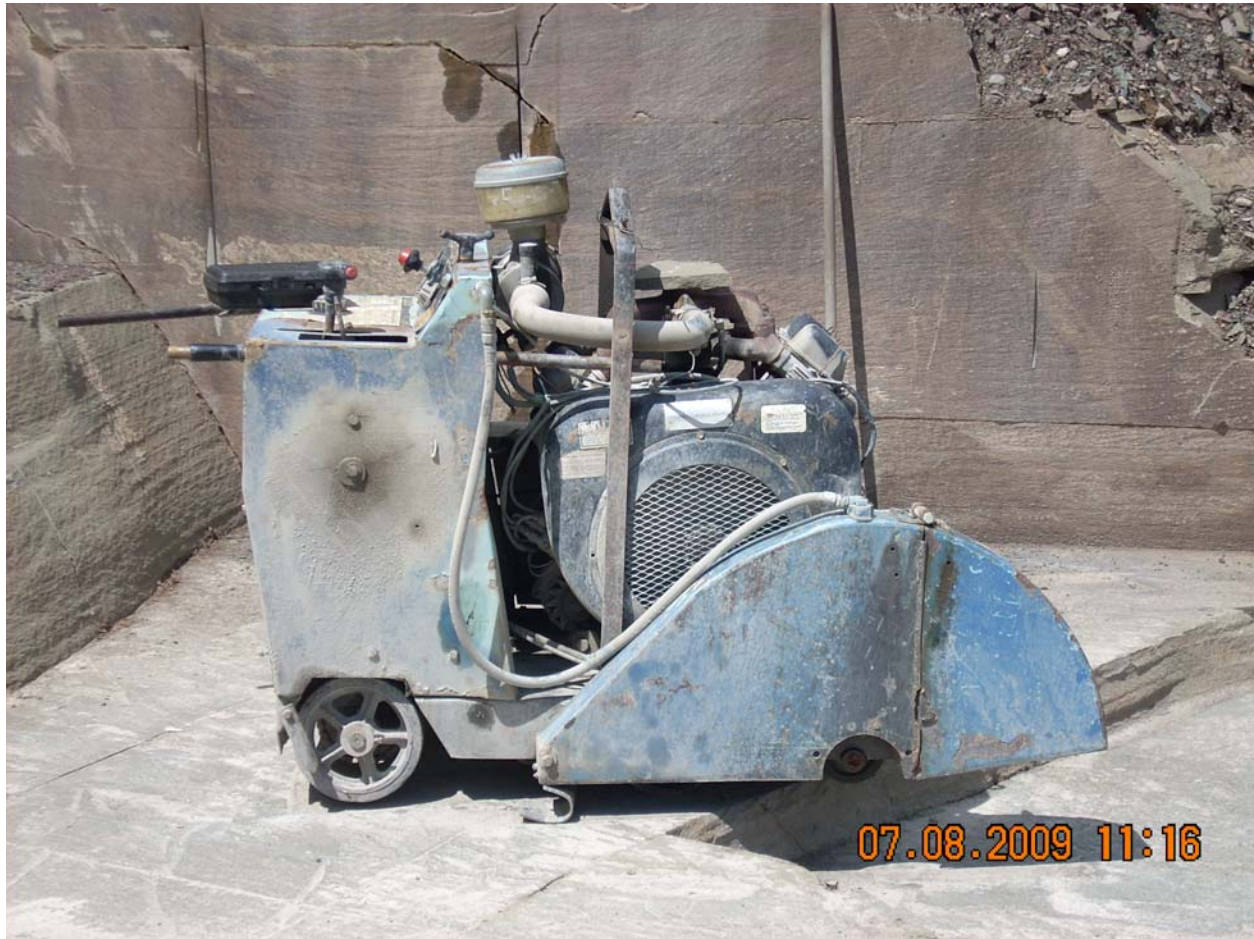
**Walk-Behind Concrete Saw Involved in the Accident**

While Arnold was walking backwards near the highwall edge to position the saw, he slipped or tripped. Investigators determined that while trying to hang on to the saw, Arnold grabbed the saw's hydrostatic transmission control and pulled it backward. The movement of the saw caused Arnold and the saw to fall over the edge nine feet to the bench below. About 9:00 a.m., Manning went to the quarry to see if Arnold needed help removing the cut slabs of stone from the bench.

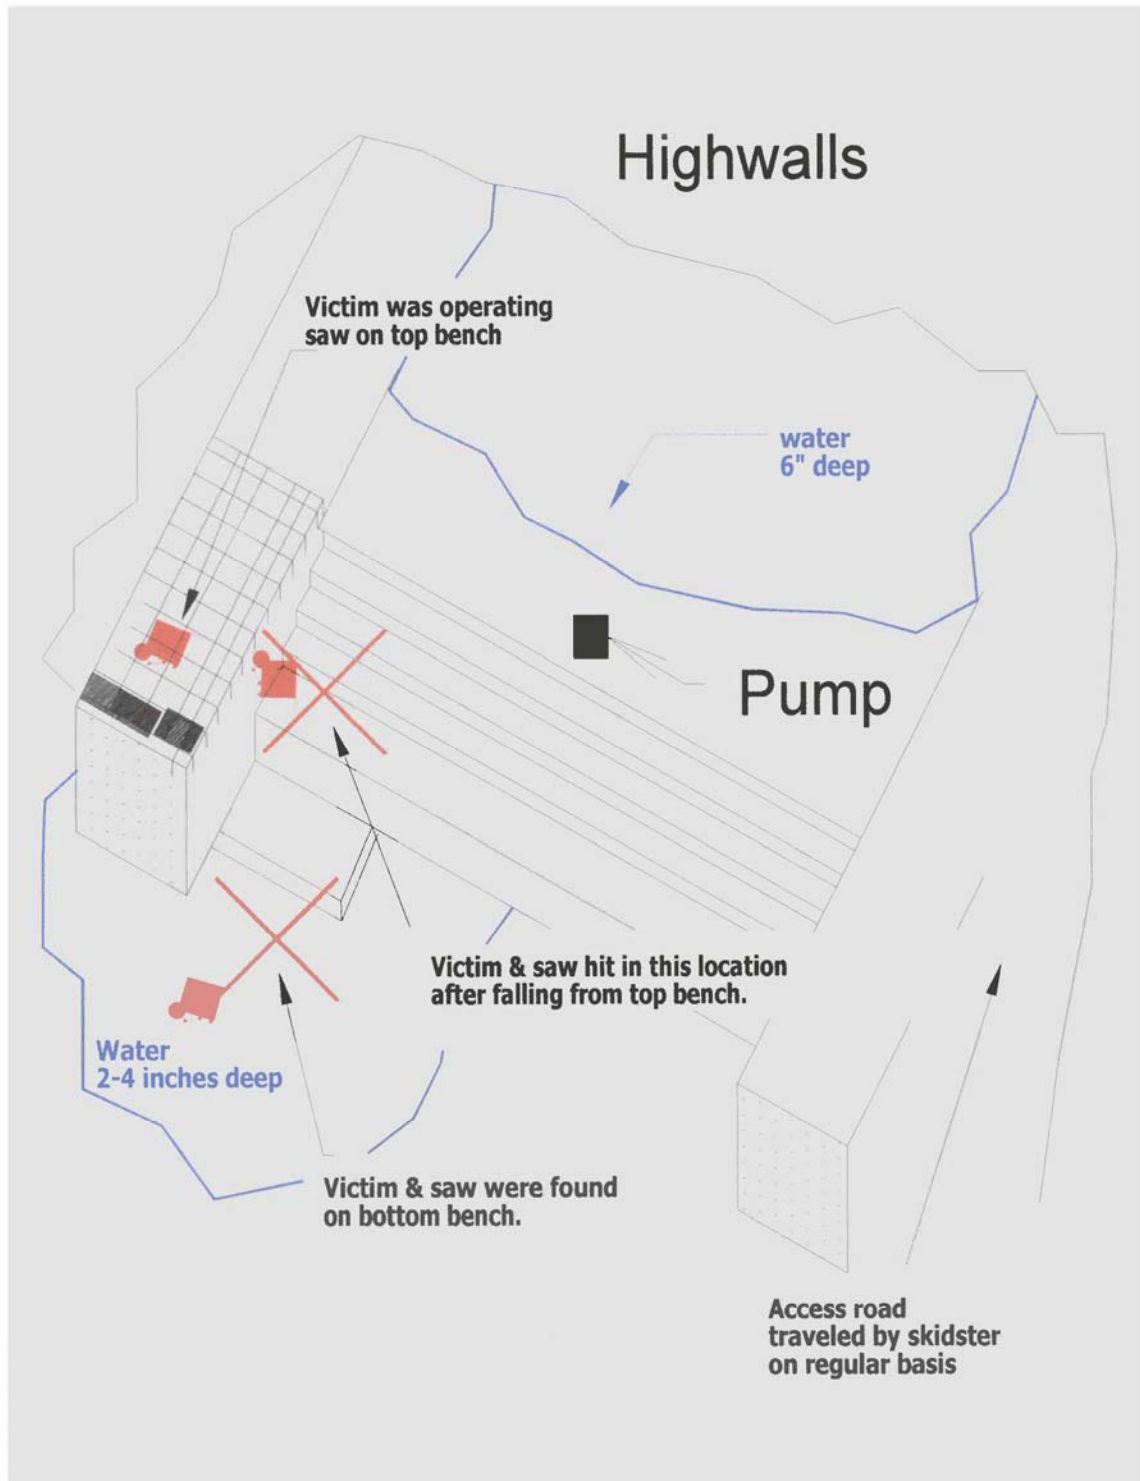
**Figure 1 – Schematic of the Accident Scene**

The quarry pit dimensions were approximately 90 feet long by 70 feet wide. The two sides of the pit had benches approximately 10 feet high by 15 feet wide. The center portion of the pit had been mined and the level of stone stepped down from the rear center bench to the floor approximately 9 feet below the east (right) and the west (left) benches. At the time of the accident, the victim was cutting stone on the east bench and fell into standing water on the quarry floor below (See Appendix C – Figure 1).

**Root Cause:** No procedures were in place for persons to safely operate a walk behind concrete saw on an elevated bench where there was a hazard of falling. No berms or guardrails were provided and maintained along the edge of the bench where a nine foot drop off existed.
