# MNMM Fatal 2010-09

- Explosives Accident
- May 28, 2010 (California)
- Underground Gold Mine
- Supervisor
- 62 years old
- 20 years of experience

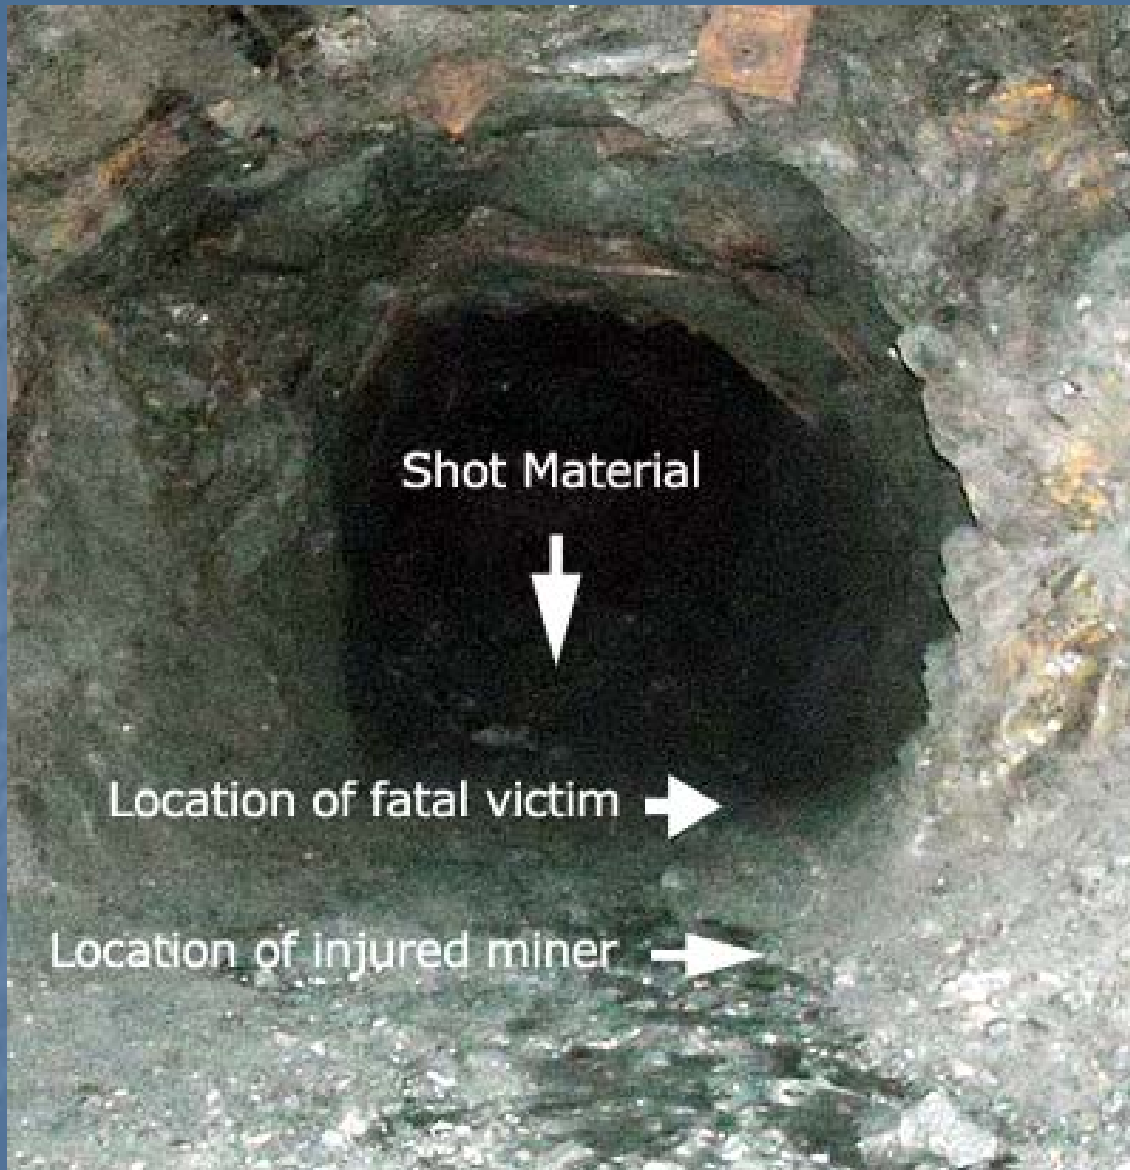
The victim died when an unplanned delayed initiation of explosives occurred. The victim and another miner entered a blast area to check it. When they were within 25 feet of the face, the misfire detonated and both miners were struck by fly rock from the blast. The other miner was injured, hospitalized, and later released.

The accident occurred because management failed to ensure that policies and procedures to protect miners in blast areas were followed. The procedures did not ensure that miners did not return to the blast site for at least one hour after the suspected burning stopped.

Shot Material

Location of fatal victim →

Location of injured miner →

**Corrective Action:** The deteriorated explosives have been removed from the mine site. Management trained all miners in the proper time to wait for suspected misfires or burning explosives.
