MNM Fatal 2010-12

- Powered Haulage Accident
- June 20, 2010 (Arizona)
- Copper Operation
- Mechanic
- 52 years old
- 8 years of experience

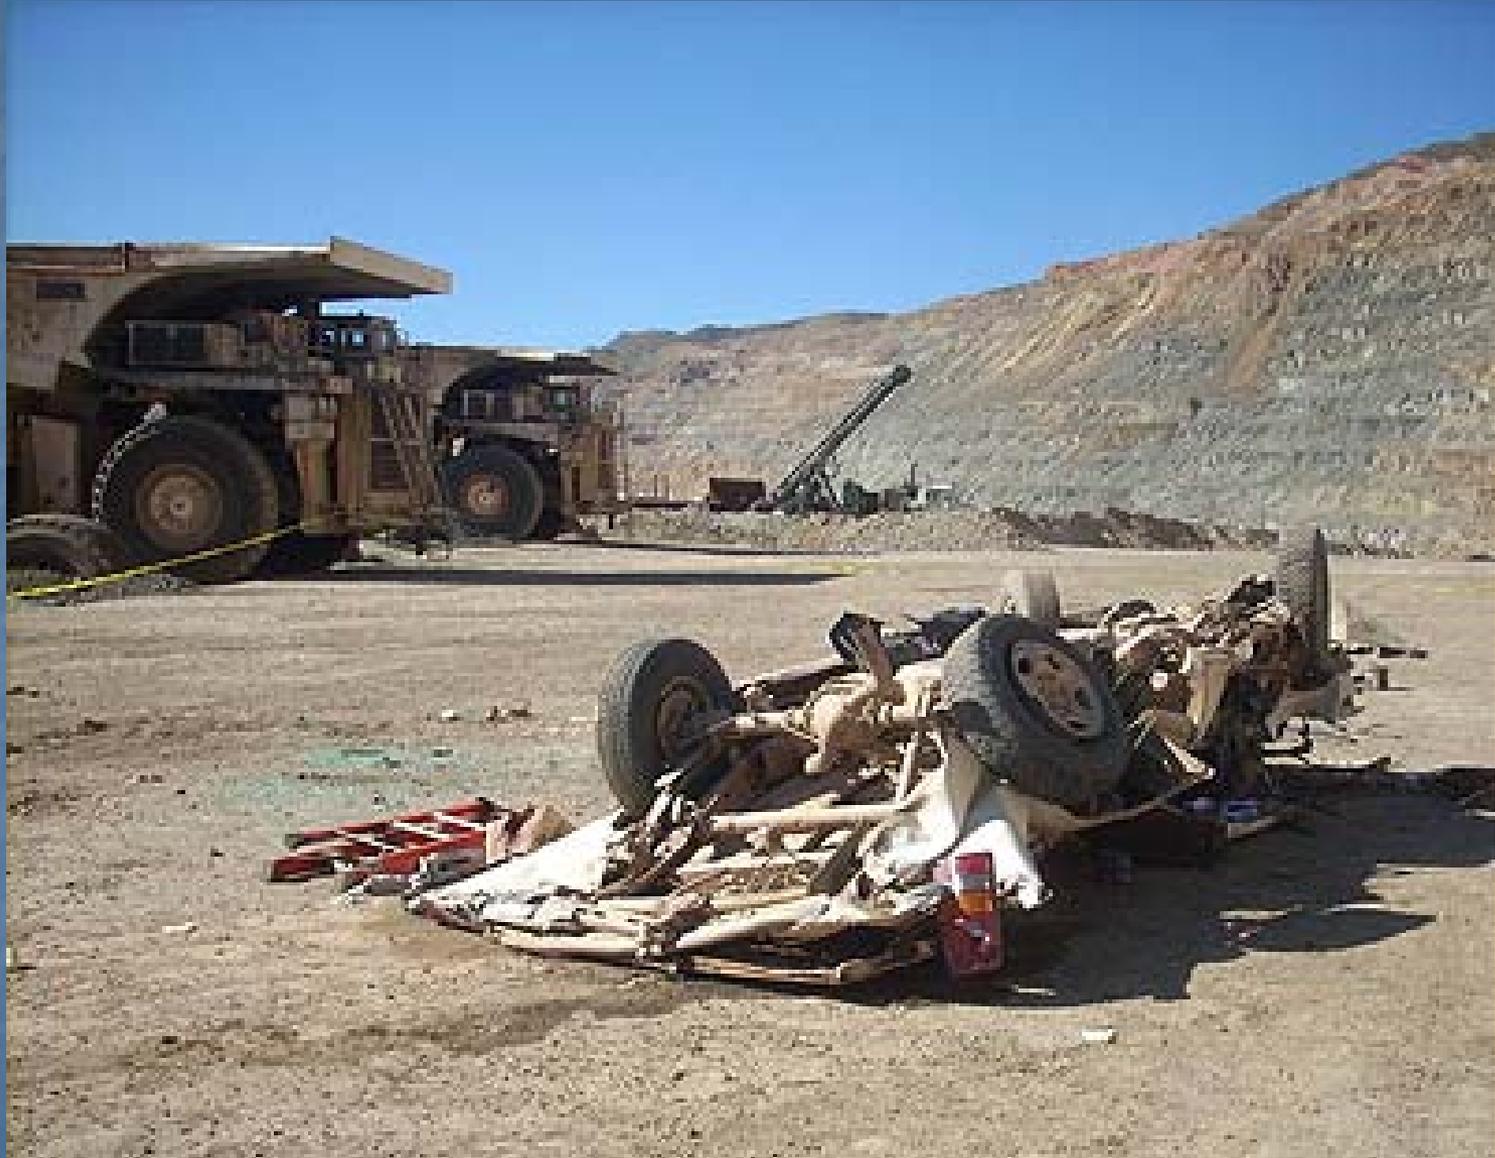
The victim died on June 20, 2010, when the ½-ton pickup truck he was operating was struck by a 240-ton haul truck. The pickup truck had parked in front of the haul truck just prior to the accident. A passenger in the pickup truck, was seriously injured in the accident.

The accident occurred because management policies, procedures, and controls were inadequate and failed to ensure that persons could safely park small vehicles near larger haul trucks. On June 14, 2010, large haul truck tires were placed in the parking area to demarcate parking spaces for mobile equipment that would then be parked between the large tires. This project was completed on June 16, 2010, four days prior to the accident.

With this configuration, the smaller vehicles could not park beside the larger haul trucks as before. Management did not establish new procedures and policies designating specific non-blind parking areas for smaller vehicles or require radio communications between the drivers of small vehicles and the haul truck operators.

Root Cause: Established traffic control policies and procedures were not being followed for travel in the pit area. Tires added to demarcate parking spaces prevented service and maintenance vehicles from parking next to the driver's side of any haul truck.

Corrective Action: Management established new procedures in the mine's "Self-Propelled Mobile Equipment Field Service & Repair Approach and Departure" policy designating specific non-blind areas for service and maintenance vehicles to park. Procedures were established requiring service and maintenance vehicles to be parked next to the driver's side of a haul truck.

The procedures also require persons traveling in service and maintenance trucks in the pit area to monitor a specific radio channel. These persons must make contact with the haul truck operator or the dispatcher prior to pulling up to a truck that was in use. Persons must also yield the right of way to haul trucks. The 8-foot buggy whips on service and maintenance trucks were replaced with 12-foot buggy whips with orange mesh flags mounted at the top. All miners were trained regarding these new policies and procedures.
