MNMM Fatal 2010-20

- Powered Haulage Accident
- November 13, 2010 (Texas)
- Sand & Gravel Operation
- Contract Mechanic
- 42 years old
- 23 years of experience

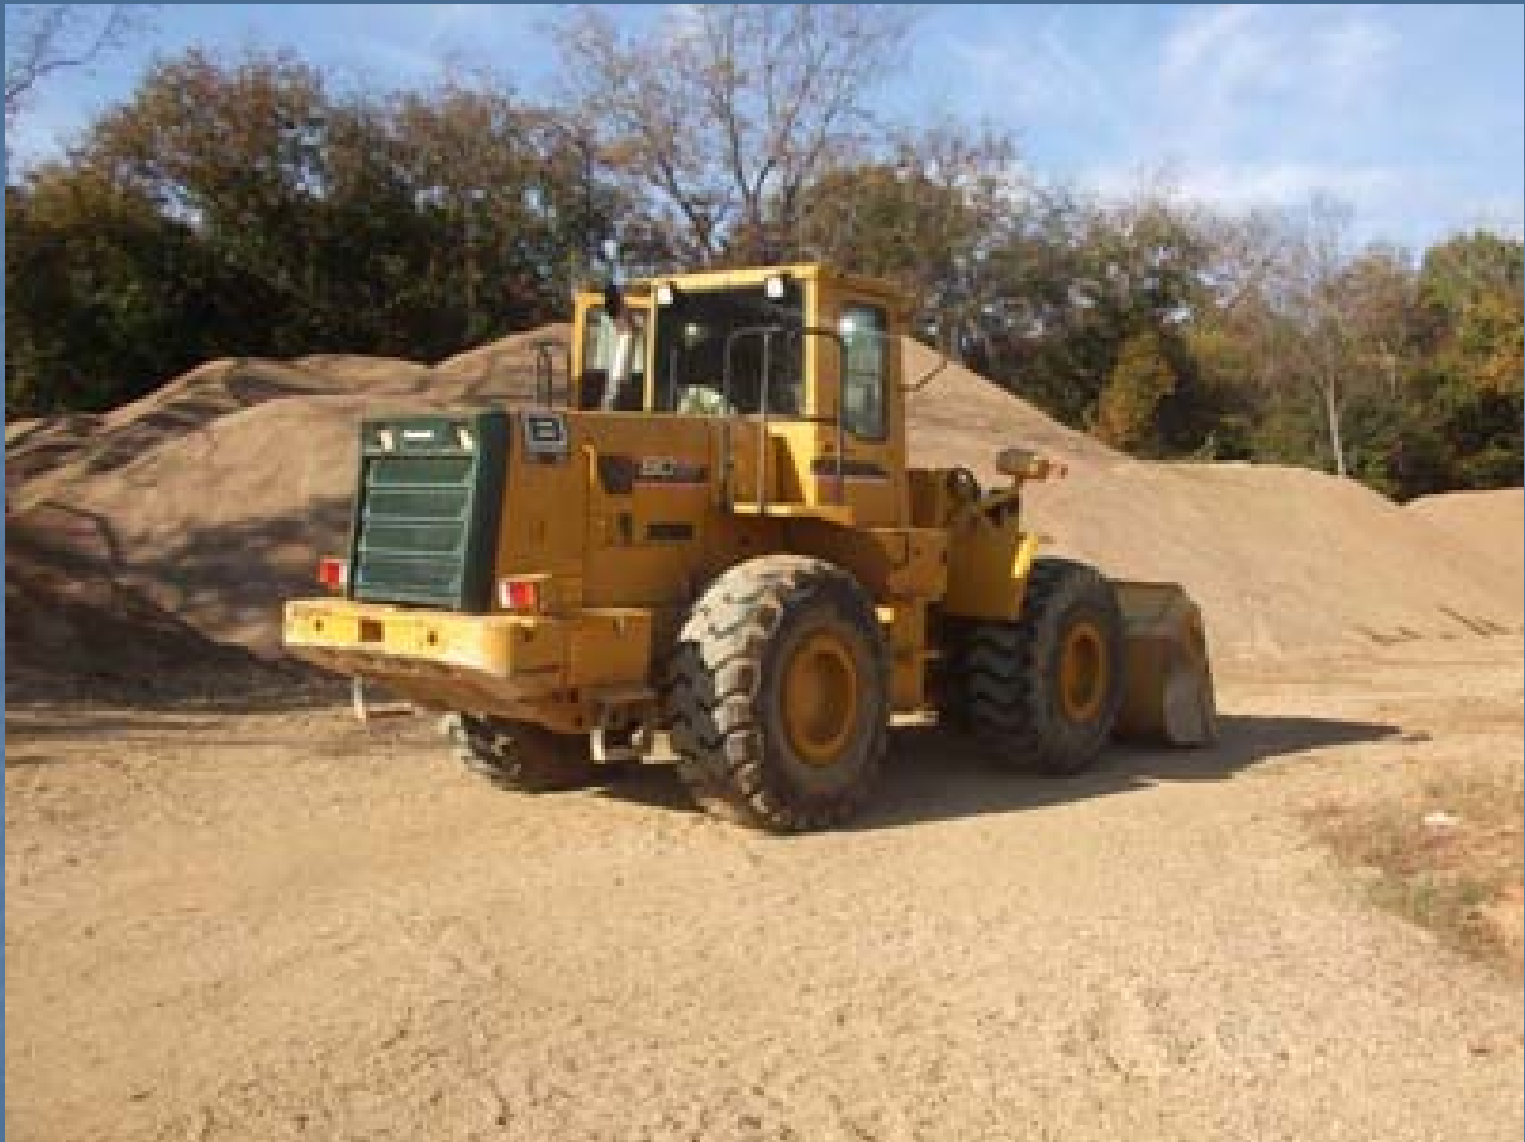
The victim died when a front-end loader rolled over him. He was underneath the loader, with the engine running, checking for leaking fluid.

The accident occurred because management policies and procedures did not ensure that persons could safely perform maintenance tasks on a front-end loader. The power was not off and the front-end loader was not blocked against hazardous motion. The machine was parked on a slight grade, the bucket was raised off the ground, and the wheels were not chocked.

Root Cause: The contractor did not utilize safe work procedures while performing maintenance work on mobile equipment.

Root Cause: Mine management failed to correct unsafe work practices by the contractor working on mobile equipment at the mine.

Corrective Action: The victim was a sole proprietor working as a contractor. Upon his death, the sole proprietorship ceased to exist.

Corrective Action: All persons were retrained in proper procedures for working around unattended mobile equipment. Mine management will monitor contractors working at the mine for safe work practices.
