**Fatality #23 - December 23, 2010**

**Falling, Rolling, Sliding Material - Florida - Crushed, Broken Limestone NEC  
MID Coast Aggregates LLC - Mid-Coast Aggregates LLC-Mazak Mine**

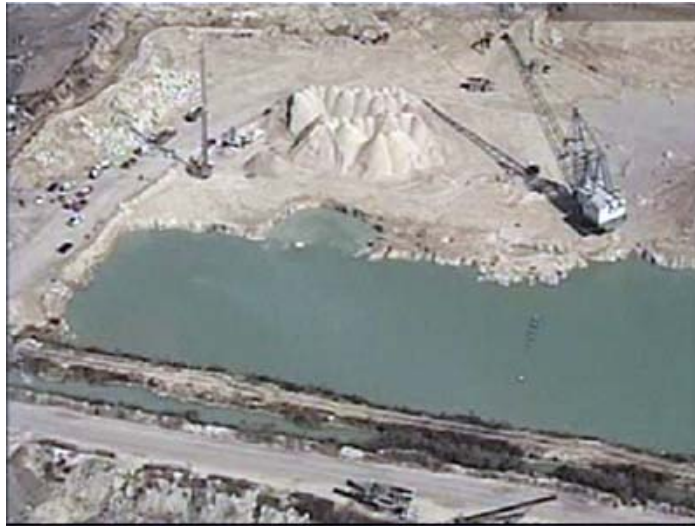
**METAL/NONMETAL MINE FATALITY** - On December 23, 2010, a 35 year- old contract blaster with 12 years of experience died at a crushed stone operation. After firing the blast, he immediately walked into the blast site to examine the shot material. The victim was approaching the edge of the shot material when the ground collapsed, engulfing him in the water-filled pit.

- Conduct effective workplace examinations in areas where contractors are working. Identify all hazards, and take action to correct them.
- Establish mining plans based on geological evaluations and implement procedures to effectively protect all persons.
- Establish methods to identify subsurface cavities and voids such as advance drilling and geophysical surveys (ground penetrating radar - GPR), electrical resistivity, or other available methods.
- Wait at least 15 minutes or longer before conducting post-blast inspections. Take additional time if geological anomalies or other hazards are identified during drilling or blasting.
- Keep a safe distance from cracks or any other signs of unstable ground conditions.
- Tie off using a secure anchorage zone.
- Wear a life jacket where there is a danger from falling into water.
