REPORT OF INVESTIGATION

Powered Haulage
May 10, 2010

Ruby Energy
Spartan Mining Co., Inc.
Delbarton, Mingo County, West Virginia
I.D. No. 46-08808

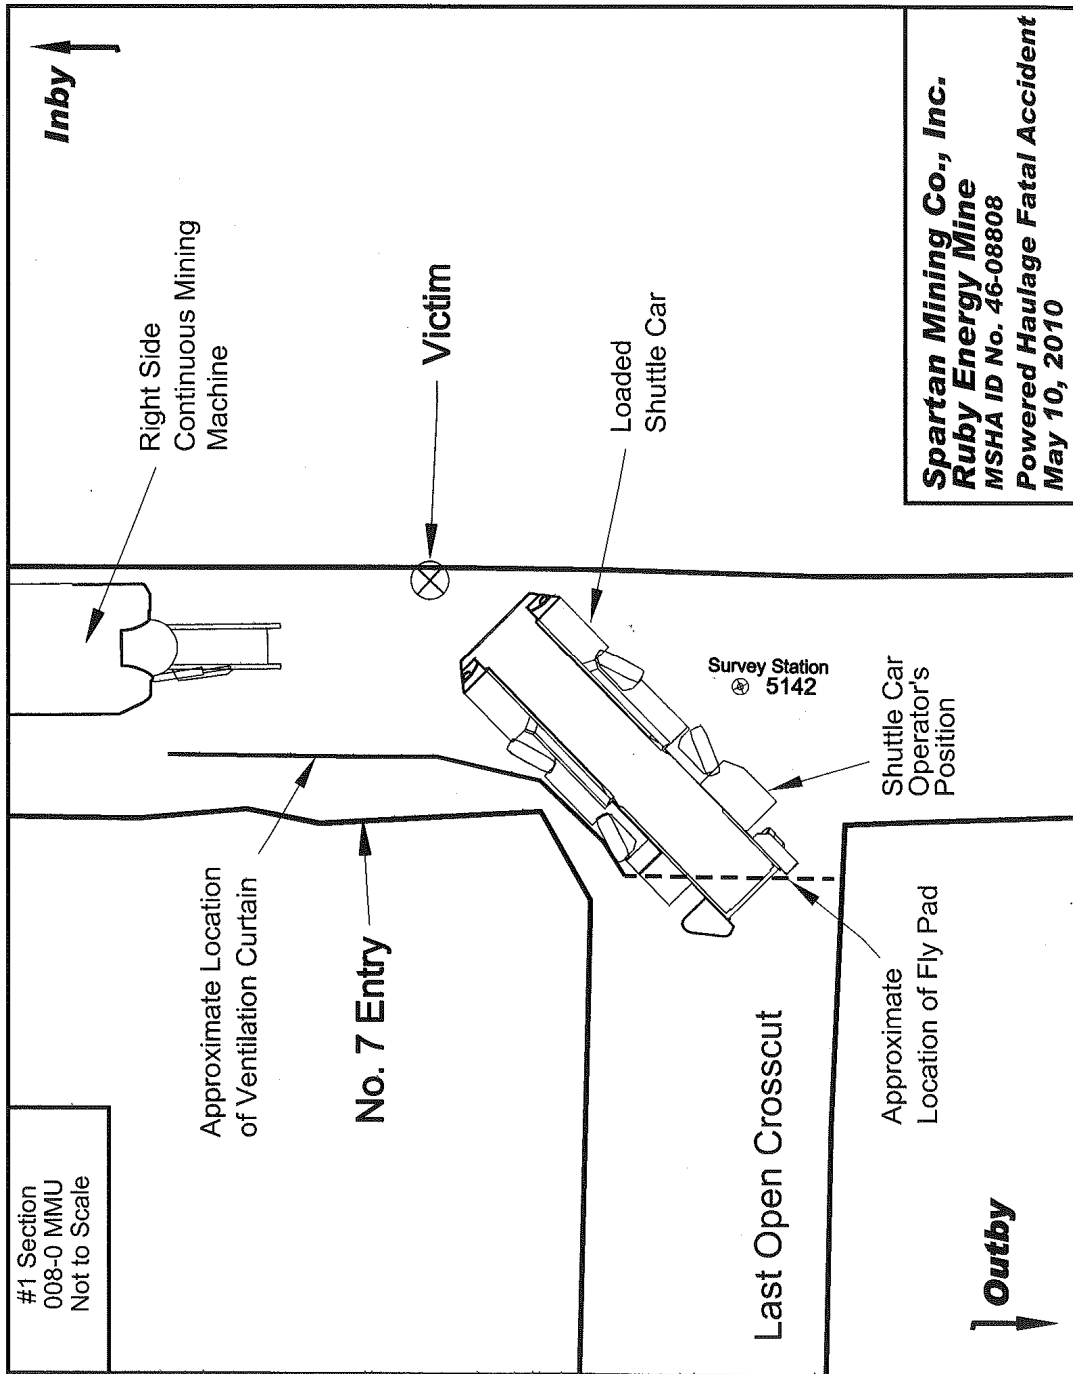
APPENDIX C
 Sketch of the Accident Scene

Erwin informed Williams that the area of the fall would have to be cleaned. With the stopping installed in the crosscut between the No. 5 and No. 6 Entries, the haul road previously used at the 2nd open crosscut was blocked. This required the shuttle cars to use the last open crosscut and travel through ventilation fly pads installed at the mouth of the No. 7 Entry. When Williams went through the fly pads into the No. 7 Entry, Erwin positioned himself in the intersection. Once the shuttle car was in the entry and under the continuous mining machine, Erwin went into the entry, stood along the right rib and loaded the car using his mining machine remote control unit. As the shuttle car left the entry, Erwin stayed in the entry near the continuous mining machine. A second shuttle car load was needed to clean the area and Williams returned with his shuttle car. Erwin again positioned himself in the intersection as the shuttle car traveled into the entry. When the shuttle car was under conveyor boom of the continuous mining machine, Erwin went back into the entry to load the car. After the shuttle car was loaded, Erwin signaled Williams, "that was all," and positioned himself along the right rib. Williams thought Erwin was in a safe location and started tramming his shuttle car out of the area. See Appendix C.

The location of the accident was approximately 23 feet inby Survey Station No. 5142 in the No. 7 Entry of the 1st East Sub Mains. The mining height in the entry

averaged 72 inches. The entry was developed approximately 56 feet in by the last open crosscut. The fallen draw rock was located approximately 20 feet in by the last open cross cut, extending in by towards the face of the No. 7 Entry. Approximately 21 feet of the entry was supported with roof bolts. The entry width in the supported area was 16 feet 9 inches, up to 17 feet 9 inches. The mine floor was dry, broken, and somewhat uneven and irregular. Mine floor elevations taken by the operator showed the entry and crosscut to be relatively flat.

When accident investigators went to the accident scene, a ventilation curtain was installed on the left side of the entry. Fly pads were installed across the intersection and curtain was installed from the fly pads to the next to last row of roof bolts. The ventilation curtain was installed 2 to 3 feet off the left rib. The distance from the curtain to the right rib averaged 14 feet. A continuous mining machine was located on the right side of the entry with the cutter head against the face. A shuttle car was located in the intersection at an angle, with the loaded end next to the right rib in the entry, extending through the fly pads and into the crosscut. The shuttle car was approximately two thirds loaded. The shuttle car had been moved to recover the victim.

Although the shuttle car operator's visibility was limited as he passed through the fly pads installed in the intersection, the car was trammed into the entry without hitting either the left or the right rib. The right inby end of the shuttle car only cleared the right rib by inches. The car was then positioned under the continuous mining machine to replicate the accident. When the shuttle car left the continuous mining machine, it started turning into the last open crosscut immediately. As the shuttle car made the turn into the crosscut, the inby end of the car, on the right side, was approximately two inches from the rib, where Erwin was reported to have been located when the accident occurred. Once the shuttle car started turning, the car operator's vision of the continuous mining machine operator was restricted by the load and the angle of the car.
